M- ARYABHATA
MAHALUNGE, PUNE, MAHARASHTRA - 411045
QAQC AUDIT REPORT
16TH APRIL 2025

Building and Infrastructure Division
Site Inspection/ Audit Report

INSPECTION / AUDIT REPORT/ MGPUNE/ARYABHATA/BVP/QAQC/CIVIL/IR-05		REV.NO. 01
<input type="checkbox"/> Initial	<input checked="" type="checkbox"/> Interim	<input type="checkbox"/> Final
<input type="checkbox"/> Resident.		
Inspection/ Audit Requested By : Malpani Venture Pvt. Ltd.		
Inspection / Audit performed as Recognised Authority : Rohan A Patil		Yes <input checked="" type="checkbox"/> NO: <input type="checkbox"/>
BV Job / Zig No : 21641326

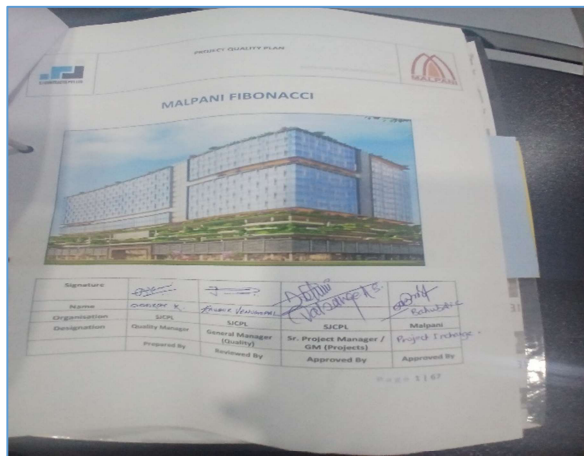
Sr. No.	LOCATION	AUDIT FINDINGS / OBSERVATIONS	TYPE OF FINDINGS	IMAGE/ EVIDENCE	Status
1	M Fibonacci Site	Construction status at Tower A & A1	Info	Building : Basement + Ground + 6 Podiums + Amenity + 11 Floors Current Status :Podium 6 RCC 100% + Amenity RCC 50 % Complete+ Office 1 Shuttering under progress.	Info
2	Site Office	Project quality plan with QAP & ITP was available at Site Office	Positive

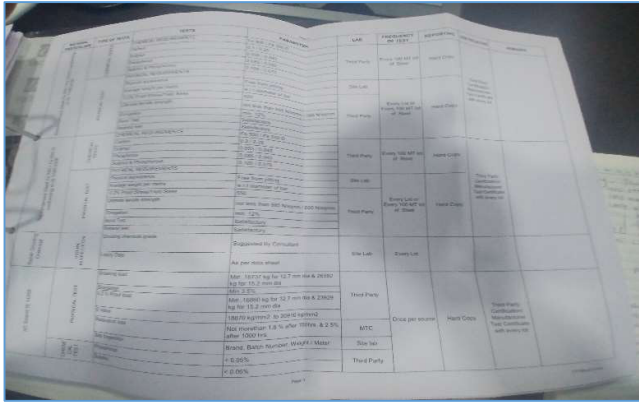
3	Site Office	ITP was available at Site Office. ITP for HT strands w.r.t the diameter needs to be revised.	Info

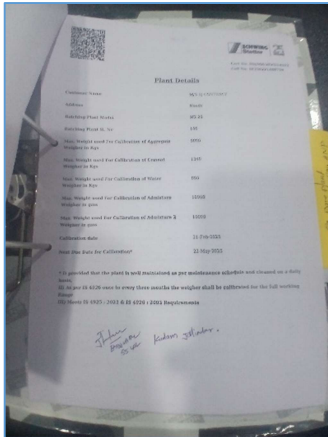
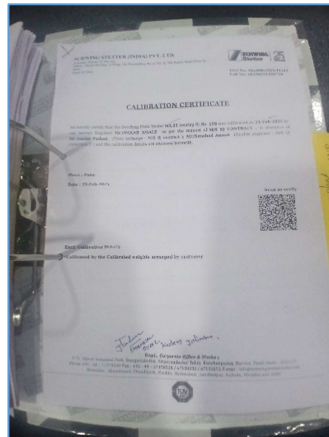
Report No- Nil Rev 03 dtd.01.12.2024
4	Site Office	Batching plant calibration certificates verified & found valid as per QAP requirements. Model M2.25 bearing Sr.No – 196 Calibration date 21/02/2025 Due date 22/05/2025	Positive

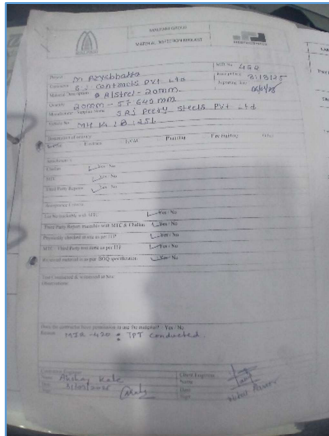
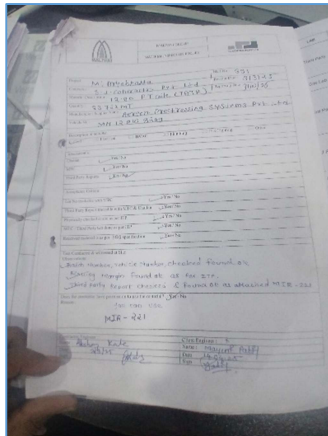
5	Site Office	<p>Material inspection report available at site. Checked randomly MIR as per ITP and found in order.</p> <ol style="list-style-type: none"> MIR no 422 dtd. 31.03.2025 of reinforcement, observations in the MIR to be filled uniformly and vehicle no to mentioned properly. MIR No 391 dtd.31.03.2025 of PT strands, one per source test as per ITP to be mentioned in the respective MIR. 	Minor Observation

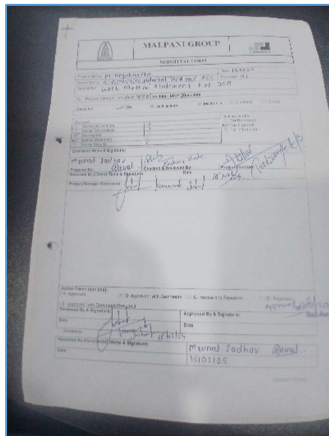
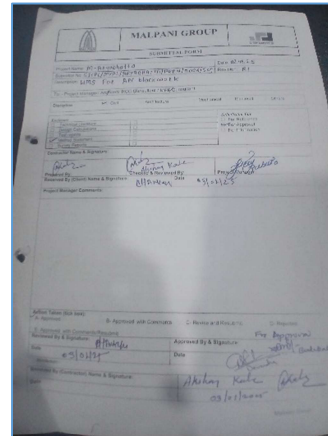
6	Site Office	<p>Randomly checked the WMS for different activities are available as per ITP and maintained at site.</p>	Positive

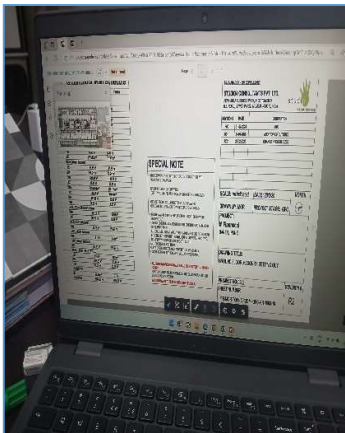
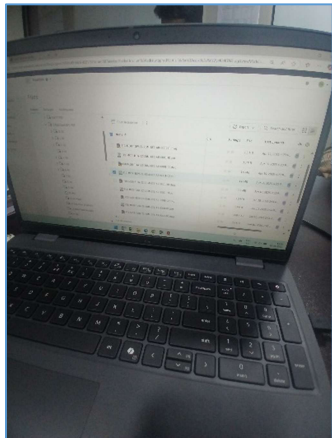
7	Site Office	Drawings are maintained on BIM Platform with latest revision. The previous revision/superseded soft copy in maintained in archive folder.	Positive

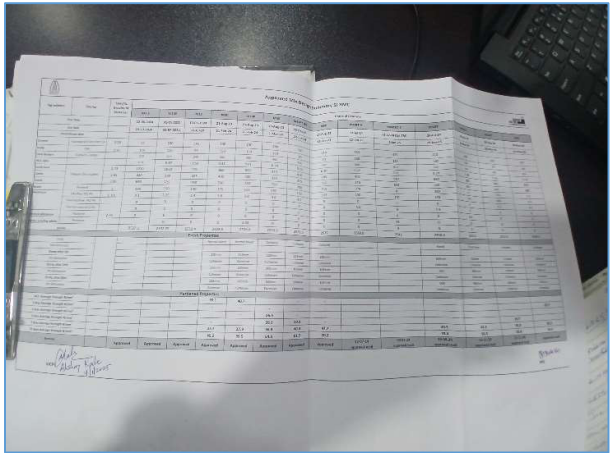
8	Site Office	Concrete mix design with Trials conducted, approved by consultant and is maintained as per QAP / ITP requirements. Standard deviation is calculated for different grades of concrete used at site and record maintained	Positive

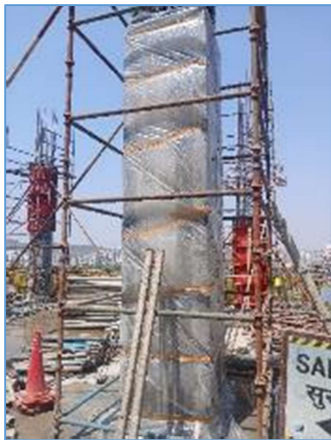
9	Site	Curing is being carried out properly and date of casting is mentioned on member. Vertical Member were covered with plastic sheet to ensure the inside surface remains wet continuously.	Positive

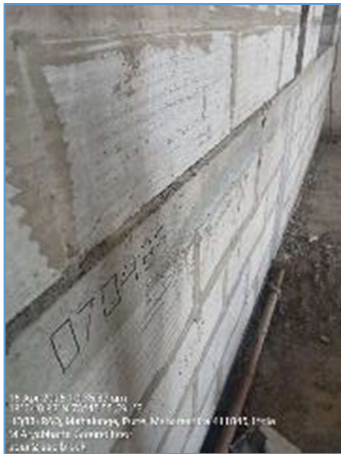
Site Inspection
10	Ground Floor Pour 2 area	AAC block work- 1) Offset observed between the AAC block course and RCC patli beam.	Minor Observation

- 1) Minor Honeycombing observed in concrete surface of wall and column.
- 2) Main bar not provided as per drawing in SW39
- 3) Parapet wall minor crack observed on the concrete surface.
- 4) Minor cracks observed in the ramp slab surface.
- 5) Offset in the AAC block and RCC patli beam observed.
- 6) Damaged block observed in the AAC block work.

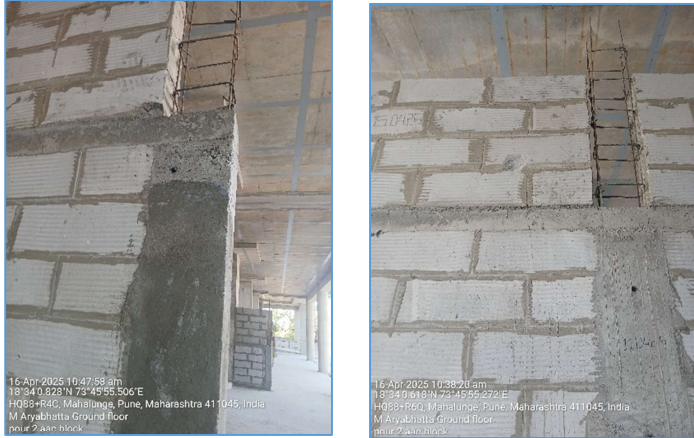
11	Ground Floor Pour 2 area	AAC Block work - 1) Damaged blocks were observed in the block work	Minor Observation

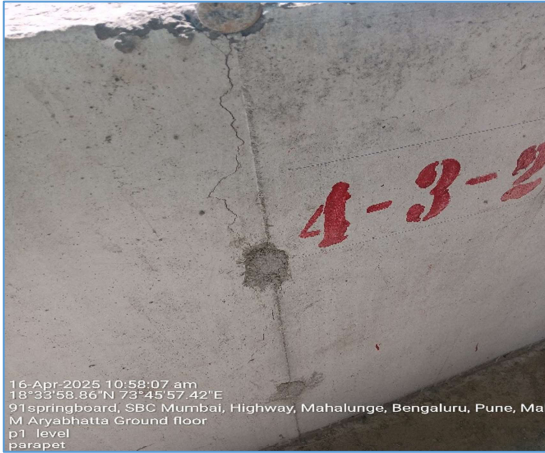
Site Inspection
12	Podium 1 level	RCC – Minor Crack observed in the concrete surface at parapet wall.	Minor observation

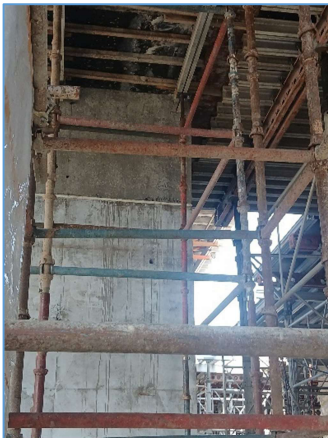
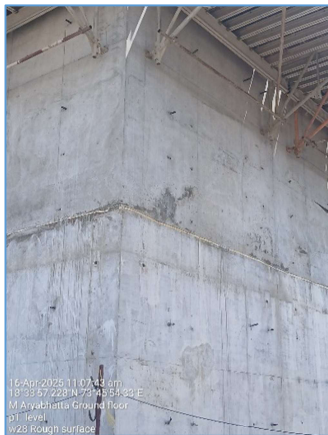
13	Podium 1 Core area Shear wall 28 & 42	RCC- Minor honeycombing observed on the concrete surface.	Minor Observation

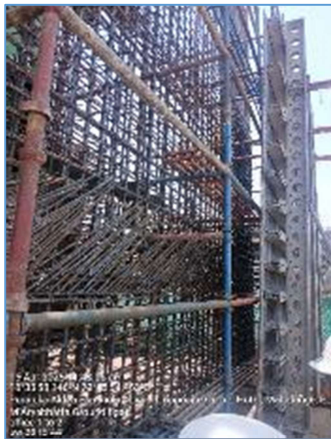
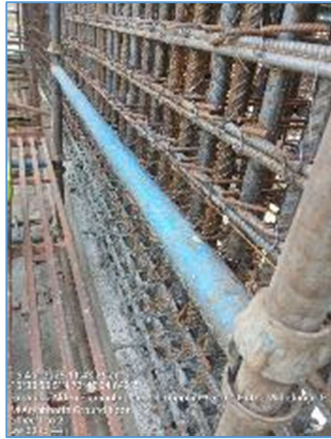
Site inspection
14	Ground Floor Office 1 to 2 SW 39 to 44	Reinforcement – Checked the reinforcement as per drawing, following observation were there, 1) No of main bars observed provided two extras than required as per drawing.	Minor Observation

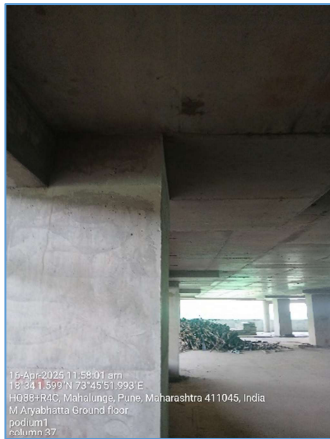
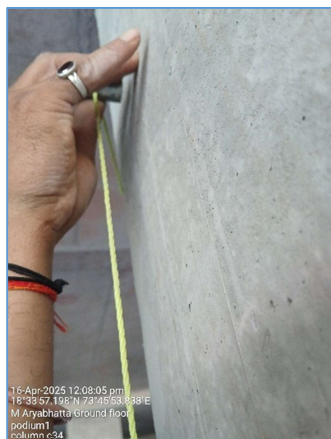
15	Podium 1 Column no 34 and 37	RCC- Deviation in verticality of column member observed up to 6mm	Minor Observation

7) Column observed out of plumb C34 and C11

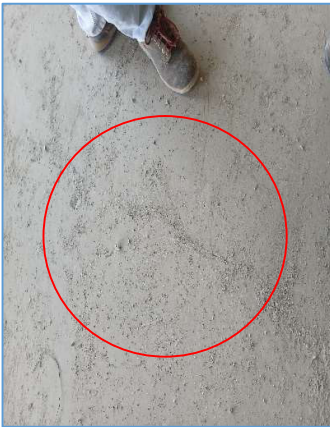
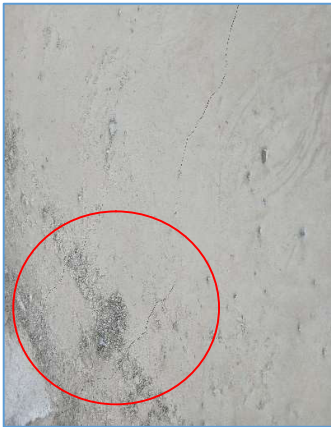
Site Inspection
16	Ground Floor Ramp slab	RCC – Minor cracks observed on the concrete surface of slab.	Minor Observation

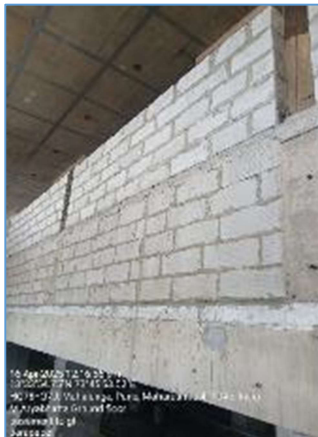
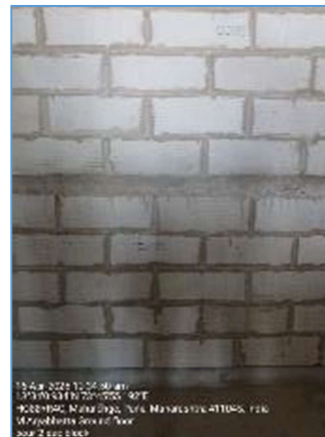
17	Site	<p>AAC Block work –</p> <ol style="list-style-type: none"> 1) AAC block construction is done properly in line and level, vertical joint are in line with alternate course and staggered. 2) Mullions are Provided @ 3m c/c as per the method statement. 3) Thickness of jointing mortar up to 3mm. 4) Concrete (patli) beam casted up to 1.2 m height as per drawing. 5) Notch trowel is used for jointing mortar above block layers. 	Positive

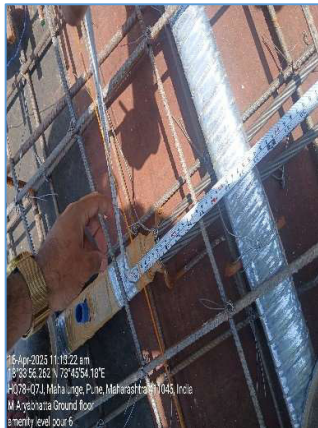
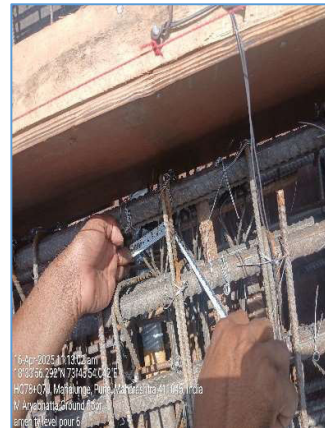
<p>IS 6041:1985 Code of practice construction of autoclaved cellular concrete block work. WMS No- SJCPL/MVPL/ARYAB HATTA/TRAN/2024. 209 R1 dtd. 02.02.2025</p>
18	Amenity Level Pour 6	<p>P T Tendon – Laying of Post tensioning tendons under progress –</p> <ol style="list-style-type: none"> 1) checked the dia. of strands observed 12.9mm 2) Checked the dia. of balloon at fixed end observed up to 75mm. 3) Checked the stressing length observed up to 300mm 	Positive

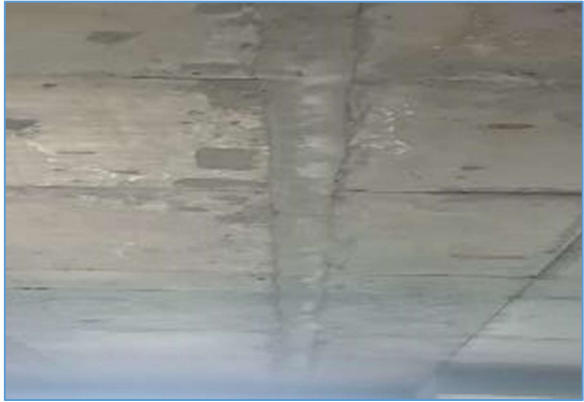
19	Site	RCC- Pour strip finished properly in line and level.	Positive

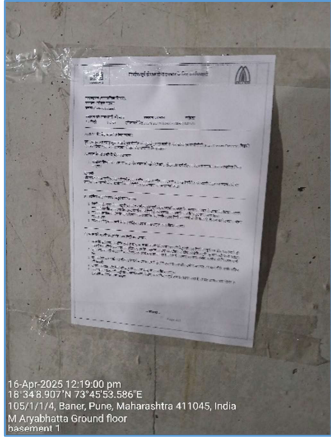
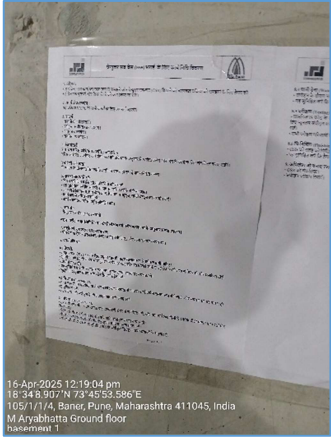
Site Inspection
20	Site	WMS of activity is displayed in regional language at the places where the respective activity is on-going	Positive

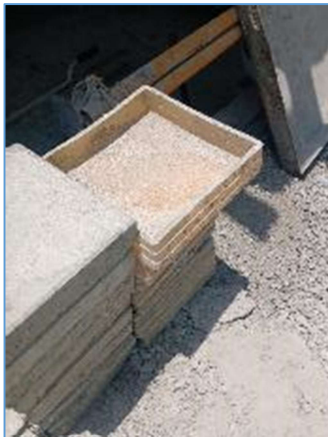
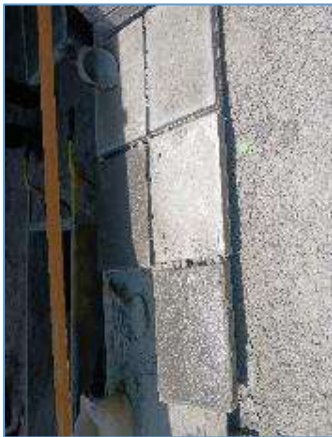
21	Site	Concrete wastage at site is used for casting of paver block and used within the site area	Positive

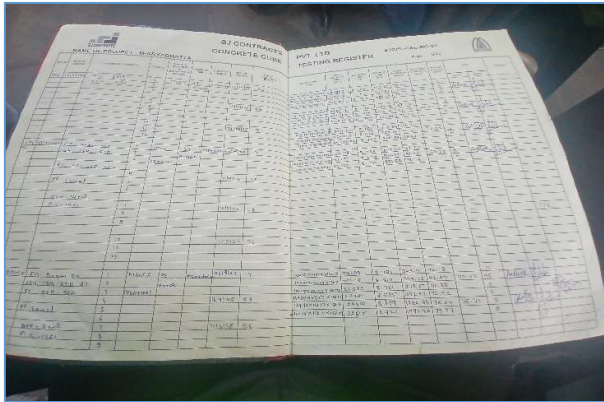
22	Quality Lab	<p>Today's Cube compressive strength test for 28 days cubes witnessed & found confirmed. Grade of concrete M-60FF.</p> <p>Cube Results @ 28 days.</p> <p>1)73.92 N/mm²</p> <p>2)76.64 N/ mm²</p> <p>3)79.57 N/ mm²</p> <p>Avg- 76.71 N/mm².</p> <p>Also Checked the cube register, testing results were observed dully filled as per the pour card and maintained properly</p>	Positive

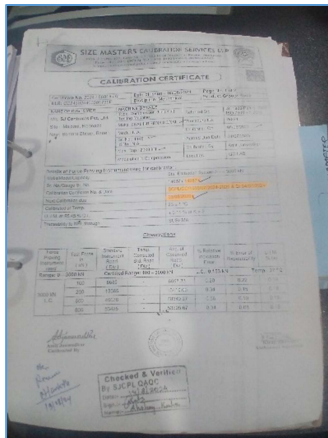
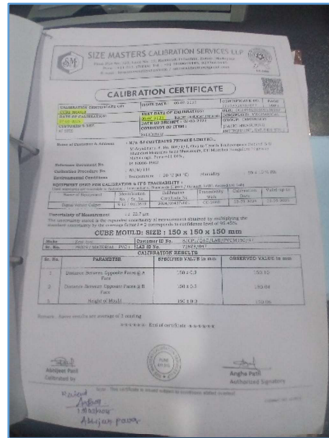
23	Site Lab	<p>CTM & Cube moulds calibration certificates verified & found valid as per QAP requirements.</p> <p>CTM Sr.no – 1148</p> <p>Capacity-3000KN</p> <p>Make -Zeal International</p> <p>Due date 31/07/2025</p>	Positive

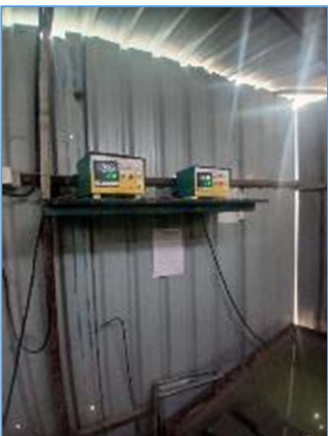
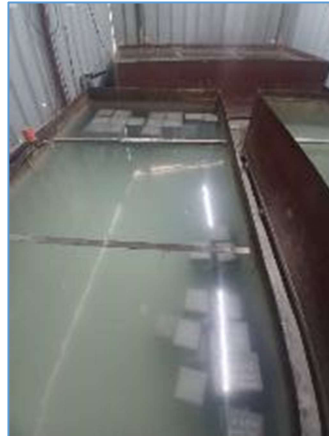
<p>Certificate No - 2024/68815/01</p> <p>dtd.03/08/2024</p>
24	Site Lab	<p>Cube curing tank with thermostatic control to maintain the temperature of water. Observed temp 27.4 °C and 27.5 °C - OK.</p> <p>Cleaning of curing tank is done weekly.</p>	Positive

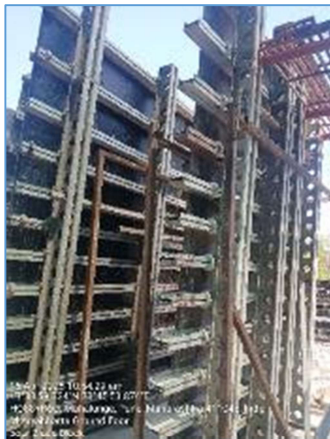
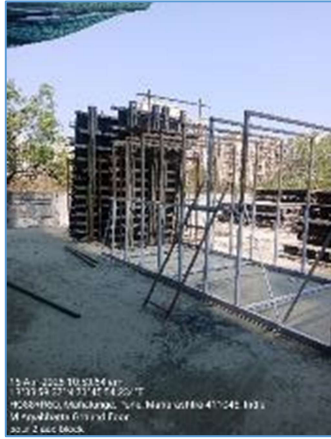
27	Site	Arrangement is done at site for vertical stacking of formwork to avoid the damages to the panel face.	Good Practice

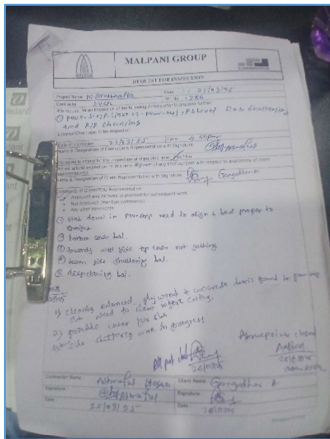
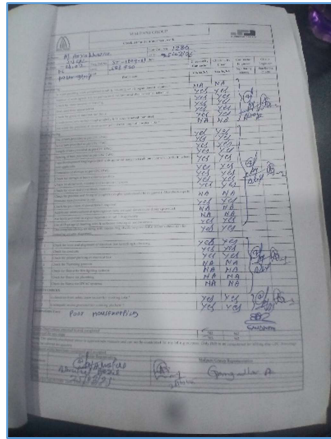
28	Site Office	RFI being raised by contractor & inspection for reinforcement, Formwork & pour card is being carried out by Client. Records are maintained as per requirements.	Positive

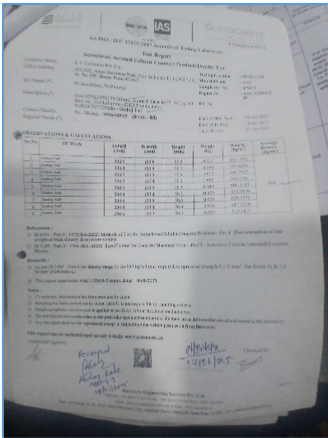
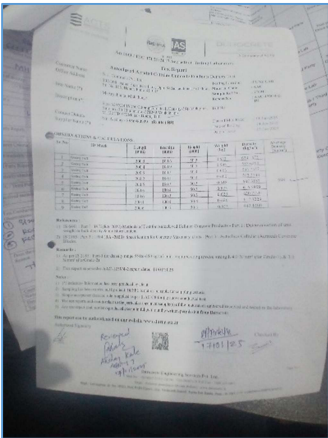
29	Site Office	<p>Randomly reviewed in house as well as third party test reports for construction materials & found maintained properly as per ITP requirements</p> <p>1) As per ITP pull off test and split tensile test has not been carried out</p>	Minor Observation

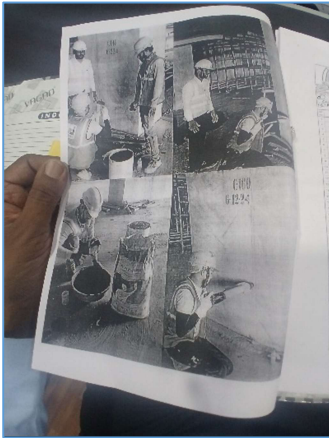
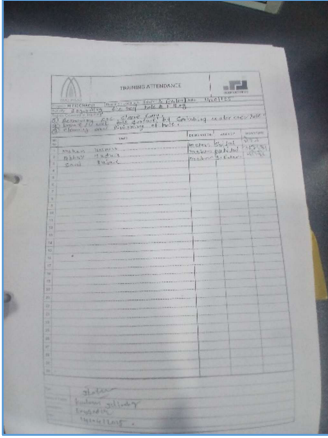
Report No – AAC-1250/4-R1 dtd11.01.2025
30	Training	Randomly checked Training records.	Positive
