Building and Infrastructure Division
Site Inspection/ Audit Report

MEP INSPECTION / AUDIT REPORT.MGPUNE/FALCON/BVP/QAQC/CIVIL/IR-01		REV.NO. 0	
<input checked="" type="checkbox"/> Initial <input type="checkbox"/> Interim <input type="checkbox"/> Final <input type="checkbox"/> Resident.			
Inspection/ Audit Requested By : Malpani Group			
Inspection / Audit performed as Recognised Authority : Sandesh Patankar		Yes	<input checked="" type="checkbox"/> NO: <input type="checkbox"/>
BV Job / Zig No : 21641199

Project Name : M Falcon	IPO (if applicable):N/A
Audit by : Bureau Veritas (India)Pvt Ltd, Mumbai	PO no. WO/BK/2024/141 Dt. 31.01.2024
Vendor/Manufacturer : Malpani Group	PO No. N/A (Client to Vendor)
Architect : <u>Morphogenesis</u>	Contractor : S J Contracts Pvt. Ltd.
Sub Vendor : NA	Vertical : Civil
Inspection Location : M Falcon – Baner Pune	Previous Inspection : No
Inspection Performed from : 22 th March 2024.	Next Inspection : As per Clients requirement

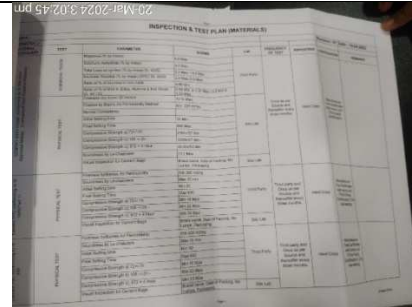
A. INSPECTION & FINDINGS					
Sr. No.	LOCATION	AUDIT FINDINGS / OBSERVATIONS	TYPE OF FINDINGS	IMAGE/ EVIDENCE	Status
1	M Falcon Site	Construction status of Tower	Info	Building : 2 Basement + Ground + Mezzanine + 5 Parkings + 17 Floors Current Status : RCC Works completed except 1 Slab + Blockwork & internal plaster in Services area ongoing	Info
2	Site Office	Project quality plan with QAP & ITP was available at Site Office	Positive

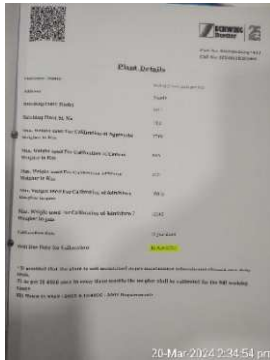
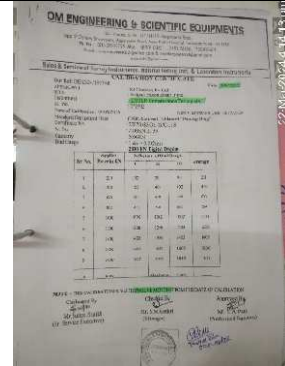
3	Site Office	Batching plant, CTM & Cube moulds calibration certificates verified & found valid as per QAP requirements	Positive

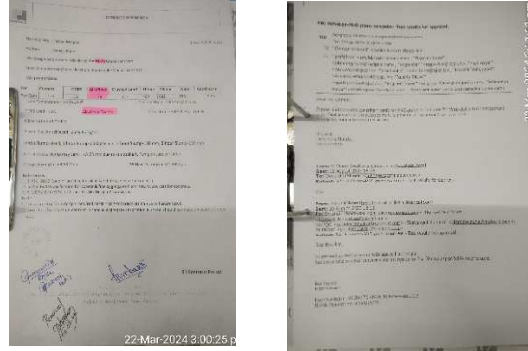
4	Site Office	Concrete mix design with Trials conducted & approval taken through mail from RCC consultant, is maintained as per QAP / ITP requirements	Positive

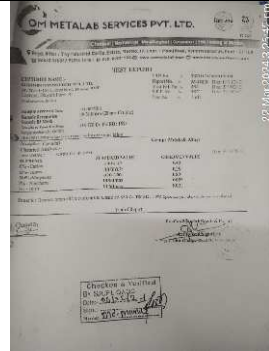
5	Site Office	Randomly reviewed in house as well as third party test reports for construction materials & found maintained properly as per ITP requirements	Positive

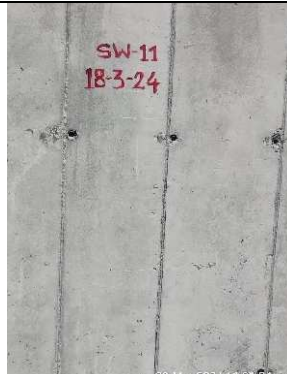
Some of the tests not performed in NABL accredited Lab as test certificates do not have NABL stamp.
6	Site	Curing compound applied over vertical RCC surface immediately after de-shuttering	Positive

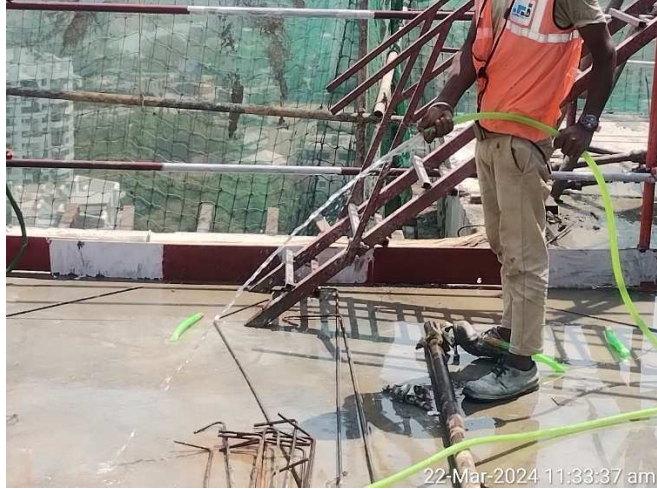
7	Site	Water pounding & curing is being done over RCC Slab (Horizontal RCC)	Positive

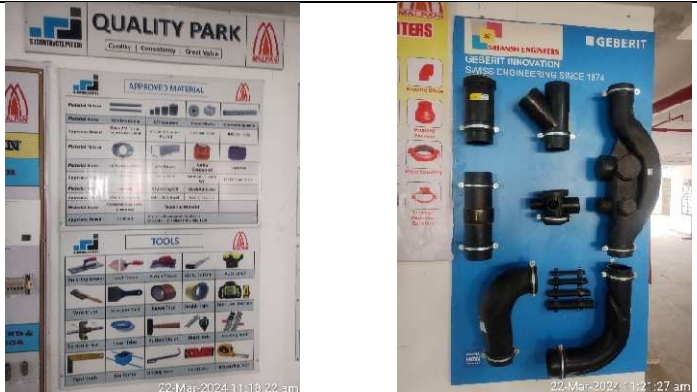
8	Quality Lab	Today's Cube compressive strength test for 28 days cubes witnessed & found satisfactory. Cube curing tank with thermostatic control to maintain the temperature of water.	Positive		
9	Site Lab	Quality park near office to understand materials to be used & procedures to be followed during construction is maintained.	Positive

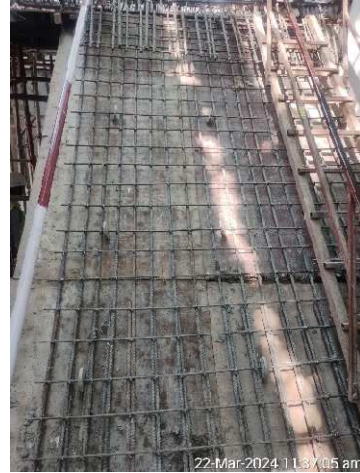
10	Site, 17 th Floor	Shuttering oil not applied over waist slab shutter but reinforcement fixed	Minor Observation

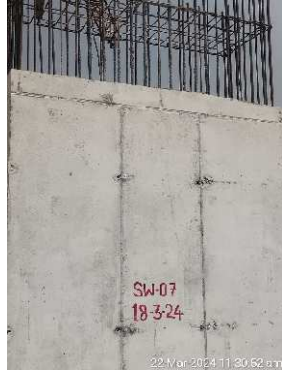
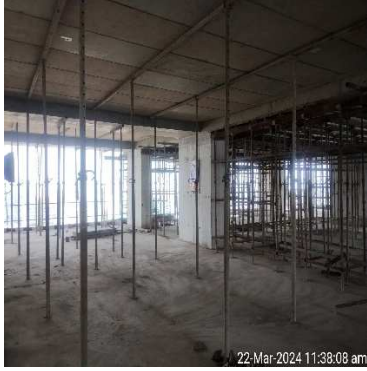
11	Site, 17 th Floor, 16 th Floor	Shutter / Joint offsets observed over RCC slabs & shear walls	Minor Observation

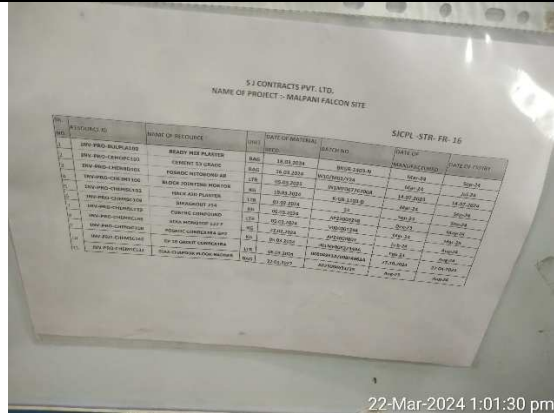
12	Material Store	All required materials are stored inside shed with their expiry date	Positive

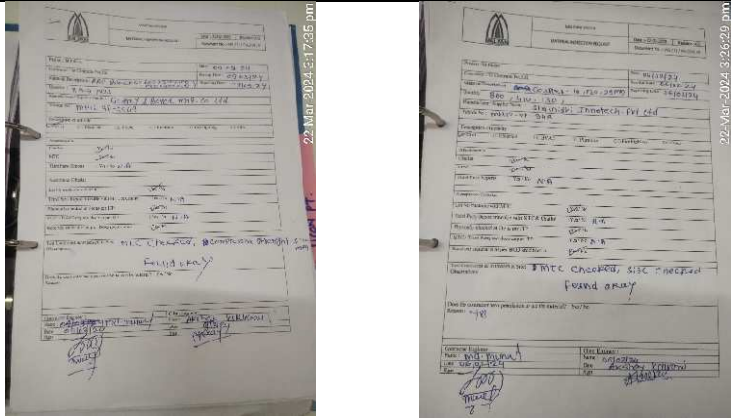
13	Site Office	MIR format for Incoming material is filled on regular basis & MTC /tests to be conducted as per ITP requirements.	Positive

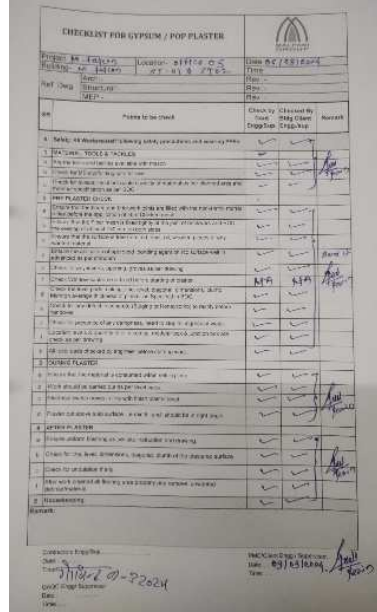
14	Site	RFI being raised by contractor & inspection for ongoing activities is being carried out by Client. Records are maintained as per requirements.	Positive

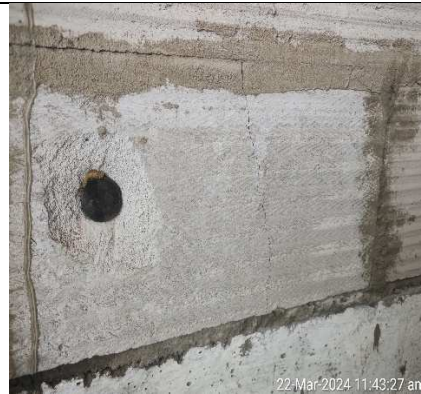
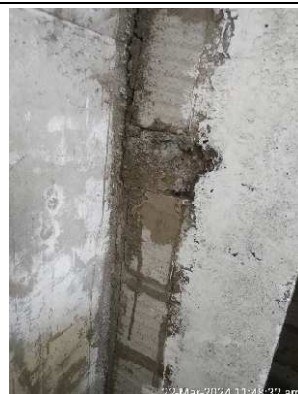
<p>Handwritten checklist titled 'CHECKLIST FOR GYPSUM / POP PLASTER'. It includes fields for Project No., Building, Plot, and Date. The checklist has multiple rows with checkboxes and handwritten notes. The date '22-03-2024' is written at the bottom.</p>	
15	Blockwork	<p>While fixing formwork for mullions & bands – Blocks damaged.</p> <p>At some places vertical joints not <u>staggered</u> at 1/3 rd length of the block</p> <p>(For 600mm Block length – Joint <u>to be placed at Min. 200mm or as per manufacture's recommendation</u>)</p>	Minor Observation
