M- KAUTILYA
VIMAN NAGAR, PUNE, MAHARASHTRA - 411014
QAQC AUDIT REPORT
17TH APRIL 2025

Building and Infrastructure Division
Site Inspection/ Audit Report

INSPECTION / AUDIT REPORT/MGPUNE/KAUTILYA/BVP/QAQC/CIVIL/IR-04		REV.NO. 00
<input type="checkbox"/> Initial	<input checked="" type="checkbox"/> Interim	<input type="checkbox"/> Final
<input type="checkbox"/> Resident.		
Inspection/ Audit Requested By: M- NETWORK ESTATE PVT LTD		
Inspection / Audit performed as Recognised Authority: Rohan A Patil		Yes <input checked="" type="checkbox"/> NO: <input type="checkbox"/>
BV Job / Zig No : 21641690

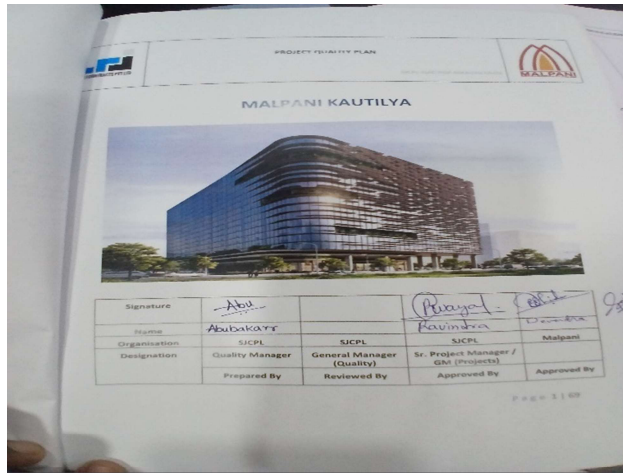
Sr. No.	LOCATION	AUDIT FINDINGS / OBSERVATIONS	TYPE OF FINDINGS	IMAGE/ EVIDENCE	Status
1	M Kautilya	Construction status at Tower	Info	Building : Basement + Stilt+Ground + Podiums + Amenity + 11 Floors B3 slab -100% +B2 slab -100%+B1 slab 100%+Stilt Floor- 100% +GF-100%+Podium 70%+Amenity 70%+Central Core upto 5 th Slab complete	Info
2	Site Office	Project quality plan was available at Site Office	Positive

<p>The image shows a Project Quality Plan (PQP) document for the Malpani Kautilya project. It includes a photograph of the building and a table with signatures and designations. The table has columns for Signature, Name, Organization, Designation, Prepared By, Reviewed By, Approved By, and Date. The document is signed by Abubakar and Ravindra, both from SJCL, with designations of Quality Manager and Sr. Project Manager / GM (Projects) respectively. The date is 01 dtd. Nil.</p>	Doc no – SJCL- QAC-PQP-Kautilya- 01 dtd. Nil

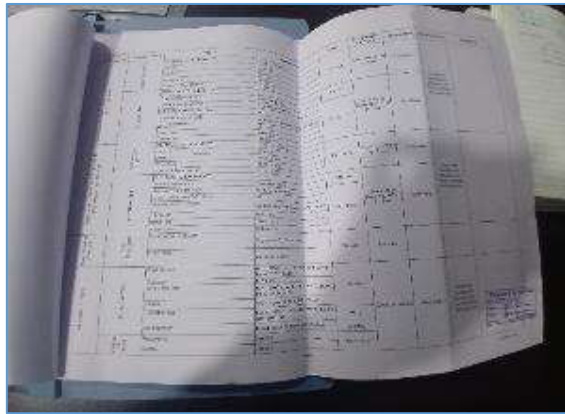
3	Site Office	ITP was available and maintained at the site. Approved by client.	Positive

IPT no Nil Rev 03 Dtd 01.12.24
4	Site Office	Material inspection report available at site. Checked randomly MIR as per ITP and found in order	Positive

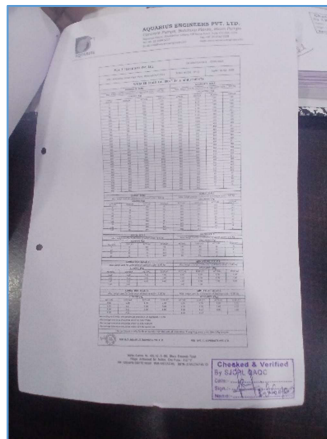
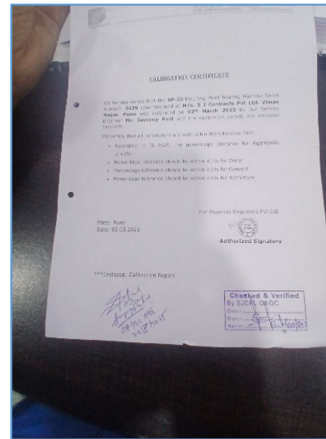
5	Site Office	Batching plant, calibration report 1) Plant Model SP30 bearing Sr. No-3039, Aquarius make calibrated on 03/03/25, verified & found valid as per QAP requirements.	Positive

Cert No -Nil dtd.03/03/25 IS 4926 : 2003 Ready Mix concrete. IS 4925:2004 Concrete Batching and Mixing Plant
6	Site Office	CTM, Cube Mould etc calibration report verified and found valid as per QAP Requirements. CTM Model -ZI-2458-ES Sr.No -1146 Due date – 25/01/2026	Positive

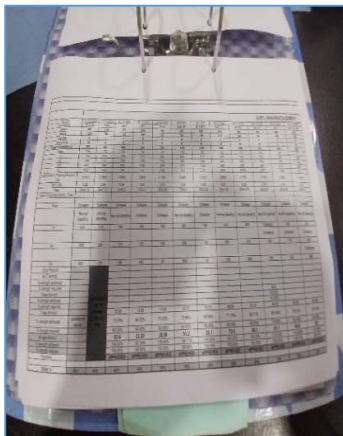
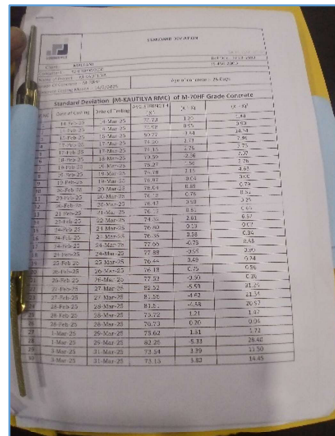
7	Site Office	Concrete mix design with Trials conducted, approved by consultant and is maintained as per QAP / ITP requirements. Standard deviation is calculated for different grades of concrete used at site and record maintained.	Positive

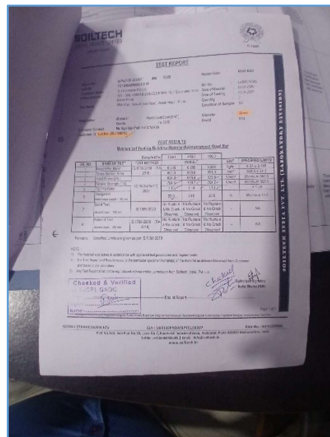
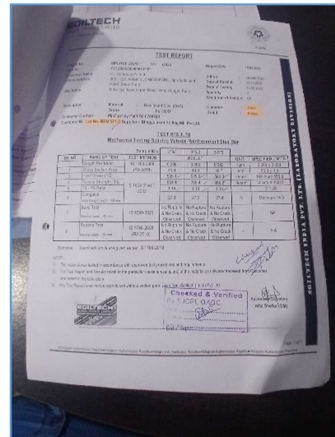
Report No - SIPL/TCF-222/ST 375/2025 dtd.15.03.2025 of Reinforcement

8	Site Office	Randomly reviewed in house as well as third party test reports for construction materials & found maintained properly as per ITP requirements	Positive

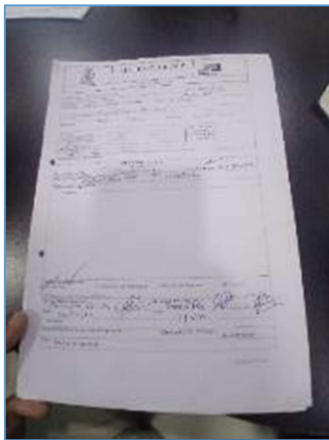
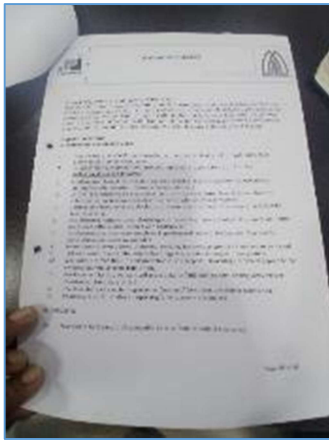
9	Site Office	Randomly checked the WMS for different activities are available as per ITP and maintained at site.	Positive

Submittal No-MKautilya/48 dtd.24.03.2025 of PT Works
10	Site office	Drawings are maintained on BIM Platform with latest revision. The previous revision/superseded soft copy in maintained in archive folder.	Positive

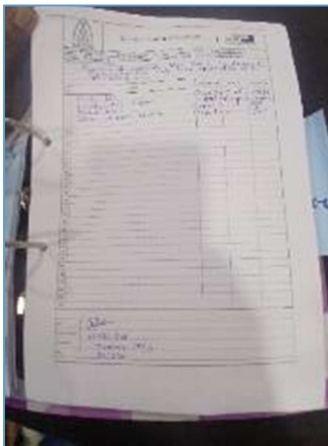
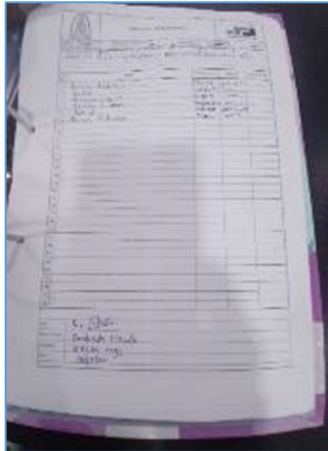
11	Site Office	Randomly checked training record for various personnel involved in the site activity. Records were in order	Positive

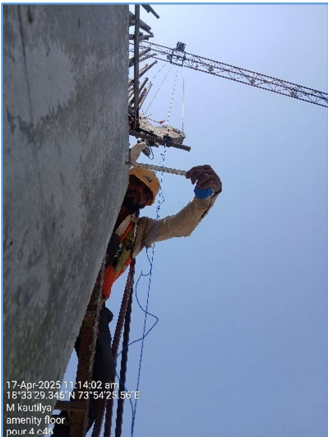
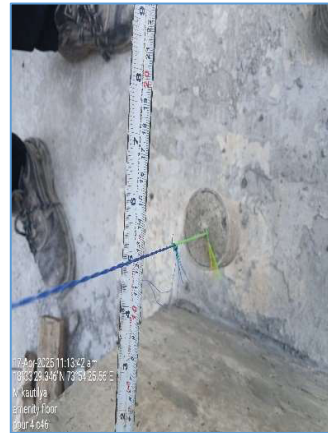
12	Amenity Floor Column C46 and C45	RCC – Deviation in verticality of column observed up to 7mm	Minor Observation

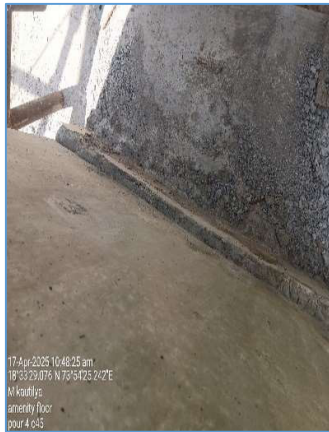
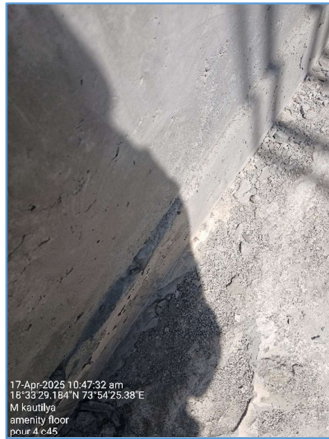
<p>17-Apr-2025 10:40:25 am 18°33'29.076"N 73°54'23.242"E M Kauliya amenity floor pour 4-c45</p>

13	Amenity Level Column no C45	RCC- Offset observed in the concrete surface at bottom level of column.	Minor Observation

- 1) Member number and date of casting not mentioned.
- 2) Offset observed at the column successive lift portion.
- 3) Binding wire were visible on the concrete surface.
- 4) Vertical Tendon profile were not as per the drawing.

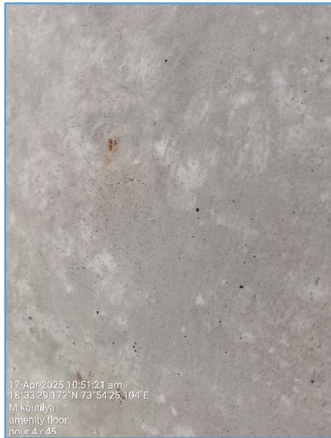
<p>17-Apr-2025 10:51:21 am 18°33'29.172"N 73°54'25.194"E M Kauliya amenity floor pour 4-c45</p>   <p>17-Apr-2025 10:48:30 am 18°33'29.076"N 73°54'25.242"E M Kauliya amenity floor pour 4-c45</p>	Site Inspection

<p>17-Apr-2025 10:47:32 am 18°33'29.154"N 73°54'23.38"E M Kauliya amenity floor pour 4-c45</p>	Site Inspection
14	Amenity Level Column C45	RCC- 1) Binding wire were visible on the concrete surface. 2) Minor honey combing observed on the concrete surface at column corner.	Minor Observation

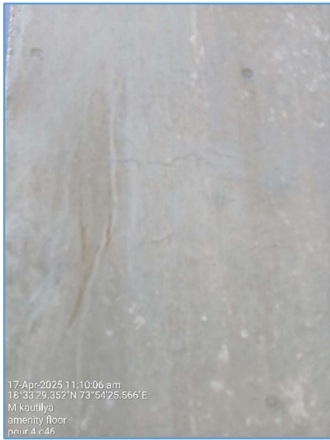
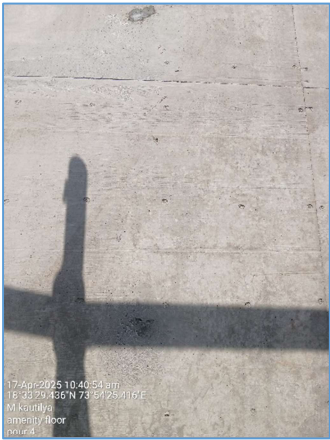
15	Amenity Level column Pour 4	RCC – Date of casting, member number were not mentioned on the columns	Minor Observation

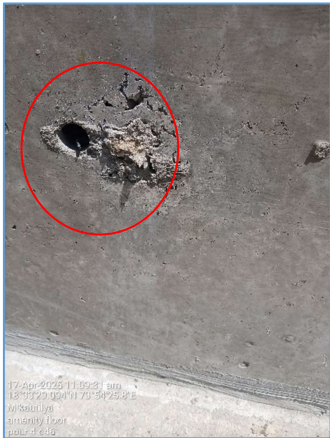
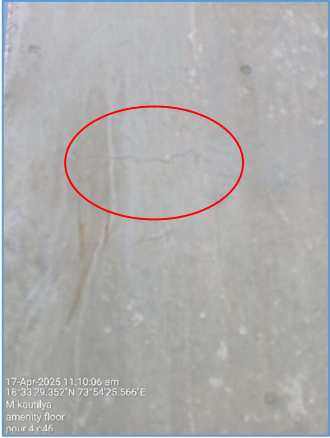
Site Inspection
16	Amenity Level Pour 4 Column C46	RCC – 1) Minor cracks observed on the concrete surface of column. 2) Shuttering panel face at the tie rod holes is being wear out leading improper/rough surface of concrete.	Minor Observation

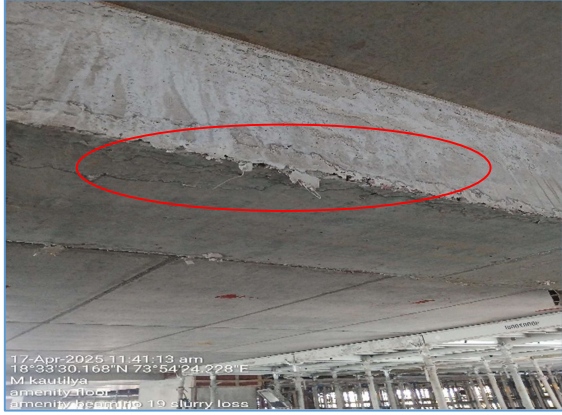
19	Amenity slab beam no 19	RCC – Slurry leakage observed at the beam soffit level.	Minor Observation

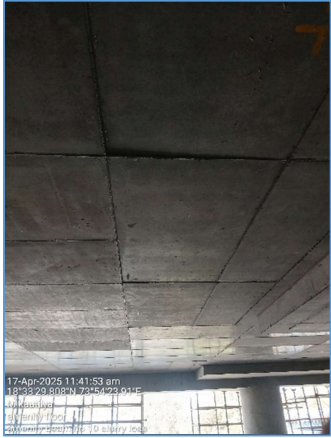
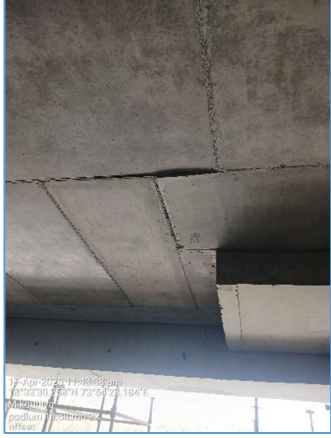
Site Inspection
20	Podium 1 Amenity soffit slab	RCC – Offset were observed in the concrete surface at form joints in slab soffit level.	Minor Observation

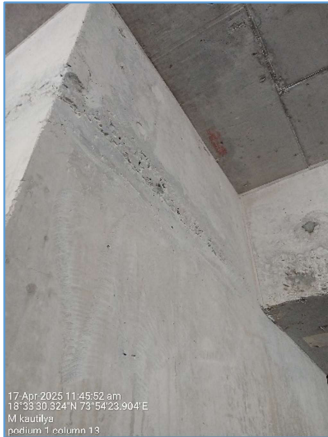
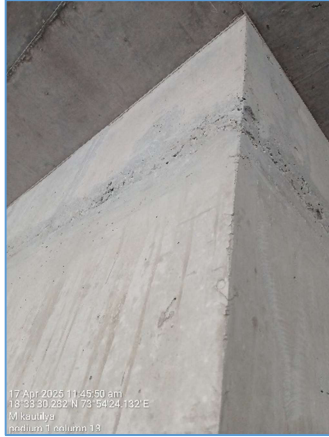
21	Podium Column no 13	RCC – Rough surface observed at the top portion of column.	Minor Observation

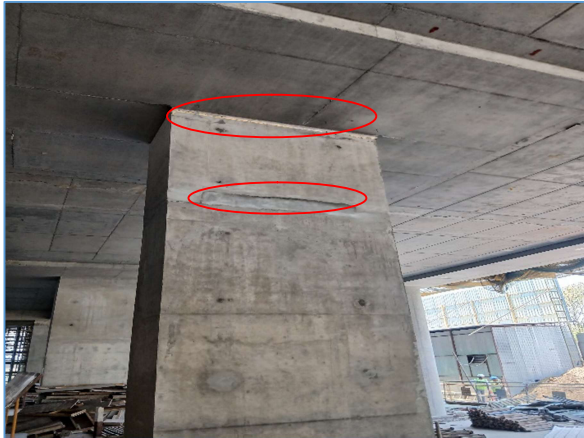
Site Inspection
22	Ground Floor Column 13	RCC- Minor cracks observed in the repair work done and double side tape not being removed even after de-shuttering (Date of casting 10.01.2025)	Minor Observation

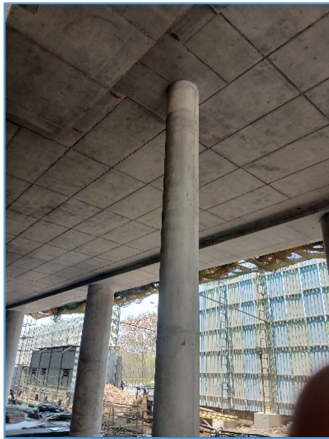
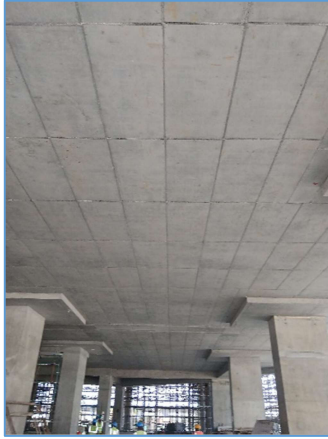
23	slab soffit level.	RCC— Form finish surface observed, no honey combing and no offset were visible on the surface.	Positive

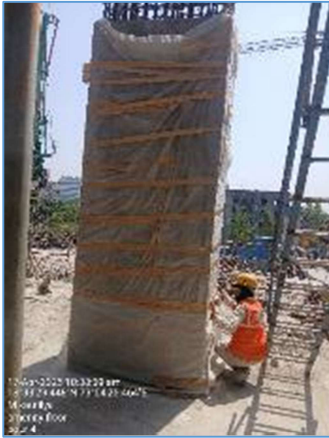
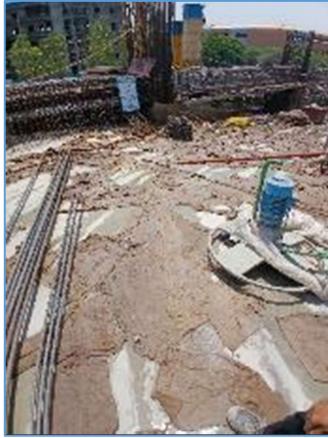
Site Inspection
24	Site	Curing is being carried out properly and date of casting is mentioned on member. Vertical Member were covered with plastic sheet to ensure the inside surface remains wet continuously. Horizontal members water sprinkling was done covered with hessian cloth.	Positive

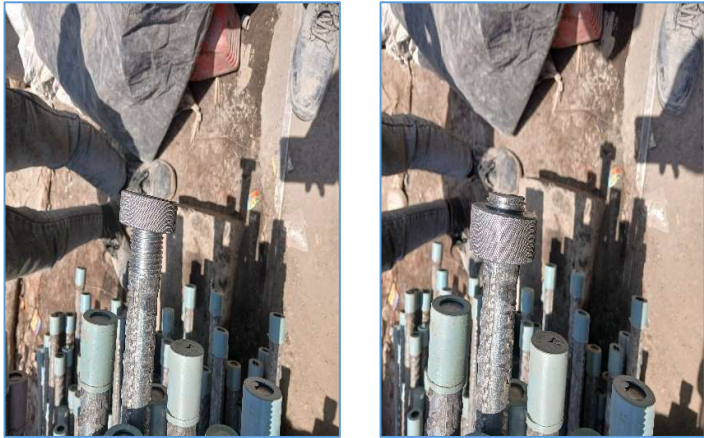
27	Site	1)Checked the thread of reinforcement with Go and No-Go gauge. 2)Checked the thread with corresponding size of coupler 3)Checked the pitch of thread And found ok	Positive

IS 16172: 2023 Reinforcement Coupler for Mechanical splices of steel bars in concrete- Specification
28	Rebar Stacking Yard	Two different diameters of steel stacked separately, and Colour tagging is done for steel which is not yet tested, and which is passed .So that there is no miss use of untested steel.	Positive

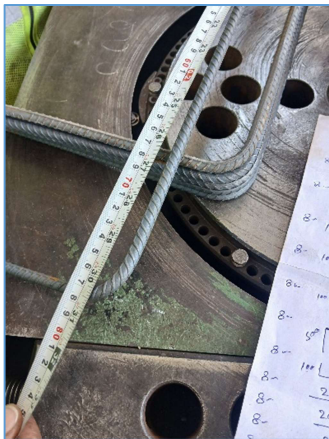
29	Site yard	Bar Bending Machine – Checked the cutting length of rebar as per BBS, cutting length and bend length should be as per BBS	Minor Observation

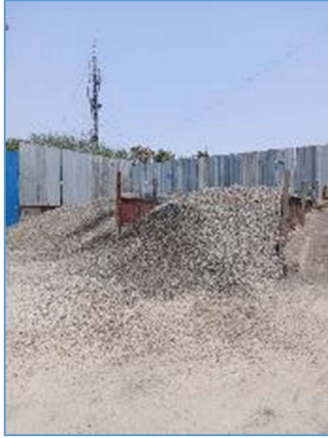
Site Inspection
30	Site RMC	1) Stacking of Fine Aggregate and coarse aggregate have separate compartment. 2) Sprinkler arrangement is available. 3) Separate silos are provided for cement and GGBS storage.	Positive

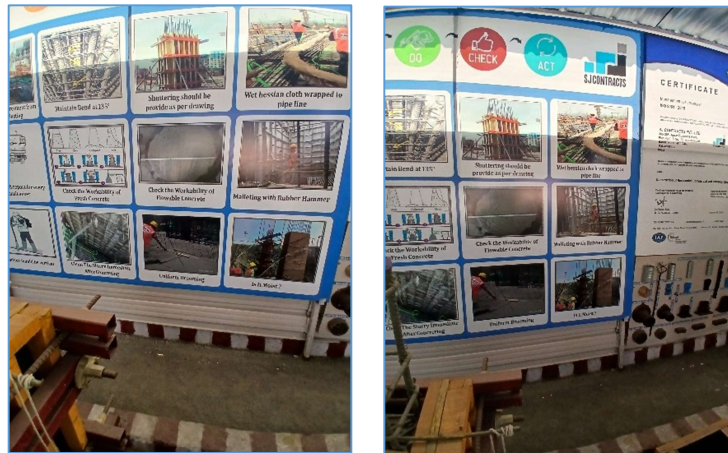
31	Site Office	Quality Park is maintained at site with display of activity and do and don't. Sample are kept for display which are used at site	Good Practice

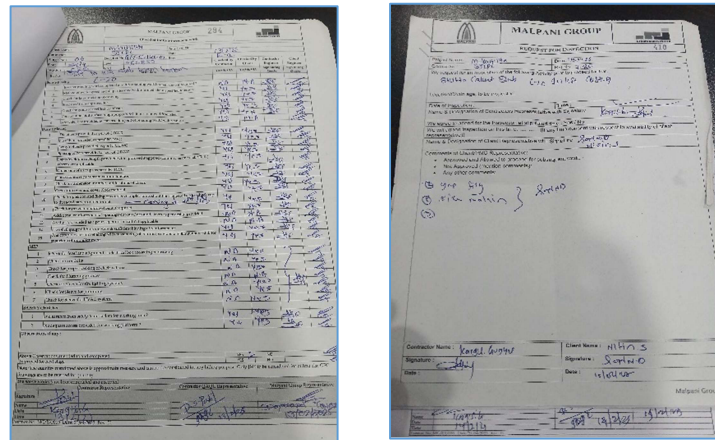
Pour card no 611 dtd.31.12.2024

32	Site Office	RFI being raised by contractor & inspection for reinforcement, Formwork & pour card is being carried out by Client. Records are maintained as per requirements. However, in pour card it was observed slump and quantity of concrete were not mentioned correctly in the pour card	Minor Observation
