Building and Infrastructure Division
Site Inspection/ Audit Report

MEP INSPECTION / AUDIT REPORT. MGPUNE/SOULSTRINGS/BVP/QAQC/CIVIL/IR-01		REV.NO. 0	
<input checked="" type="checkbox"/> Initial <input type="checkbox"/> Interim <input type="checkbox"/> Final <input type="checkbox"/> Resident.			
Inspection/ Audit Requested By : Malpani Group			
Inspection / Audit performed as Recognised Authority : Sandesh Patankar		Yes	<input checked="" type="checkbox"/> NO: <input type="checkbox"/>
BV Job / Zig No : 21641036

Project Name : M Soul Strings	IPO (if applicable):N/A
Audit by : Bureau Veritas (India)Pvt Ltd, Mumbai	PO no. WO/Pashan/2024/159 Date 31.01.2024
Vendor/Manufacturer : Malpani Group	PO No. N/A (Client to Vendor)
Architect : <u>Morphogenesis</u>	Contractor : Millenium Engineers & Contractors Pvt. Ltd.
Sub Vendor : NA	Vertical : Civil
Inspection Location : M Soul Strings – Baner Pune	Previous Inspection : No
Inspection Performed from : 21 th March 2024.	Next Inspection : As per Clients requirement

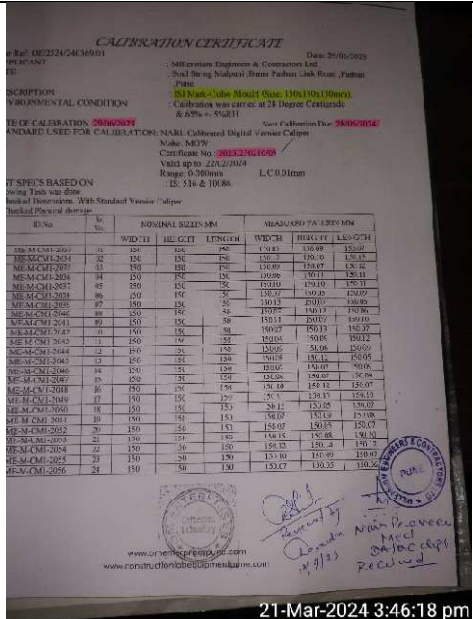
Sr. No.	LOCATION	AUDIT FINDINGS / OBSERVATIONS	TYPE OF FINDINGS	IMAGE/ EVIDENCE	Status
1	M Fibonacci Site	Construction status at Tower A & A1	Info	Building : 3 Towers – B,C,D - 2 Basement + Ground + 27 Floors Current Status : Foundation & Basement Level RCC Works + Pour 1 Slab	Info
2	Site Office	Batching plant, Lab equipment calibration certificates verified & found valid as per QAP requirements	Positive

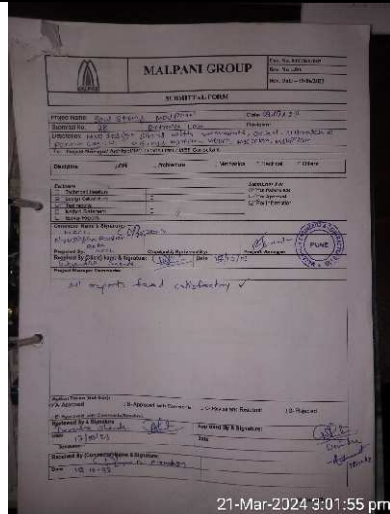
3	Site Office	Concrete mix design with Trials conducted for approval is maintained as per QAP / ITP requirements	Positive

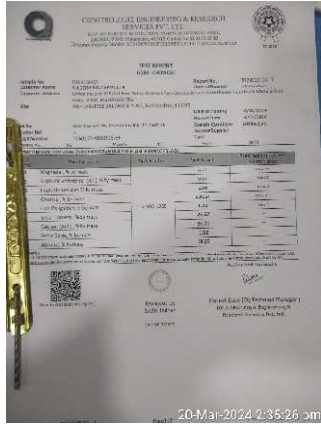
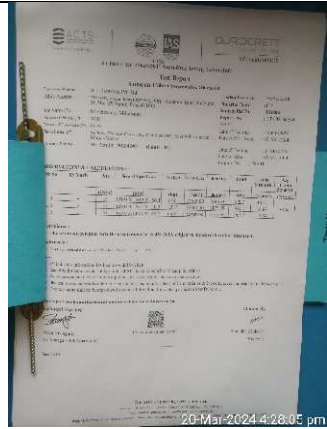
4	Site Office	Randomly reviewed in house as well as third party test reports for construction materials & found maintained properly as per ITP requirements	Positive

Some of the tests not performed in NABL accredited Lab as test certificates do not have NABL stamp.

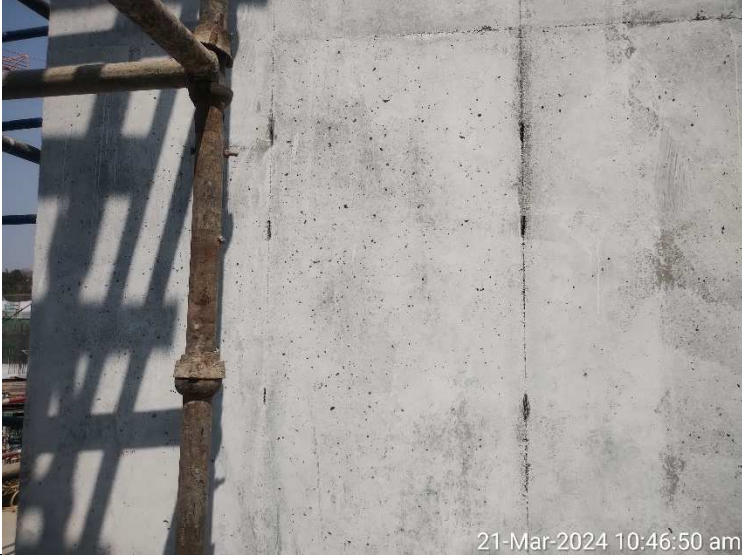
5	Site	Curing compound applied over vertical RCC surface immediately after de-shuttering	Positive

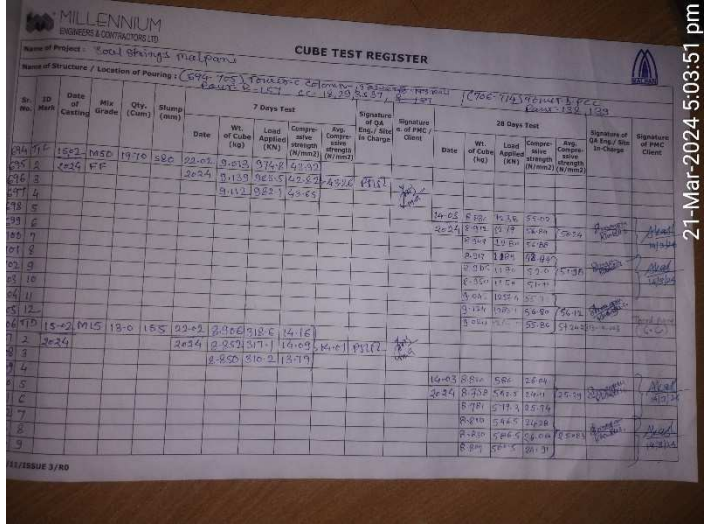
<p>21-Mar-2024 10:46:50 am</p>	
6	Quality Lab	Today's Cube compressive strength test for 28 days cubes witnessed & found satisfactory.	Positive

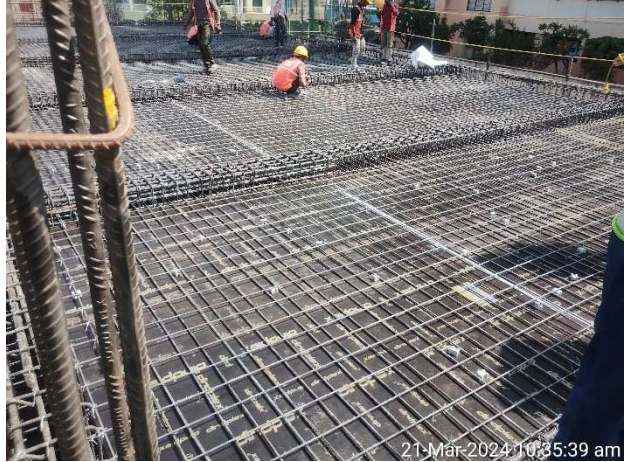
7	Site	Formwork & Reinforcement fixing is being properly done on site, needs to be continued till project end	Positive

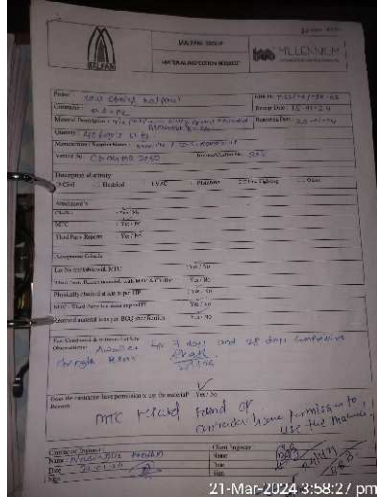
9	Site Office	MIR format for Incoming material is filled on regular basis & MTC /tests to be conducted as per ITP requirements.	Positive

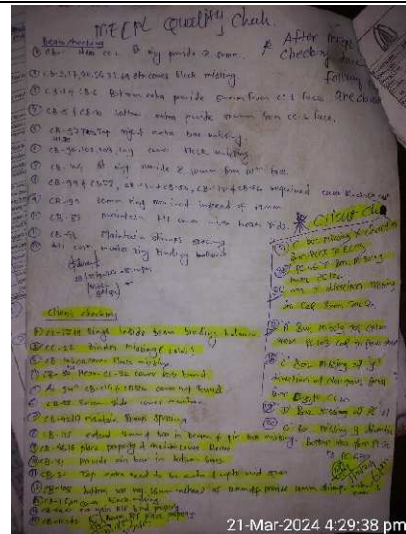
10	Site	RFI being raised by contractor & inspection for reinforcement, Formwork & pour card is being carried out by Client. Records are maintained as per requirements.	Positive

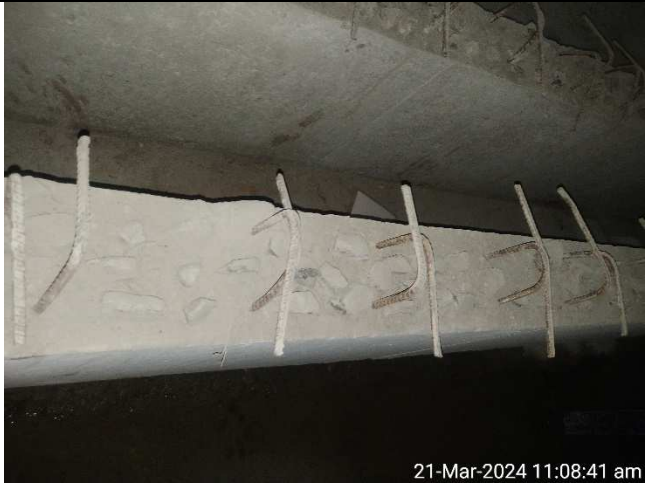
11	Tower B, C	Overall RCC surface for Slab, column capitals, Beams found satisfactory	Positive	 		
12	Tower B, C	Shear keys provided in walls	Positive

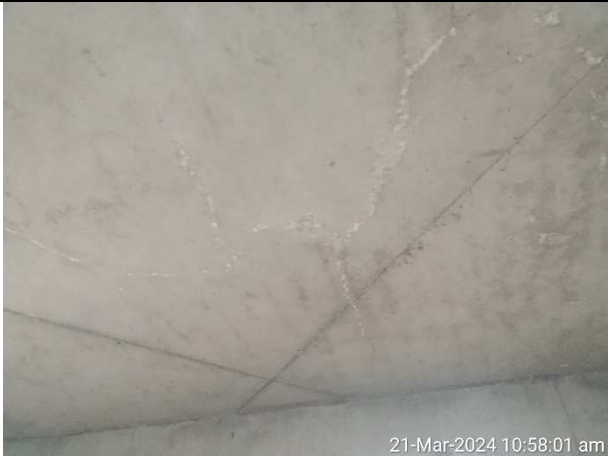
13	Tower B & C	Leakages or Leakage marks observed from slabs in some area's	Major

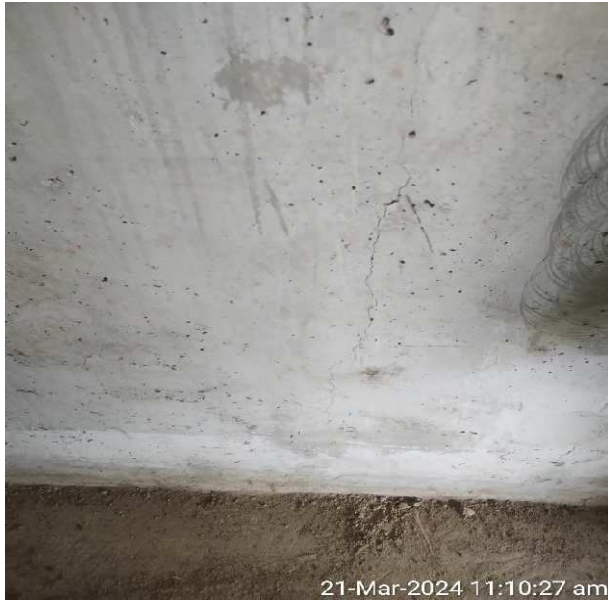
14	Tower B & C	Surface cracks observed in concrete surface	Major

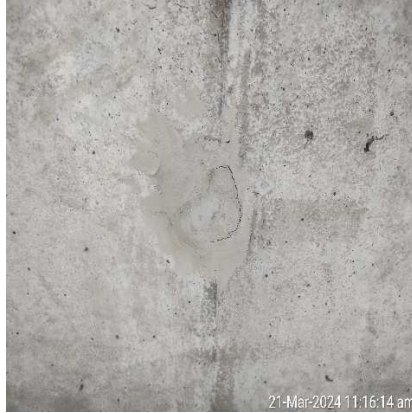
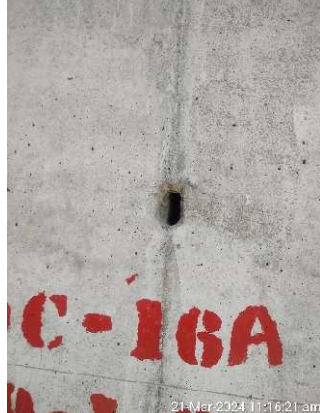
15	Tower D	Tie rod holes repaired got shrink & needs to be filled with extra care	Major

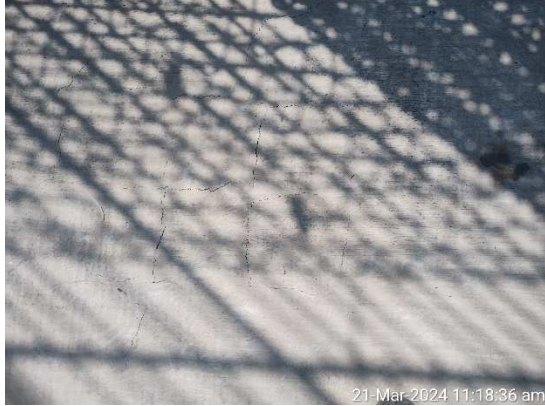
16	Tower D	Cracks observed on raft – surface may be due to less cover from top reinforcement.	Major
