# M- SOUL STRINGS

## QAQC AUDIT REPORT

15TH APRIL 2025

<b>INSPECTION / AUDIT REPORT/MGPUNE/SOULSTRINGS/BVP/QAQC/CIVIL/IR-05</b>		<b>REV.NO. 0</b>
<input type="checkbox"/> Initial	<input checked="" type="checkbox"/> Interim	<input type="checkbox"/> Final
<input type="checkbox"/> Resident.		
Inspection/ Audit Requested By : Malpani Estates		
Inspection / Audit performed as Recognised Authority : Rohan A Patil		Yes <input checked="" type="checkbox"/> NO: <input type="checkbox"/>
BV Job / Zig No : 21641036

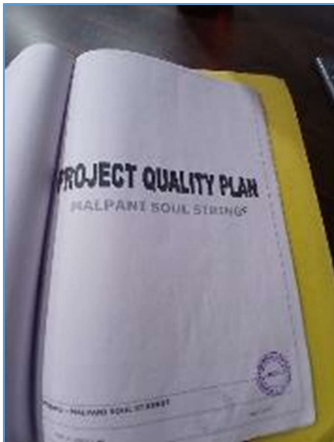
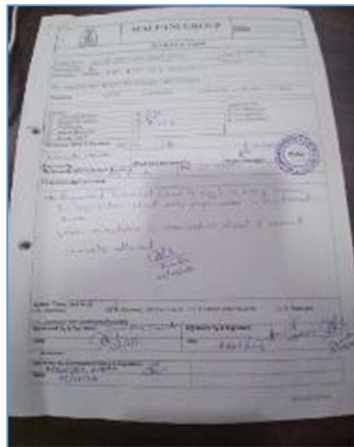
Submittal No-10 dtd 18/7/2023

A. INSPECTION & FINDINGS					
Sr. No.	LOCATION	AUDIT FINDINGS / OBSERVATIONS	TYPE OF FINDINGS	IMAGE/ EVIDENCE	Status
1	M Soul String	Construction status	Info	Building : 3 Towers – B,C,D - 2 Basement + Ground + 27 Floors Current Status : Tower B up to 9 <sup>th</sup> floor Complete-100 % + Tower C up to 10 <sup>th</sup> floor Complete-100 % +Tower D- Core area complete.	Info
2	Site Office	Project quality Plan Available at site office and maintained.	Positive

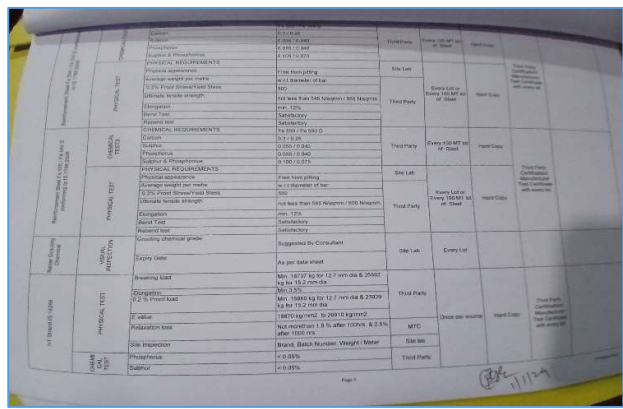
3	Site Office	ITP Available at site office and maintained	Positive

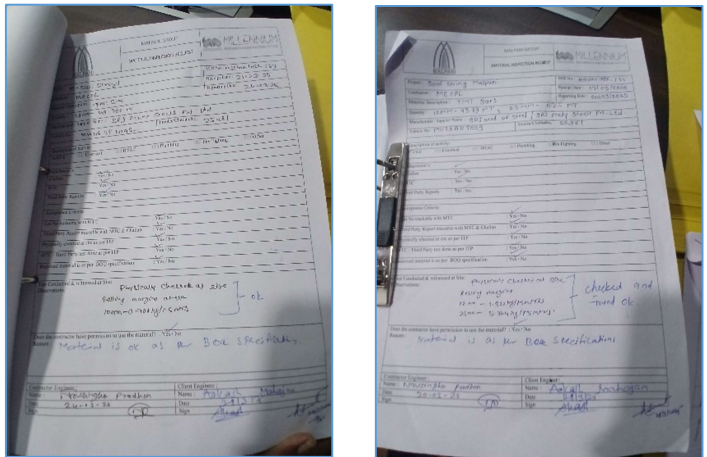
MIR No - MSS/ME/MIR/157

ITP no Nil Rev 03 dated 01.12.02024
4	Site Office	Randomly checked the MIR for different incoming material at site. MIR is maintained and filled regularly as per ITP.	Positive

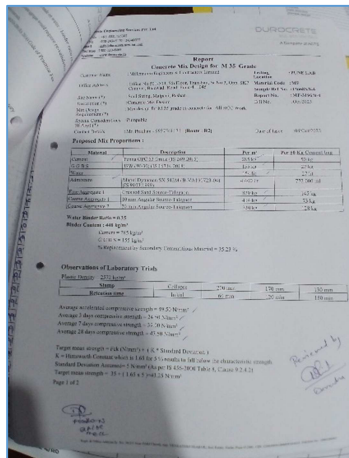
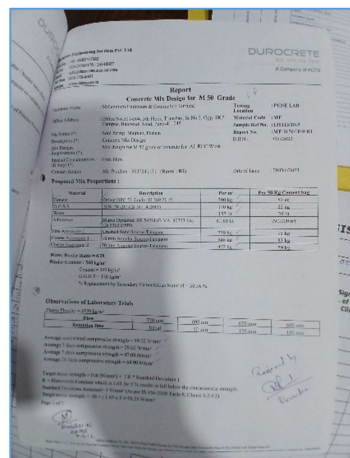
5	Site Office	Concrete mix design with Trials conducted for approval is maintained as per QAP / ITP requirements	Positive

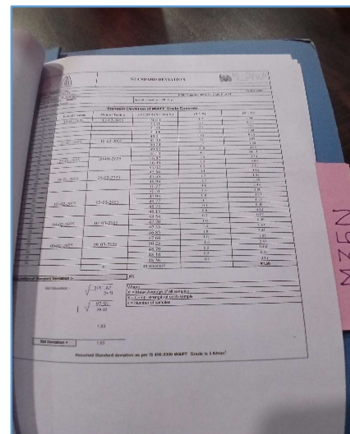
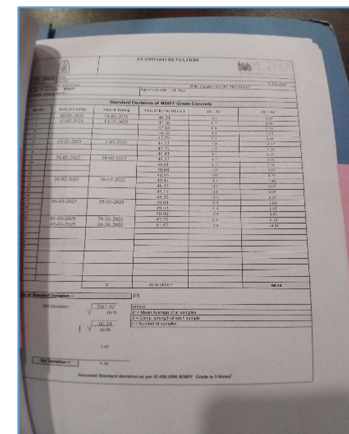
6	Site Office	Standard deviation for different grade of concrete used at site calculation done. However It is observed that, wrong heading M50 FF was mentioned instead of M40 FF in the Standard deviation calculation sheet.	Minor Observation

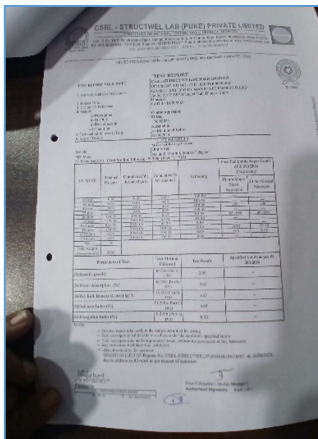
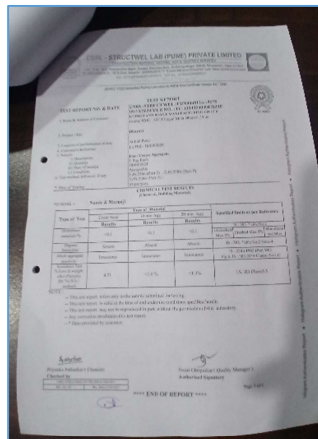
7	Site Office	Randomly reviewed in house as well as third party test reports for construction materials & found maintained properly as per ITP requirements	Positive

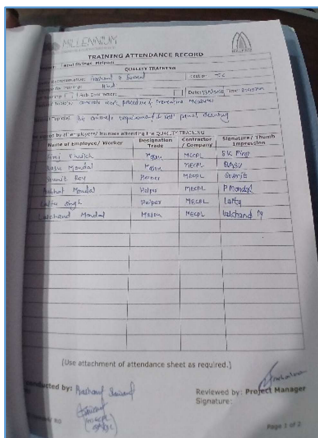
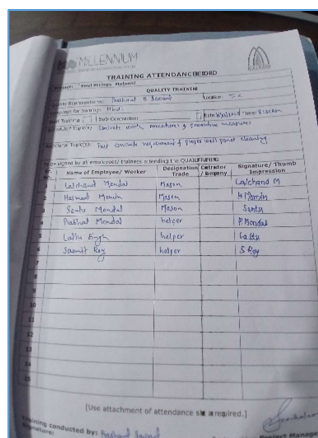
8	Site Office	Randomly checked for training records. Training are provided regularly and records are maintained.	Positive

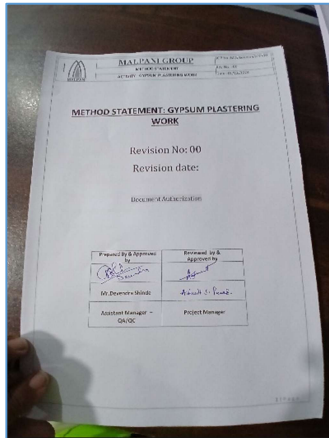
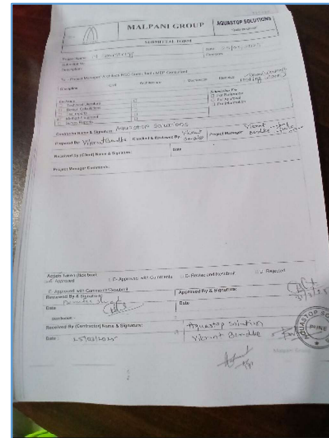
9	Site Office	Work method statement of activities are available site and approved by client.	Positive

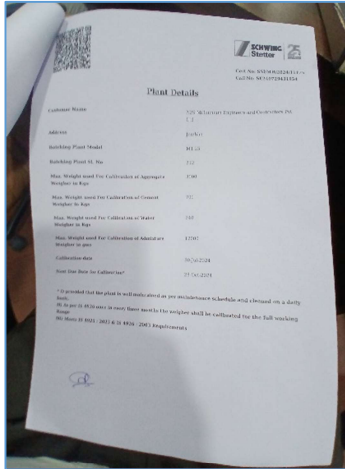
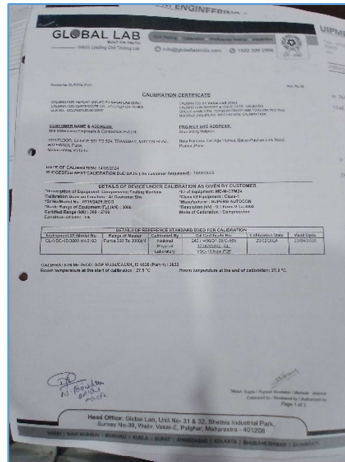
Cert. No - SSI/MH/2025/1117 5 dtd NIL Due date 27.05.2025

Submittal no Nil dtd 31.03.25 -water proofing
10	Site	Batching plant, calibration report Plant Model -M1.25 bearing Sr. No 212 Schwing stetter Calibrated on -26.02.2025 and found valid as per QAP. Calibration report of water need to be rectified w.r.t missing data.	Minor Observation

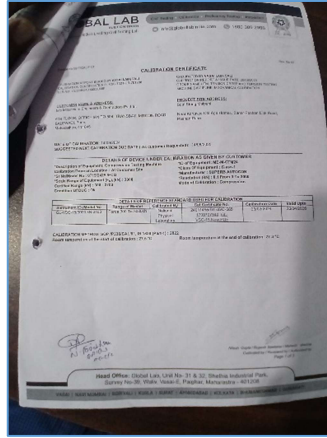
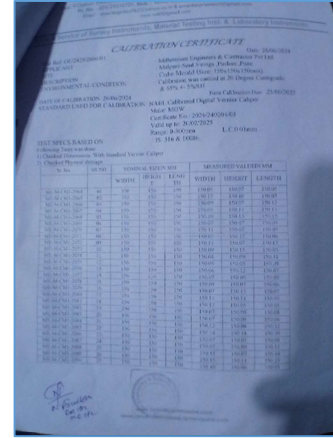
11	Site Office	<p>CTM &amp; Cube moulds calibration certificates verified &amp; found valid as per QAP requirements.</p> <p>CTM Id.no – ME-M-CTM24</p> <p>Capacity-3000KN</p> <p>Make -ECO</p> <p>Due date 14/08/2025</p>	Positive

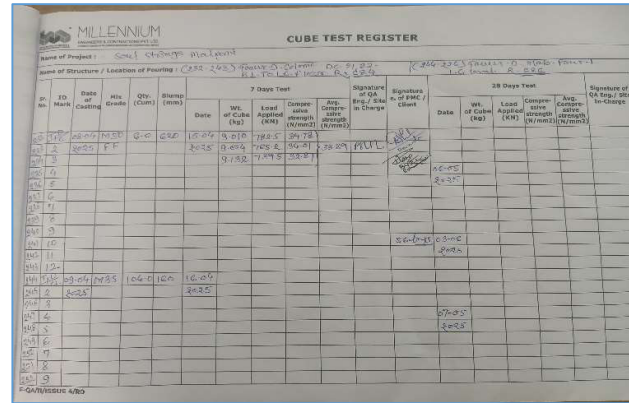
<p>Cert No -VSC-7621- CR-761908 dtd 14.08.2024</p>
12	Quality Lab	<p>Concrete cube register checked for testing records. Results were observed dully filled as per the pour card and maintained properly.</p> <p>Todays Cube compressive strength test for 7 days cubes witnessed &amp; found confirmed. Grade of concrete M-50FF.</p> <p>Cube Results @ 7 days.</p> <ol style="list-style-type: none"> <li>1) 34.78 N/mm<sup>2</sup></li> <li>2) 34.01 N/ mm<sup>2</sup></li> <li>3) 34.87 N/ mm<sup>2</sup></li> </ol> <p>Avg- 33.89 N/ mm<sup>2</sup></p>	Positive

<p>IS 456 : 2000 reaff 2021</p> <p>Plain and Reinforced Cement Concrete.</p> <p>Table 11.</p>

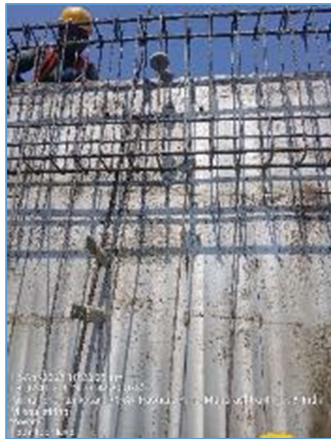
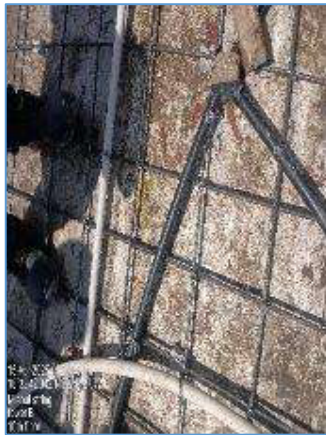
13	1)Tower C 15 <sup>th</sup> Floor Slab. 2)Tower B 10 <sup>th</sup> Floor Slab	Formwork On-going work. 1)It was observed that the Cleaning of aluform panel not done properly.	Minor Observation

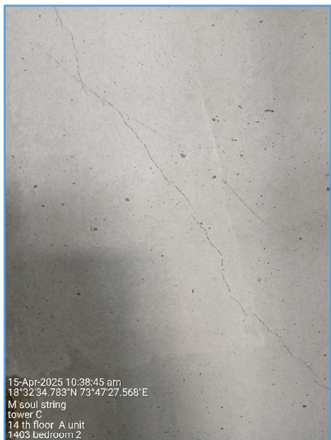
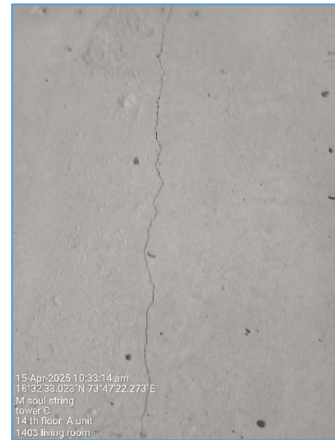
Site Inspection
14	Tower C  1)Flat No 1403 Living room, Bedroom2 2)Flat No 801 Master Bedroom2. 2)Flat no 803 Bedroom	RCC – 1)Minor Crack observed on concrete surface of NS wall	Minor Observation

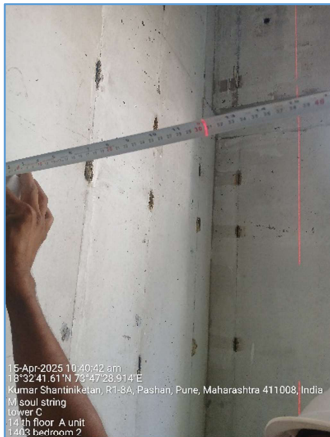
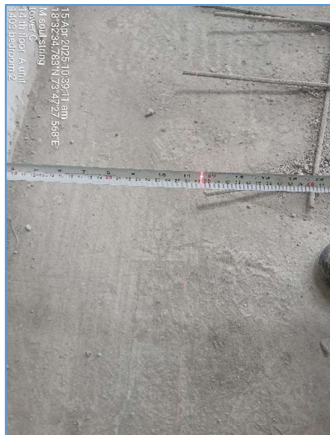
15	Tower C – 14 <sup>th</sup> floor Flat No 1403 Bedroom 2	RCC – 1) Deviation in right angle observed up to 6mm 2) Deviation in plumb observed upto 6m	Minor Observation

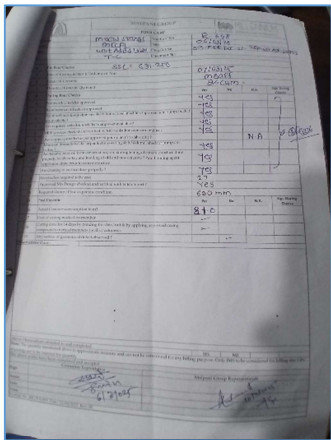
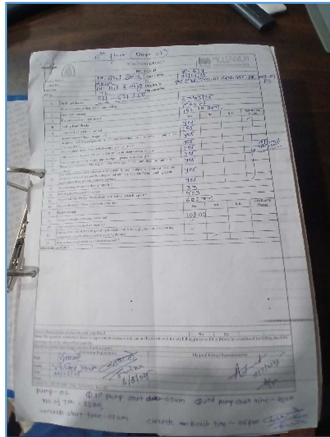
Pour card no- R 647/648 dtd 04.03.2025

<p>15-Apr-2025 10:39:11 am 18°32'40.78"N 76°47'27.58"E 14<sup>th</sup> floor A unit 1403 bedroom 2</p>	Site Inspection
16	Site Office	RFI being raised by contractor & inspection for reinforcement, Formwork & pour card is being carried out by Client. Records are maintained as per requirements.	Positive

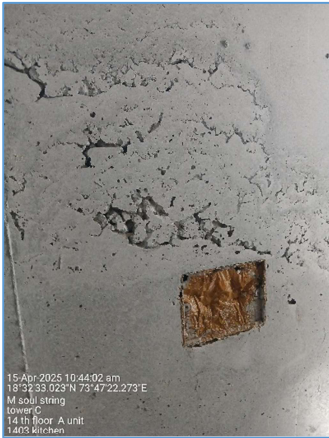
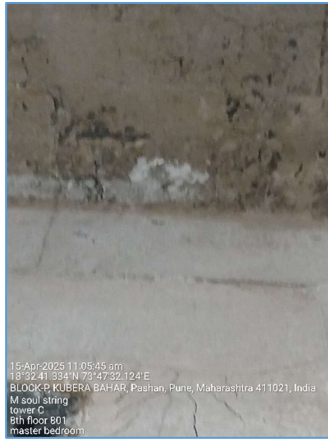
17	Tower C- 1)14 <sup>th</sup> Floor A unit Flat no 1403 Kitchen 2)8 <sup>th</sup> Floor Flat No 801 Master bedroom	RCC— Minor honeycombing observed in the concrete surface	Minor Observation

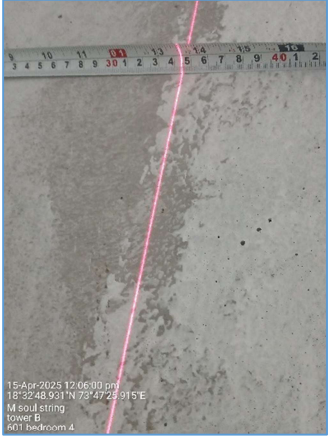
25	Tower B Flat no 601 Bedroom 4 and masterbed	RCC – 1) Deviation in right angle observed up to 6mm	Minor Observation	  <p>15-Apr-2025 11:55:51 am 18°32'42.18"N 73°47'27.618"E Misoul string Tower B 601 Bedroom 2</p>

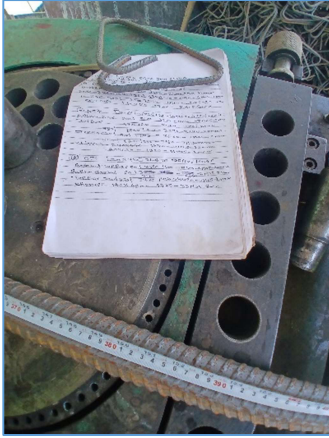
<p>15-Apr-2025 12:06:00 pm 18°32'48.931"N 73°47'23.915"E Misoul string Tower B 601 Bedroom 4</p>	Site Inspection
26	Steel yard	Reinforcement BBS- Measured the cutting length and bend bar as per BBS and observed 13 mm more than required.	Minor Observation

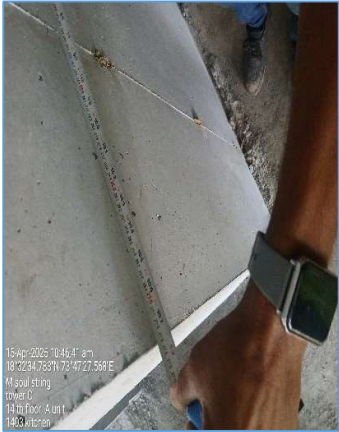
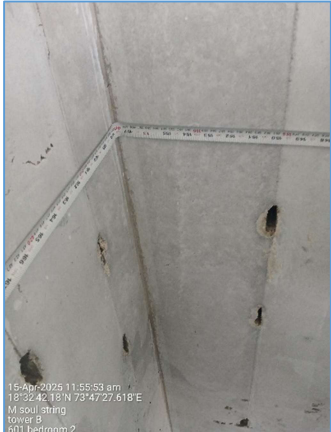
27	Site	RCC- Checked the dimension of room as per drawing and found ok	Positive

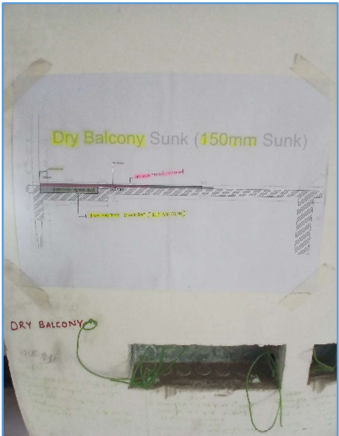
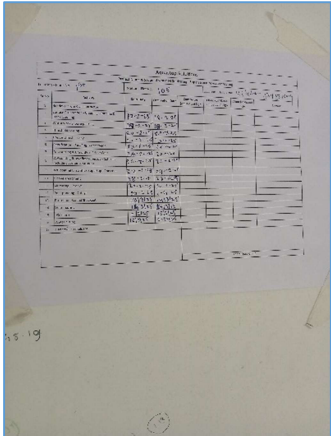
<p>15-Apr-2025 11:55:53 am 18°32'42.118"N 73°47'27.618"E Masul string tower B 6011 Bathroom 2</p>	Site Inspection Drwg No – SOS-MER-TWB-02- 2DM-GFC-A R3 dtd 14.11.24
28	Site	Water Proofing- 1)Waterproofing work tracker is maintained and displayed at respective unit. 2) Detail section drawing is displayed at site. 3)Actual consumption of coating material is displayed at respective unit.	Positive

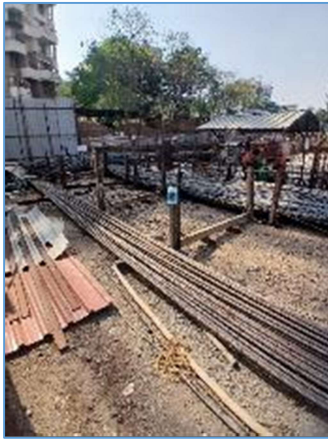
29	Site Rebar stack yard	Two different diameters of Rebar stacked separately, and colour coding done for tested and untested Rebar	Positive

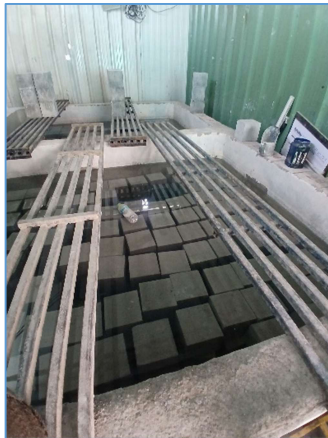
Site Inspection
30	Site Lab	Cube curing tank with thermostatic control to maintain the temperature of water. Cleaning of curing tank is done weekly.	Positive

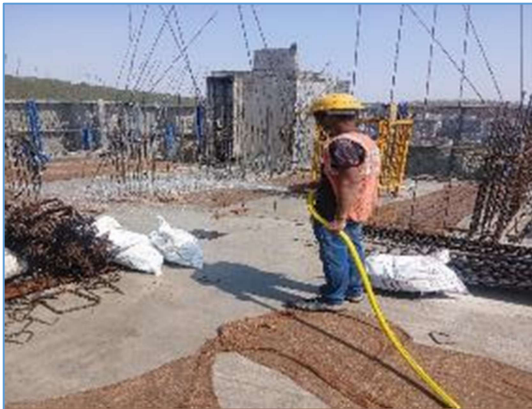
33	Site	Curing observed is done properly by spraying water on the concrete surface.	Positive

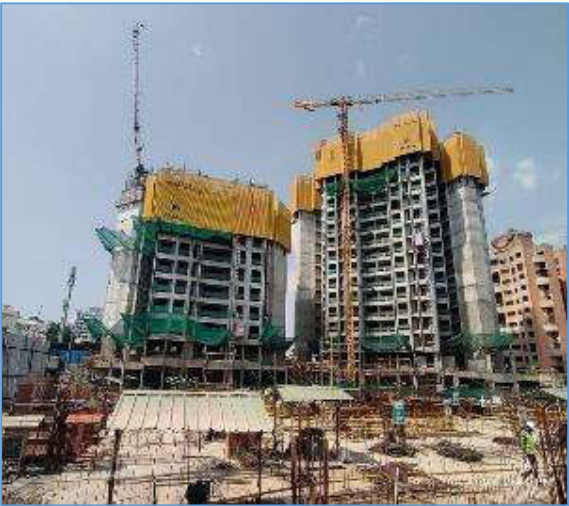
Site Inspection
34	Site	Overall view of project	Info
