**MALPANI LOGISTIC PARK PVT LTD.
AMBETHAN, CHAKAN, PUNE, MAHARASHTRA -
410501
QAQC AUDIT REPORT
22ND APRIL 2025**

Building and Infrastructure Division
Site Inspection/ Audit Report

INSPECTION / AUDIT REPORT/MGPUNE/INDUSTRIAL & LOGISTIC PARK/BVP/QAQC/CIVIL/IR-01		REV.NO. 00	
<input checked="" type="checkbox"/> Initial	<input type="checkbox"/> Interim	<input type="checkbox"/> Final	<input type="checkbox"/> Resident.
Inspection/ Audit Requested By : Malpani Industrial & Logistic Park Pvt Ltd			
Inspection / Audit performed as Recognised Authority : Rohan A Patil		Yes	<input checked="" type="checkbox"/> NO: <input type="checkbox"/>
BV Job / Zig No : 26262058

Project Name: Malpani Warehouse, Chakan	IPO (if applicable):N/A
Audit by: Bureau Veritas (India)Pvt Ltd, Pune	PO no. WO/Warehouse/2025/147 Date 01 Apr 2025
Vendor/Manufacturer: Malpani Group	PO No. N/A (Client to Vendor)
Architect: PROCONVIS CONSULTANCY PVT LTD	Contractor: GROUP SURYA
Sub Vendor: NA	Vertical: Civil
Inspection Location: Chakan	Previous Inspection: NA
Inspection Performed from: 21 st April 2025.	Next Inspection: As per Clients requirement

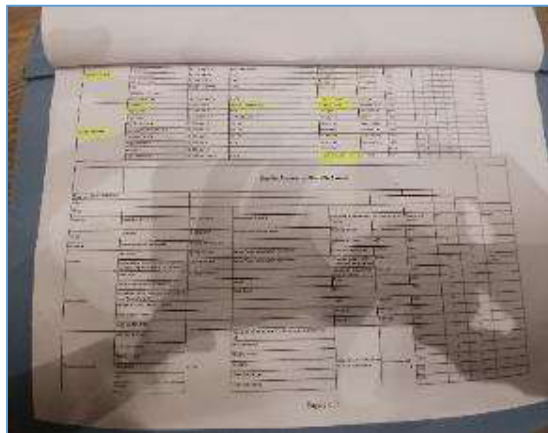
Sr. No.	LOCATION	AUDIT FINDINGS / OBSERVATIONS	TYPE OF FINDINGS	IMAGE/ EVIDENCE	Status
1	Malpani Industrial & Logistic Park	Construction status of Warehouse	Info	03 nos of warehouse, warehouse1 and warehouse 3 are complete and handover to client. Warehouse 2 work in progress.	Info
2	Site Office	ITP available at site but, 1) There is no approval sign and stamp. 2) Date and control document number is also not present on ITP. 3) FM2 Flooring activity is not included in the ITP.	Minor Observation

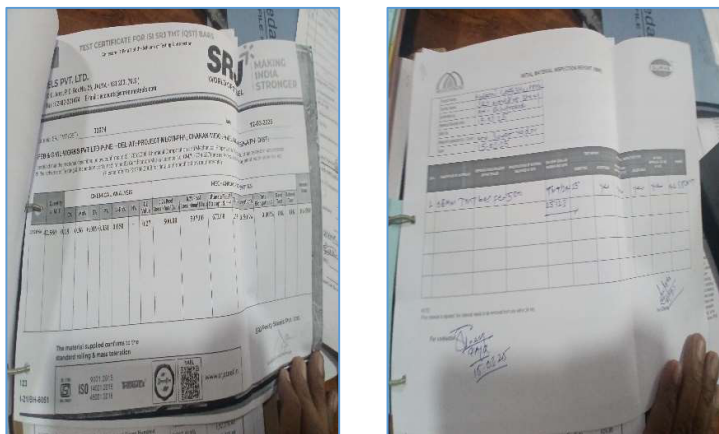
3	Site Office	<p>Material inspection report available at site. Checked randomly MIR as per ITP. MIR of steel to be filled in detail w.r.t</p> <ol style="list-style-type: none"> 1) Diameter of steel received. 2) Lot number verification with MTC. 3) Grade of steel. 	Minor Observation

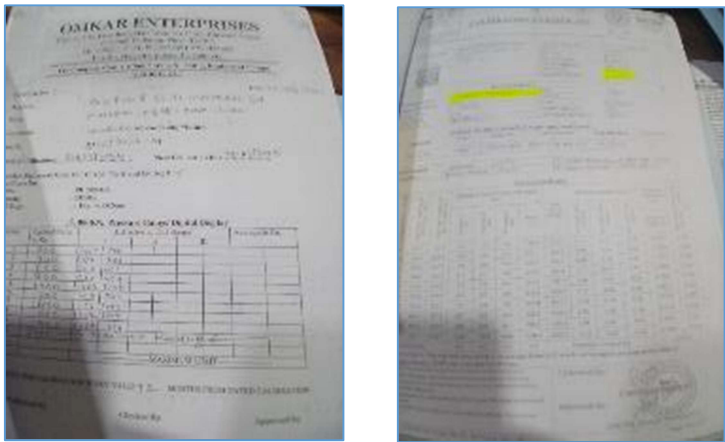
5	Site Office	<p>CTM, Cube Mould etc calibration report verified. CTM Model/Make -FIE Sr.No -0106-2023-24.</p> <ol style="list-style-type: none"> 1) It was noticed that the calibration was done by one agency, and certificate was issued by another agency. 2) There was no record available of traceability w.r.t standard instrument used with the NABL for both CTM and cubes. 	<p>Minor Observation</p>

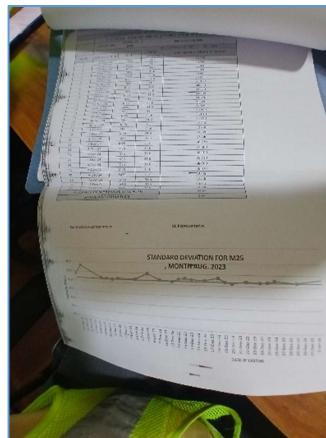
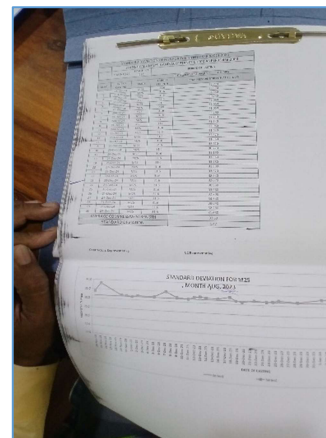
8	Site Office	<p>Standard deviation is calculated for different grades of concrete used at site and record maintained.</p> <p>It was observed that the graph plotted for Standard deviation were not matching w.r.t cube results and date.</p>	Minor Observation

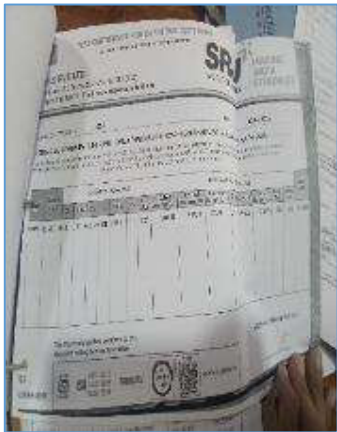
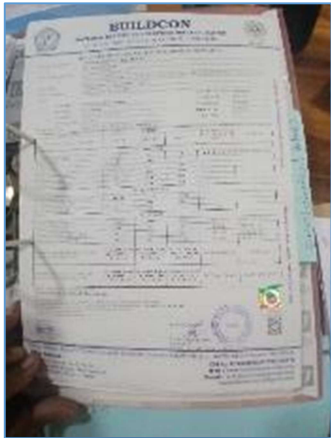
9	Site Office	Randomly reviewed in house as well as third party test reports for construction materials & found maintained properly as per ITP requirements. Traceability w.r.t heat number/lot number for Steel report is not evident.	Minor Observation

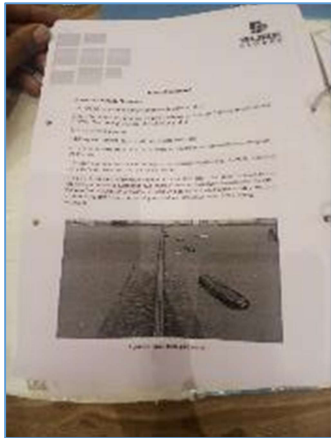
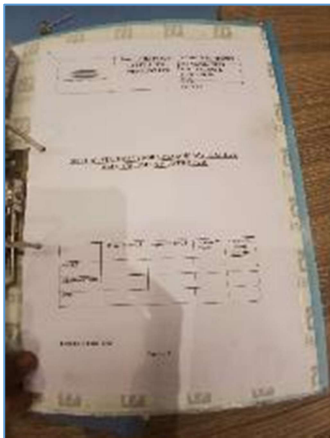
Report No - BMTS/21032025/072 697 dtd 23.03.2025 of Reinforcement
10	Site Office	Randomly checked the WMS for different activities are available as per ITP and maintained at site. 1)Control Document No., date, approval sign and stamp to be present on WMS.	Minor Observation

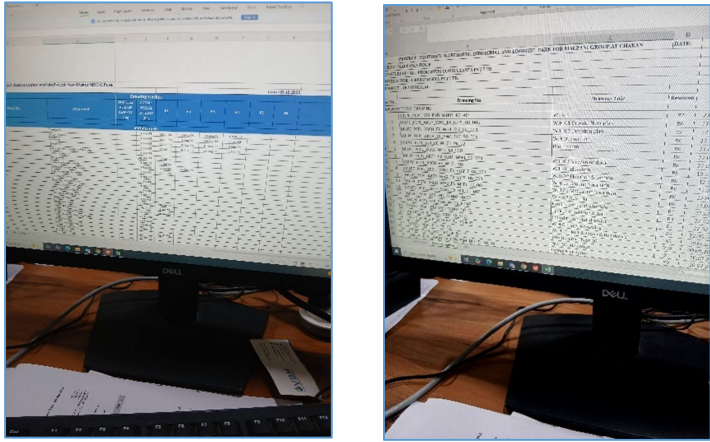
11	Site office	Drawings registers are maintained latest revision. There is no mechanism/record found to maintain the previous revision / superseded of copy drawing.	Minor Observation

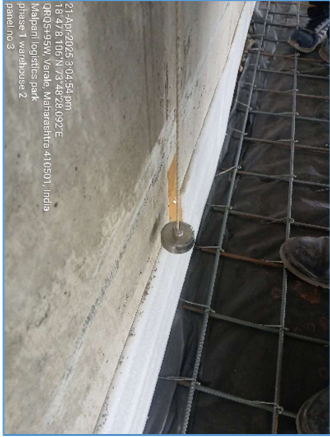
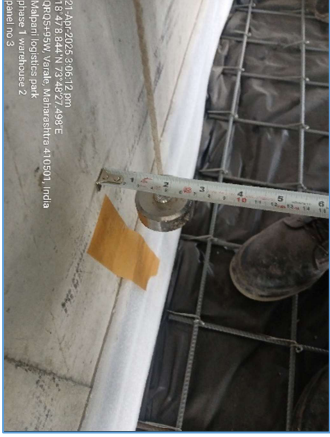
15	Warehouse 2 Partition wall West side	RCC- Deviation in plumb observed up to 7 to 10mm in the wall	Minor Observation

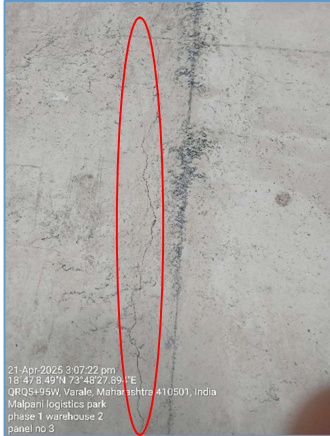
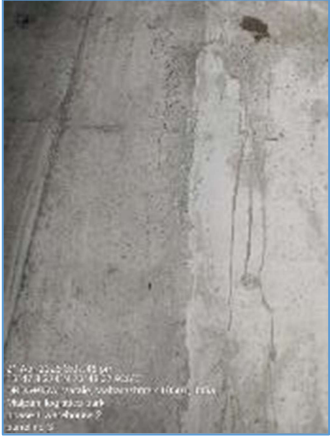
Site Inspection
16	Warehouse 2 Partition wall West side	RCC – Minor crack observed in the concrete surface throughout along the height of partition wall.	Minor Observation

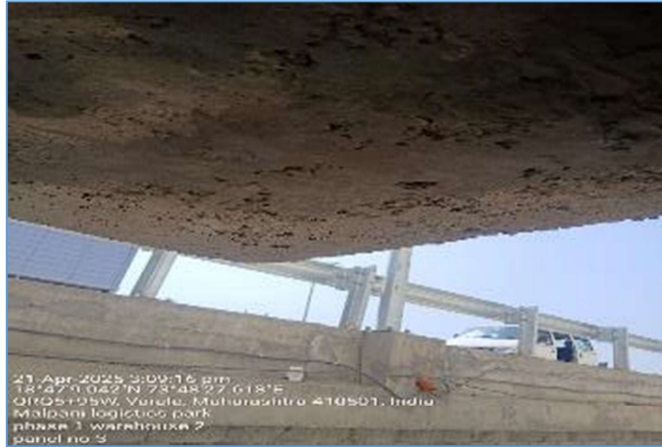
17	Warehouse 2 Partition wall West side	RCC – Minor honeycombing observed at the chajja soffit level concrete	Minor Observation

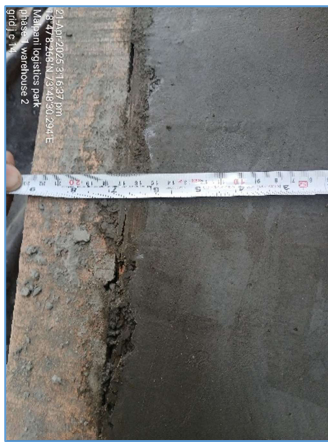
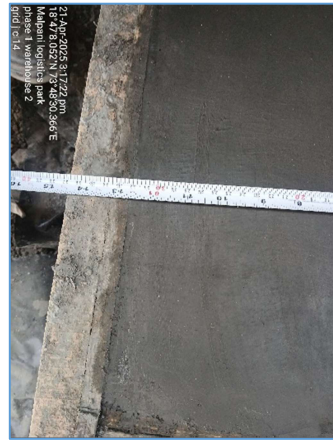
Site Inspection
18	Warehouse2 Grid J structural column C14 and C18	The side distance of structural column w.r.t concrete pedestal are not equidistance (centre of both are not in line with each other)	Minor Observation

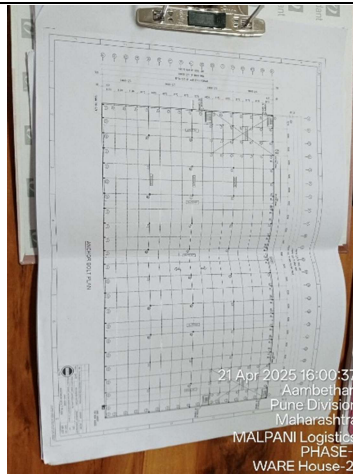
A. INSPECTION & FINDINGS					
Sr. No.	LOCATION	AUDIT FINDINGS / OBSERVATIONS	TYPE OF FINDINGS	IMAGE/ EVIDENCE	REFERENCE
Documents Review					
1	Phase 1 Warehouse-02	Approved Drawings not available.	Major Observation

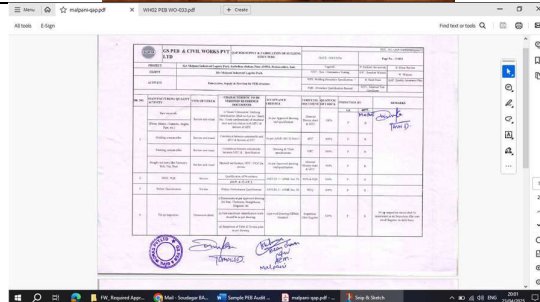
As per work order & technical Spec.
2	Phase 1 Warehouse-02	Available ITP Observed Without Client Approval Stamp	Major Observation

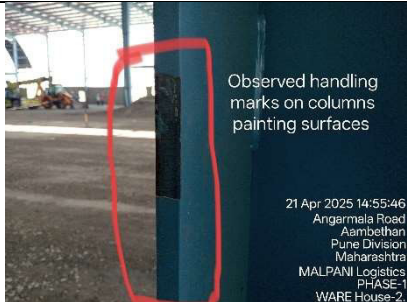
12	Phase 1 Warehouse-02 (As per Field QAP S.N 10)	Review of Final Documents & Dispatch at Mfr yard inspections Reports record Not Available	Major Observation	As per QAP S.N.-10	As per QAP (For Site)
Site Observation					
1.	Phase 1 Warehouse-02	Painting Touch up – Activity Pending	Minor Observation

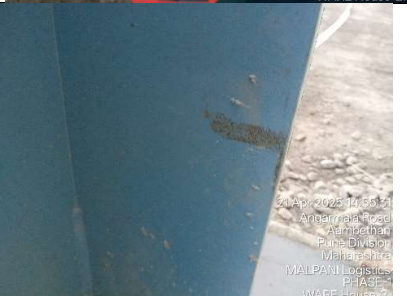
Visual
2.	Phase 1 Warehouse-02	Painting Touch up – Activity Pending	Minor Observation

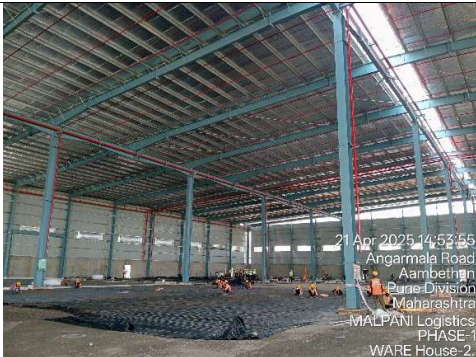
3.	Phase 1 Warehouse-02	No Permanent Identification Observed on Erected Columns	Minor Observation

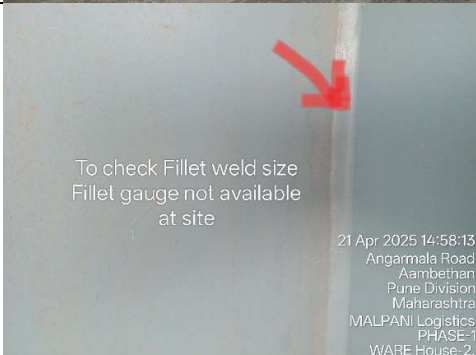
<p>21 Apr 2025 14:53:55 Angarmala Road Aambethan Pune Division Maharashtra MALPANI Logistics PHASE-1 WARE House-2.</p>	Visual
4.	Phase 1 Warehouse-02	To check Fillet Size Fillet weld Guge Not Available at Site	Minor Observation

<p>To check Fillet weld size Fillet gauge not available at site</p> <p>21 Apr 2025 14:58:13 Angarmala Road Aambethan Pune Division Maharashtra MALPANI Logistics PHASE-1 WARE House-2.</p>	Visual

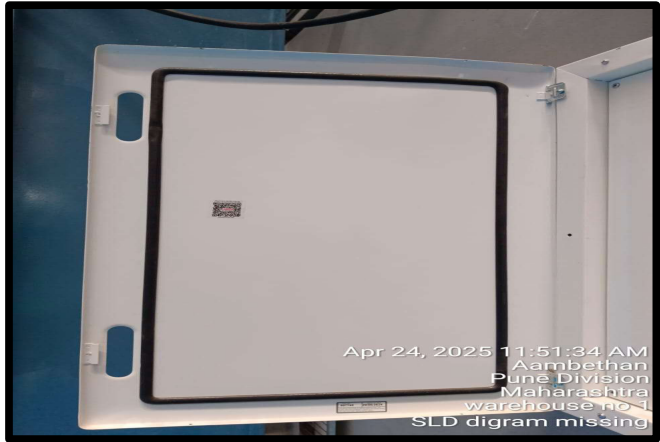
A. INSPECTION & FINDINGS					
Sr. No.	LOCATION	AUDIT FINDINGS / OBSERVATIONS	TYPE OF FINDINGS	IMAGE/ EVIDENCE	Status
1	Warehouse No:1	A Single Line Diagram (SLD) is not provided in the Distribution Board (DB) box. This omission can lead to confusion during maintenance or troubleshooting, increasing the risk of incorrect handling or isolation of circuits.	Minor Observation

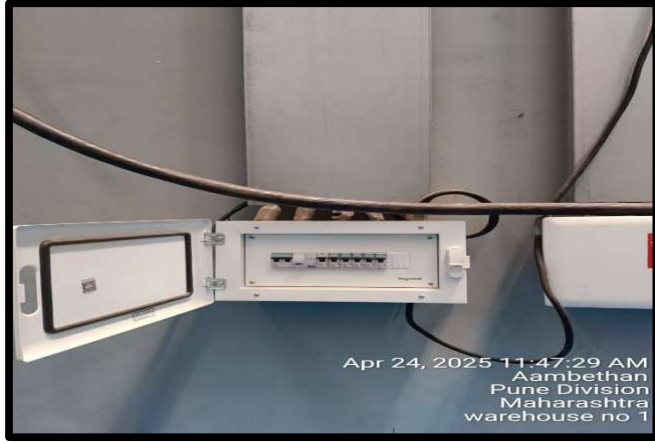
2	Warehouse No:1	A Single Line Diagram (SLD) is not provided in the Distribution Board (DB) box. This omission can lead to confusion during maintenance or troubleshooting, increasing the risk of incorrect handling or isolation of circuits.	Minor Observation

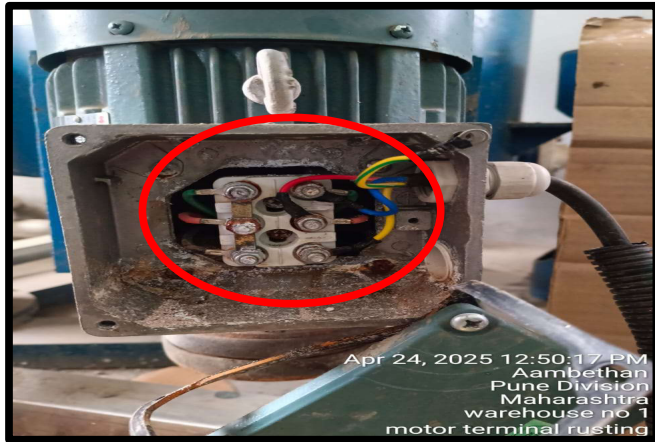
<p>Apr 24, 2025 11:47:29 AM Aambethan Pune Division Maharashtra warehouse no 1</p>	Open
3	Warehouse No:1	The motor terminals are showing signs of rusting. This corrosion can lead to poor electrical connectivity, increased resistance, and potential overheating.	Minor Observation

<p>Apr 24, 2025 12:50:17 PM Aambethan Pune Division Maharashtra warehouse no 1 motor terminal rusting</p>	Open

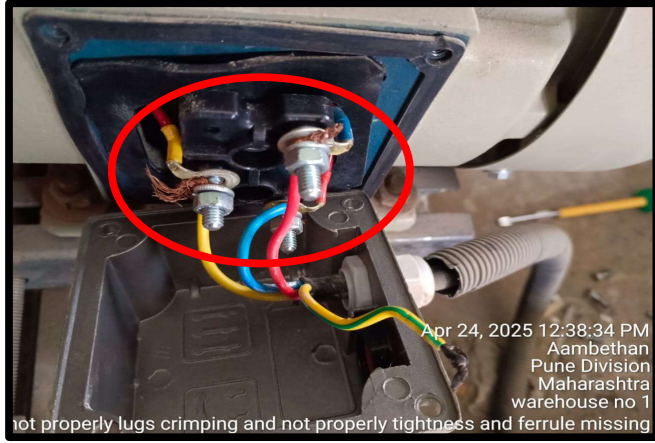
4	Warehouse No:1	The lugs are not properly crimped, and ferrules are missing from the cable terminations. Poor crimping can lead to loose connections, resulting in overheating or electrical arcing. Missing ferrules further increase the risk of wire strand breakage or short circuits.	Major Observation

<p>Apr 24, 2025 12:38:34 PM Aambethan Pune Division Maharashtra warehouse no 1 not properly lugs crimping and not properly tightness and ferrule missing</p>	Open
5	Warehouse No:1	Ferrules are missing in the cable terminations inside the DB box. This can lead to fraying of wire strands, resulting in poor contact or potential short circuits.	Minor Observation

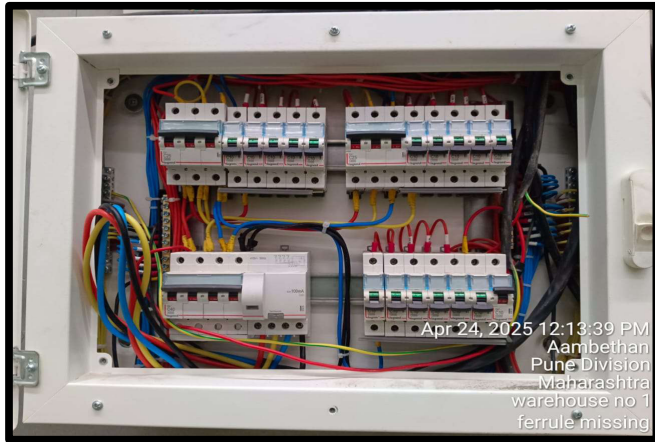
<p>Apr 24, 2025 12:13:39 PM Aambethan Pune Division Maharashtra warehouse no 1 ferrule missing</p>	Open

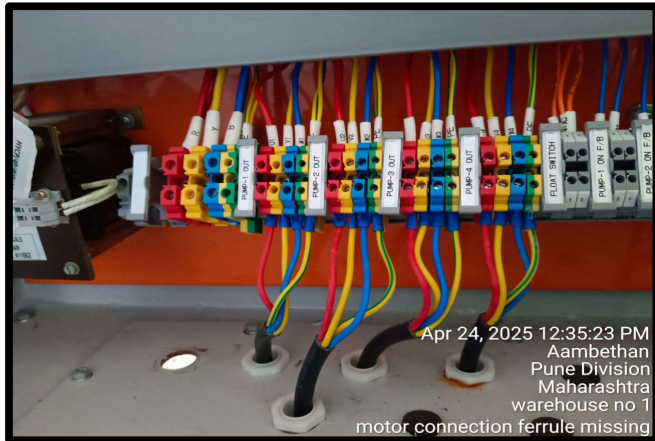
6	Warehouse No:1	Ferrules are missing in the cable terminations. This can lead to fraying of wire strands, resulting in poor contact or potential short circuits.	Minor Observation

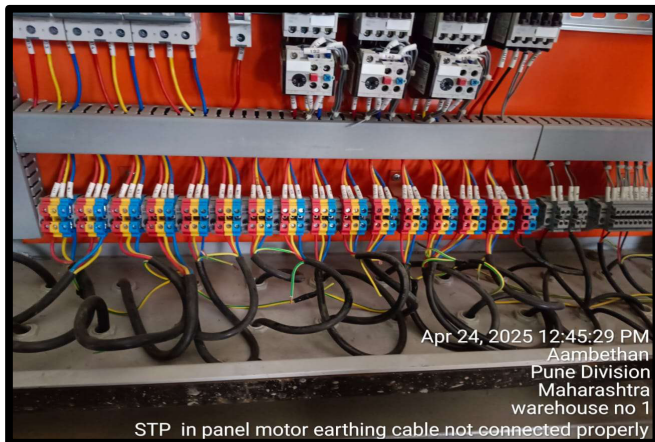
Open
7	Warehouse No:1	The earthing cable is not connected properly, which compromises the effectiveness of the grounding system.	Major Observation

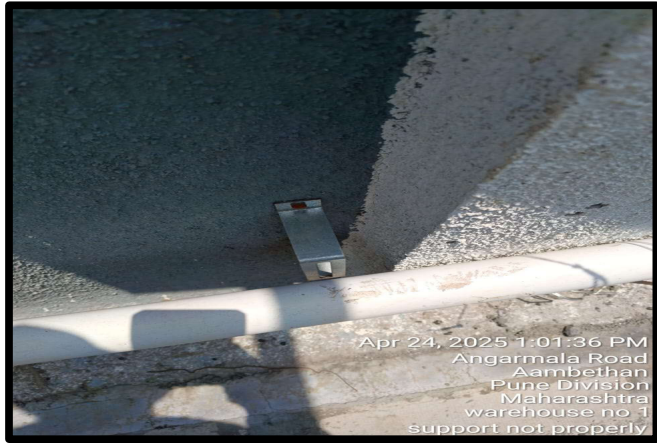
8	Warehouse No:1	A U-clamp is not provided for the pipe support, leading to inadequate securing of the pipe.	Minor Observation

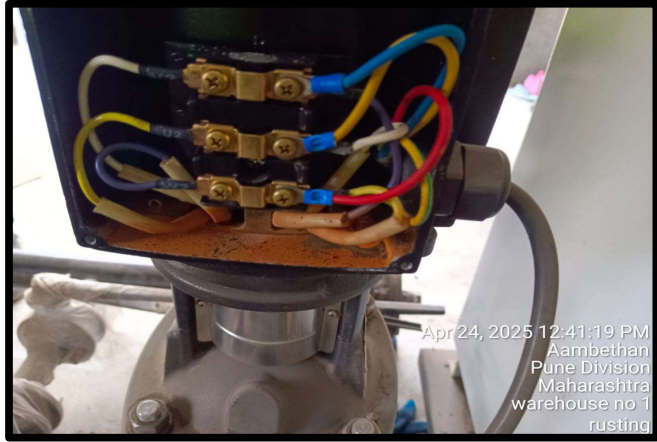
Open
9	Warehouse No:1	The motor terminals are showing signs of rusting. This corrosion can lead to poor electrical connectivity, increased resistance, and potential overheating.	Minor Observation

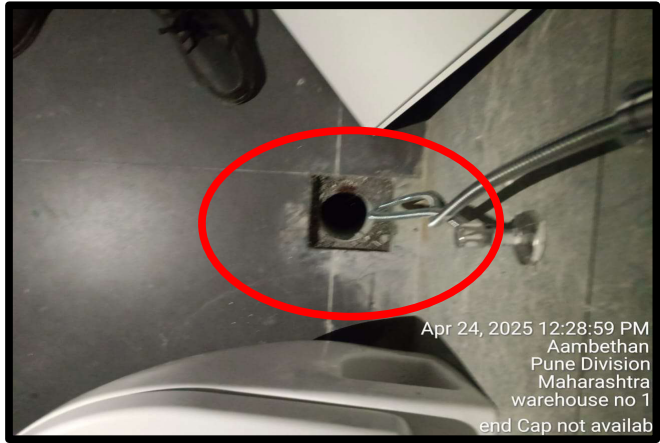
10	Warehouse No:1	End caps are not provided in the drainage outlets, leaving them exposed to debris, pests, or accidental ingress.	Minor Observation

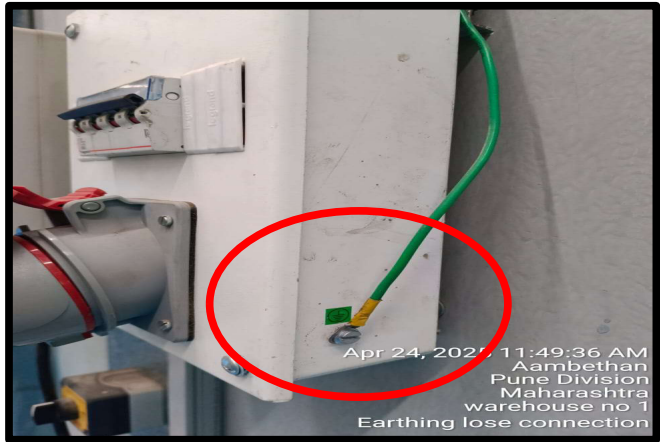
Open
11	Warehouse No:1	The DB body earthing connection is loose, compromising the effectiveness of the grounding system. This can result in improper fault current dissipation, increasing the risk of electric shock or equipment damage.	Minor Observation

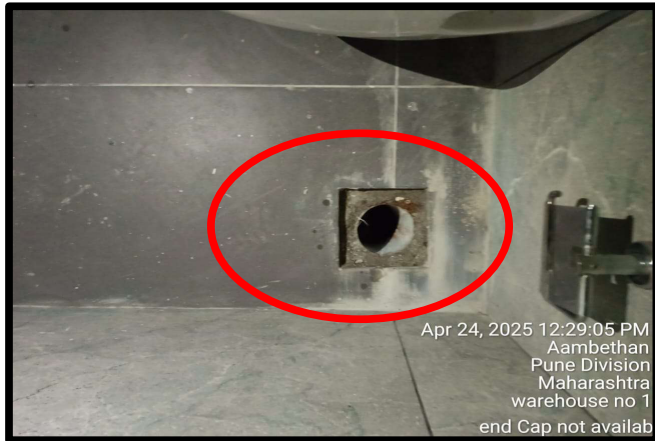
12	Warehouse No:1	End caps are not provided in the drainage outlets, leaving them exposed to debris, pests, or accidental ingress.	Minor Observation

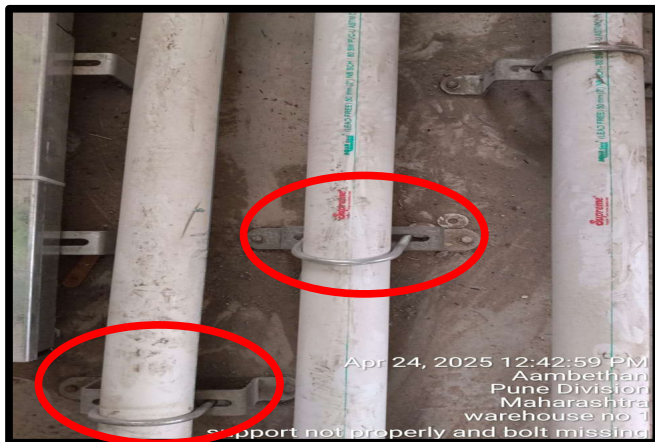
Open
13	Warehouse No:1	The U-clamp supports are not properly tightened with the pipe, leading to unstable and insecure pipe installation.	Minor Observation

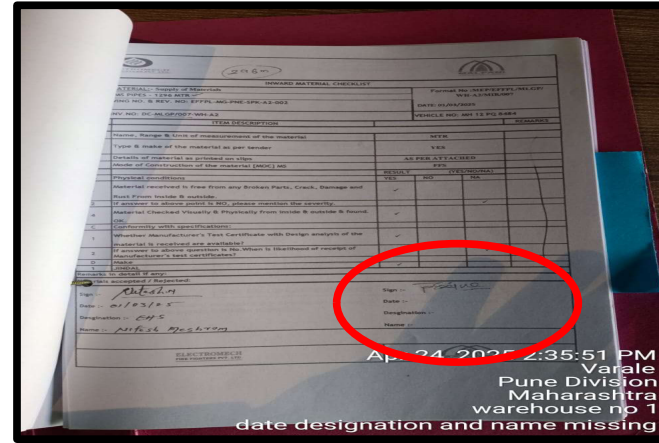
14	Warehouse No:1	In the MEP/EFFPL/MLGP/WH-A2/MIR/007 document, the date, name, and designation fields are not filled.	Minor Observation

<p>date designation and name missing</p>	Open
15	Warehouse No:1	In the inward material checklist, an incorrect Delivery Challan (DC) number has been recorded. This error can lead to mismatches between received materials and official records, potentially causing issues during audits or inventory verification.	Minor Observation

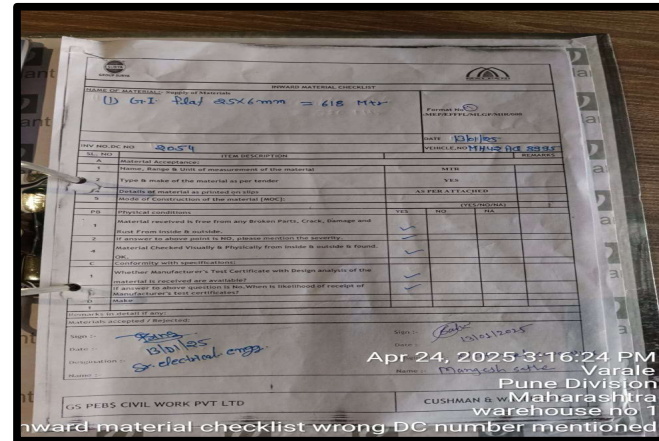
<p>inward material checklist wrong DC number mentioned</p>	Open

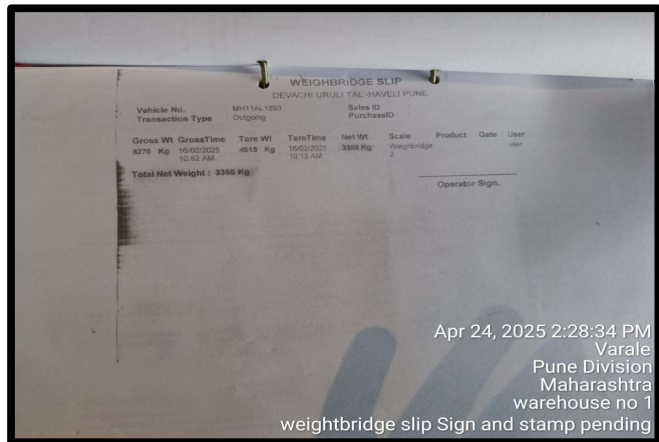
16	Warehouse No:1	The weighbridge slip lacks the required sign and stamp, making it an unofficial and unverifiable document.	Minor Observation
