M- FALCON (RAMANUJAM)

LALIT ESTATE, BANER, PUNE, MAHARASHTRA - 411045

QAQC AUDIT REPORT

24 SEPTEMBER 2024

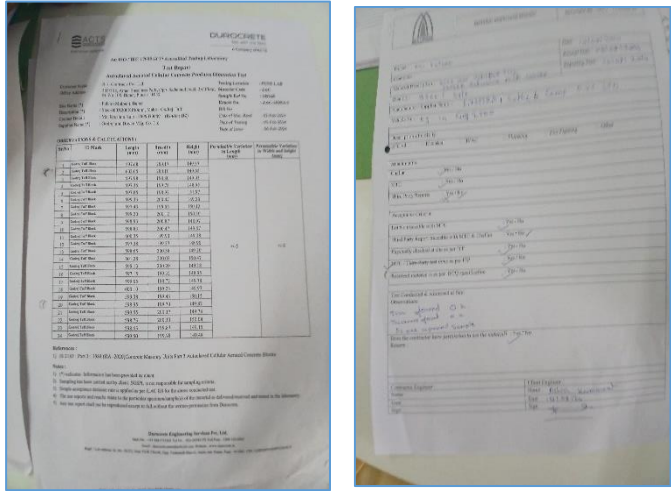
3	Site Office	Randomly Checked the MIR for different works are maintained properly. MIR of AAC block dimension checked at site as per ITP requirement to be evident in the report.	Information

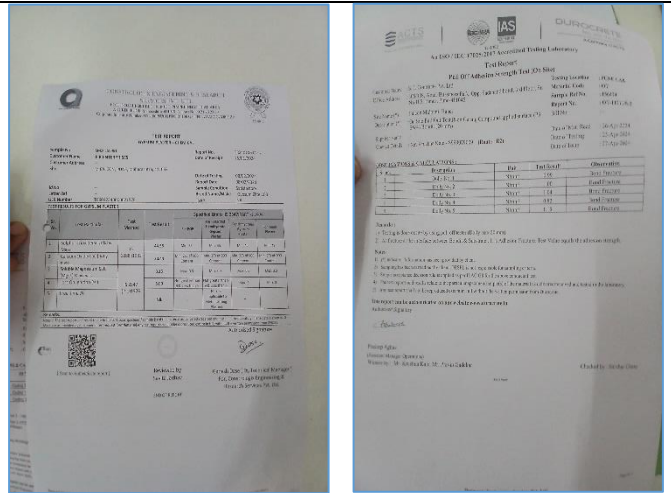
Site Inspection
4	Site Office	Randomly checked the Third party test report for different material. 1)Gypsum Bonding agent third party test is not done as per ITP. Pull out test is carried out only. 2)Gypsum Plaster physical third party test not done. Only chemical test report available.	Minor Observation

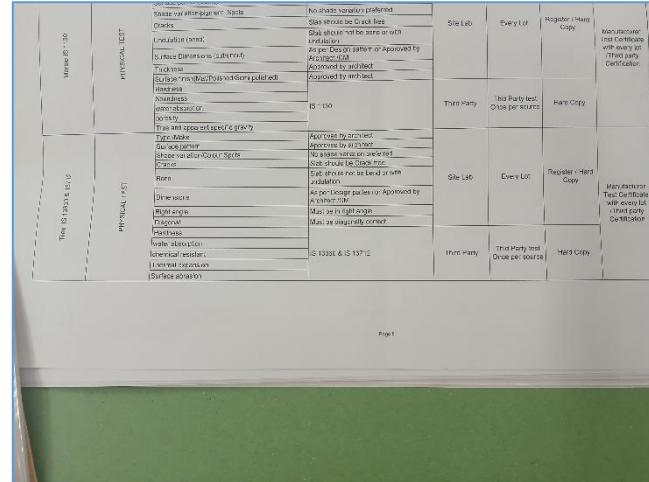
5	Site Office	Tile Testing report were checked as per ITP. ITP doesn't specify test for Breaking Strength and Modulus of rupture which are important test as per IS 15622. It is recommendation to incorporate these test in ITP	Information

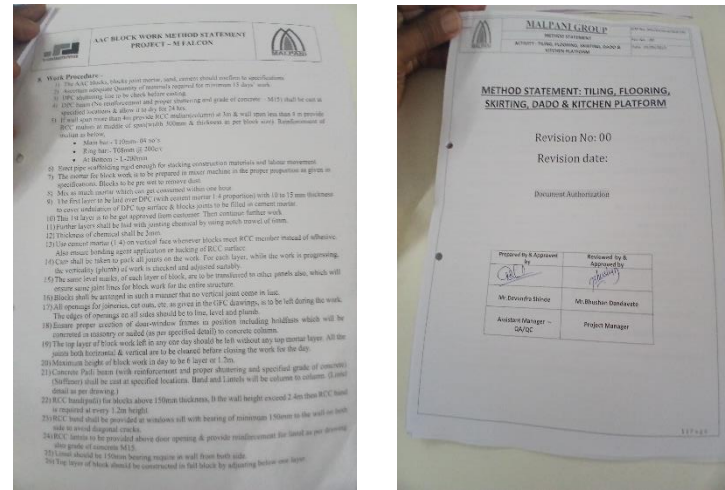
IS 15622:2017 Pressed Ceramic Tile
6	Site Office	Randomly reviewed in Work method statement for construction activities & found maintained. WMS of Gypsum plaster and Painting is not available	Minor Observation

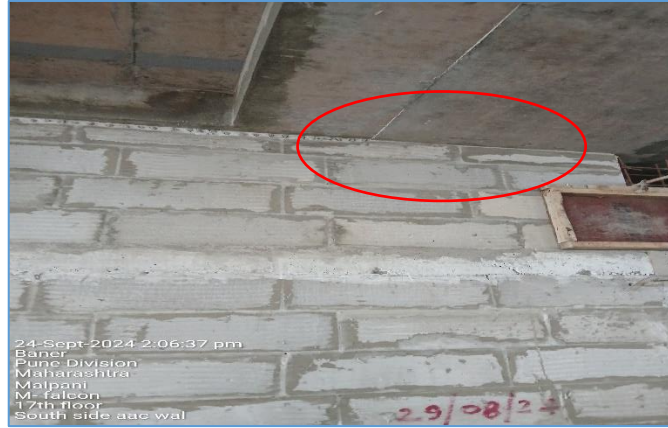
7	Site 17 th Floor South Side wall	AAC Block – As per WMS The gap of 10-20mm in between top layer and Beam not filled properly through out the top course.	Minor Observation

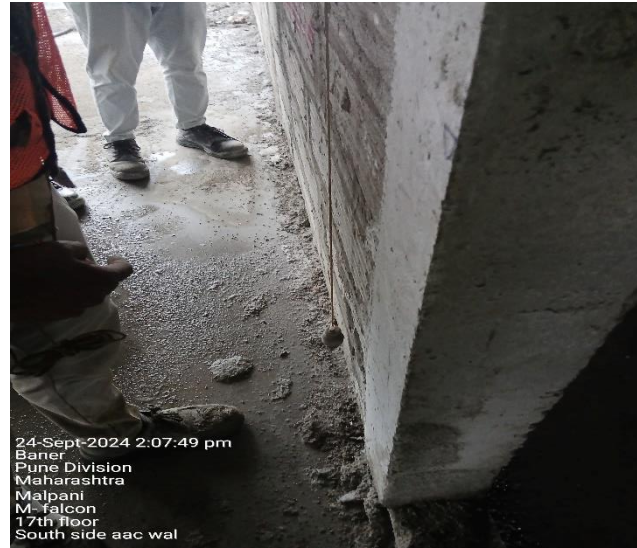
<p>24-Sept-2024 2:06:37 pm Baner Pune Division Maharashtra Malpani M- Falcon 17th floor South side aac wal 29/08/24</p>	Site Inspection
8	Site 17 th Floor South Side wall	AAC Block – The wall checked for plumb deviation upto 3mm observed	Minor Observation

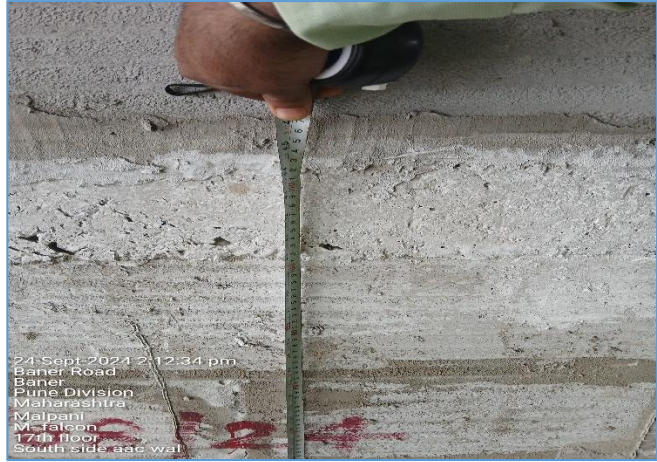
9	Site 17 th Floor South Side wall	AAC Block – Height of block work above which RCC band cast observed upto 1m required as per WMS max 1.2m	Positive

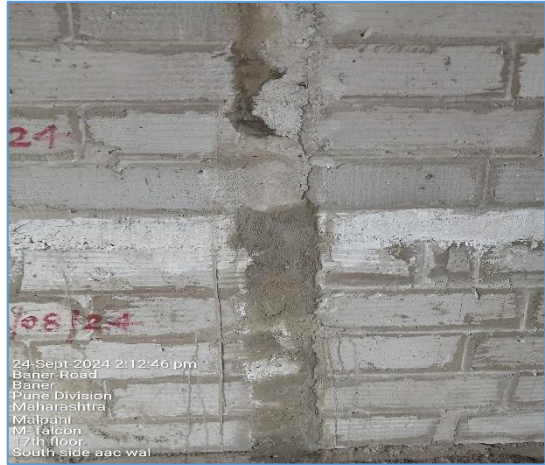
Site Inspection
10	Site 17 th Floor South Side wall	AAC block- RCC mullion casted width observed 150mm at one location required 300mm as per WMS	Minor Observation

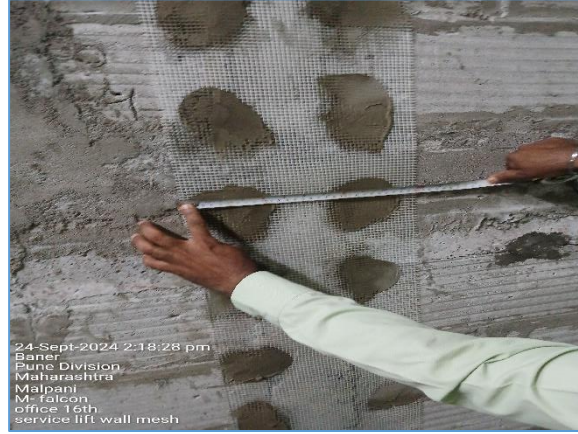
11	Site 16 th Floor Office near service lift	AAC Block Work- Fiber mesh of 300mm with proper overlap at the junction of RCC and Block work provided	Positive

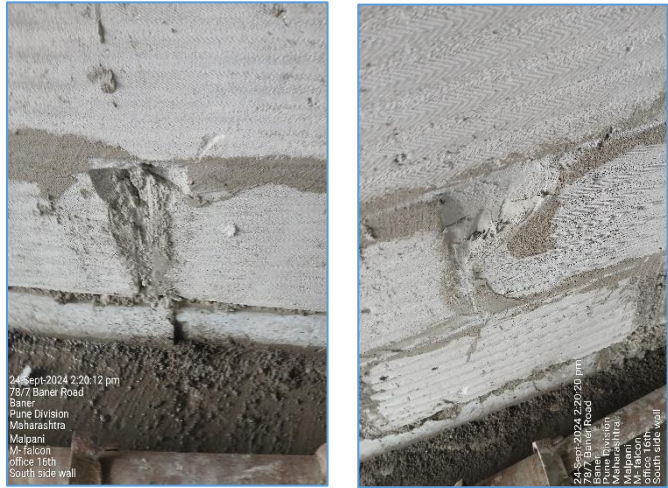
<p>24-Sept-2024 2:18:28 pm Baner Pune Division Maharashtra Malpani M- falcon office 16th service lift wall mesh</p>	Site Inspection
12	Site 16 th Floor Office South Side Wall	AAC Block work – AAC block observed damaged in the block work complete.	Minor Observation

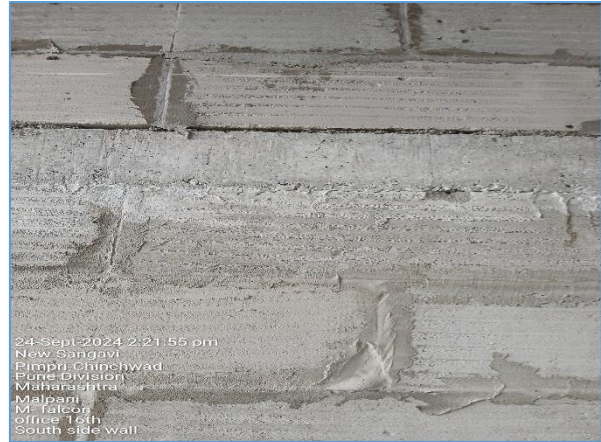
13	Site – 16 th Floor South Side Wall	AAC Block work – Horizontal bed joint above RCC band not filled properly gap observed.	Minor Observation

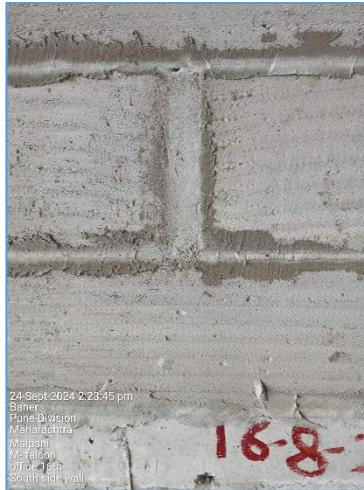
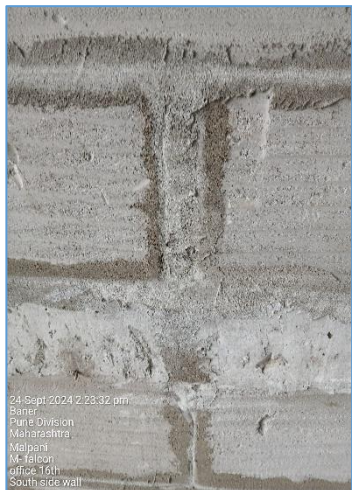
<p>24-Sept-2024 2:21:55 pm New Sangavi Pimpri Chinchwad Pune Division Maharashtra Malpuri M. Falcon Office 16th South side wall</p>	Site Inspection
14	Site 16 th Floor South Side Wall	AAC Block work – Vertical joint thickness observed above 3mm not as per WMS	Minor Observation

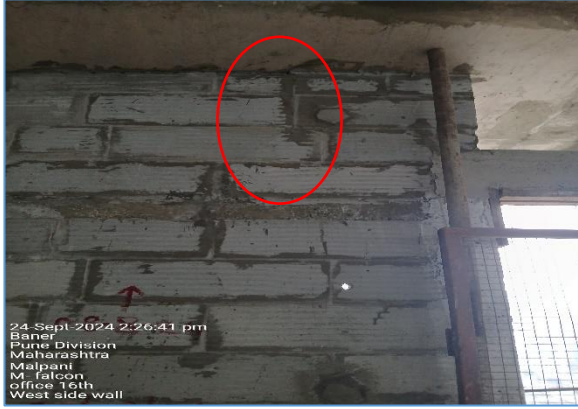
15	Site 16 th Floor West Side Wall	AAC Block Work- Vertical joint in masonry work not staggered. Joint observed in one line in alternate course	Minor Observation

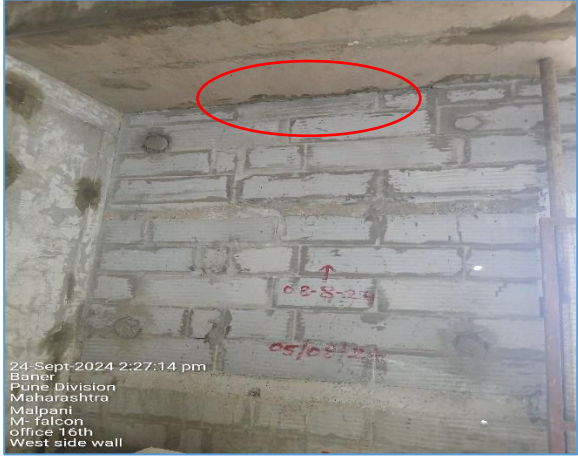
<p>24-Sept-2024 2:26:41 pm Baner Pune Division Maharashtra Malpani M- falcon office 16th West side wall</p>	Site Inspection
16	Site 16 th Floor West Side Wall	AAC Block Work- Full size are to used in top course as per the WMS , cut block were used in the top course	Minor Observation

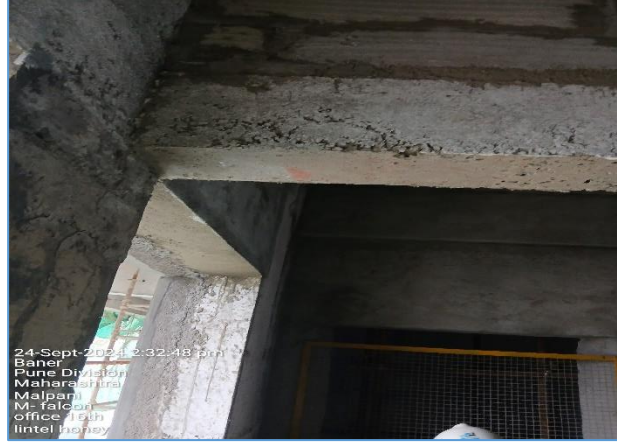
17	Site 16 th floor Near service shaft	Honey-combing observed in lintel above door opening.	Minor Observation

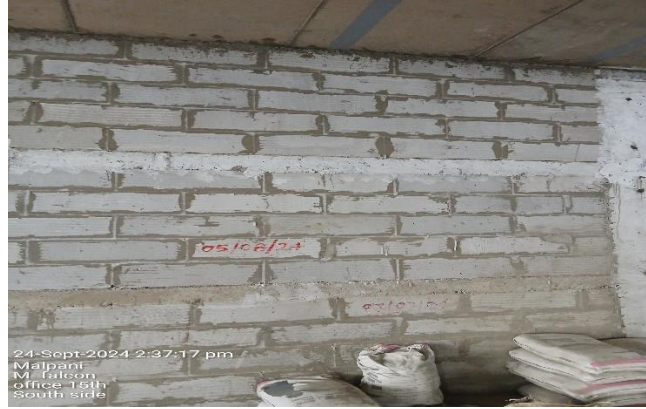
19	15 th Floor South Side Wall	AAC block Work- Date of construction of AAC block work mentioned. Vertical Joints are properly staggered more than 1/3 rd of length of block.	Positive

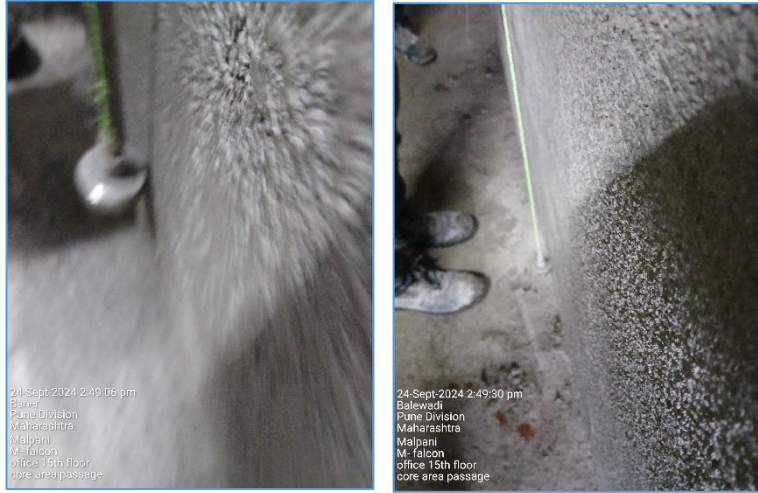
Site Inspection
20	15 th Floor Core passage	Plastering work – Checked the plaster surface for plumb with plumb bob and found true vertical	Positive

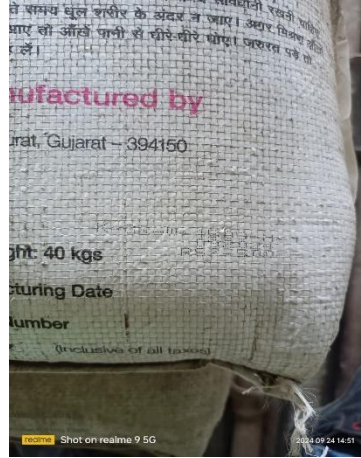
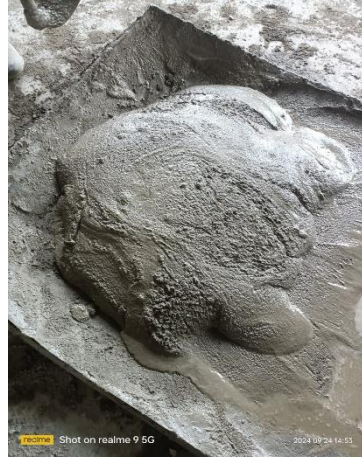
21	Site	Plaster Work – 1)Checked the readymix plaster bag for batch no and date of manufacturing -ok 2)Tray was used for mixing the ready mix plaster with W/C as per the requirement.	Positive

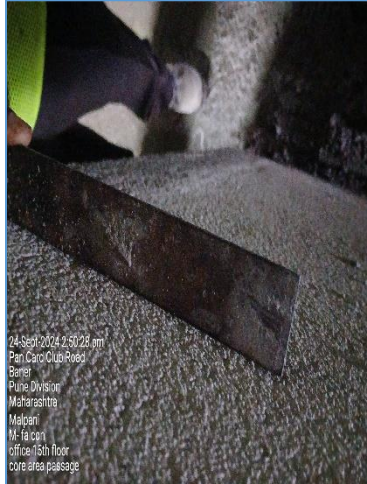
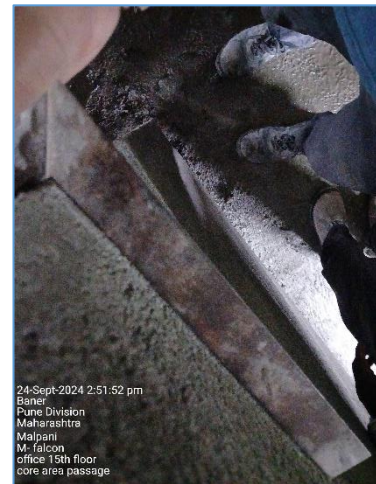
22	15 th Floor core area.	Plastering work – Checked the plaster wall for right angle, deviation at one corner observed upto 2mm.	Minor Observation

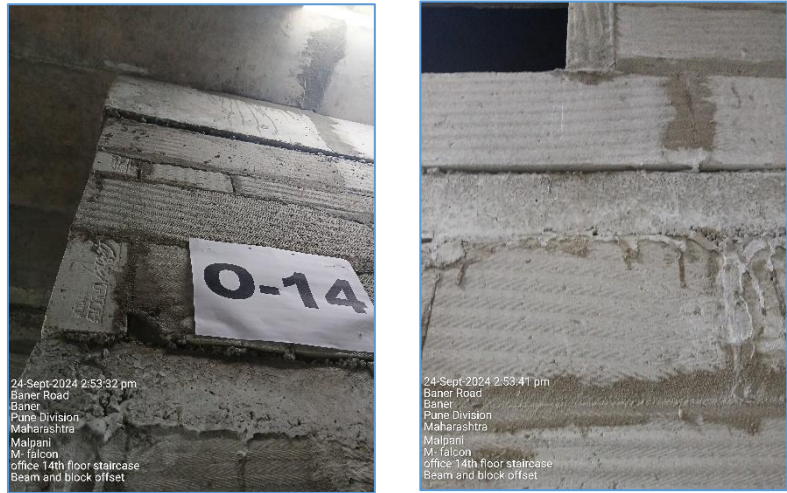
23	14 th Floor Staircase area	AAC Block Work – 1)Offset observed between block work and beam. 2)Offset observed between RCC band and block work.	Minor Observation

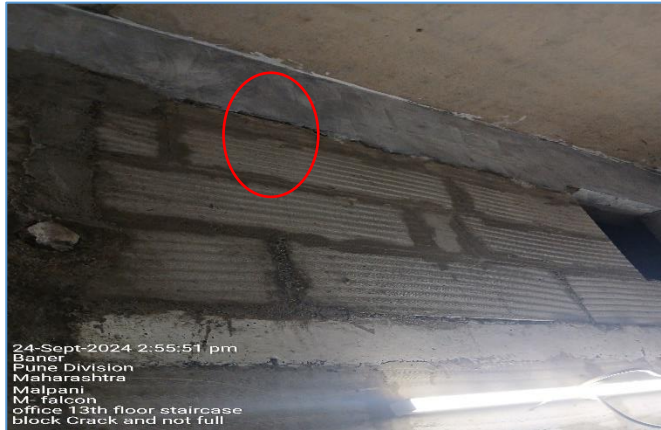
<p>24-Sept-2024 2:53:32 pm Baner Road Baner Pune Division Maharashtra Malpani M. falcon office 14th floor staircase Beam and block offset</p> <p>24-Sept-2024 2:53:41 pm Baner Road Baner Pune Division Maharashtra Malpani M. falcon office 14th floor staircase Beam and block offset</p>	Site Inspection
24	13 th Floor Near staircase area	AAC Block Work – AAC block was observed cracked in the top course and also full size block not used in the top course.	Minor Observation

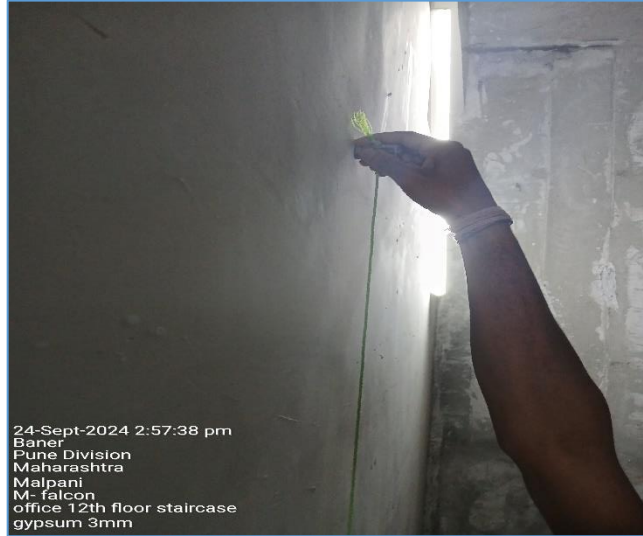
25	12 th Floor Staircase area	Gypsum Plaster – Checked the gypsum plaster for plumb deviation upto 3mm observed.	Minor Observation

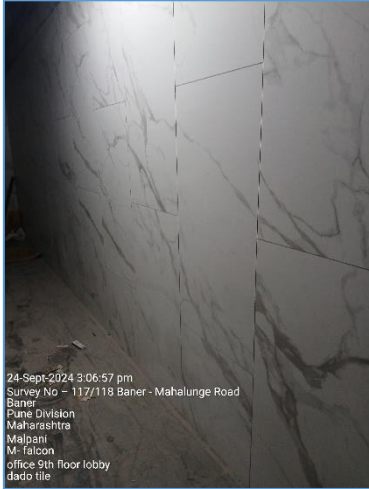
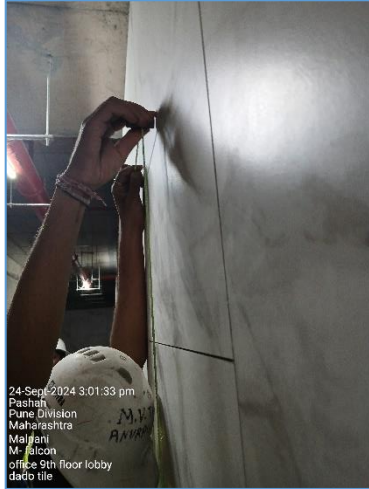
<p>24-Sept-2024 2:57:38 pm Baner Pune Division Maharashtra Malpani M- falcon office 12th floor staircase gypsum 3mm</p>	Site Inspection
26	9 th Floor Office lobby	Dado Tile work – Checked the dado tile for plumb and evenness and found satisfactory.	Positive

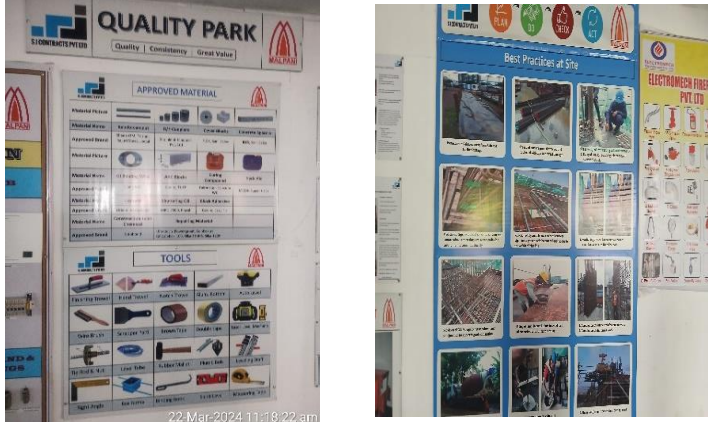
27	Site Lab	Quality park near office to understand materials to be used & procedures to be followed during construction is maintained.	Positive

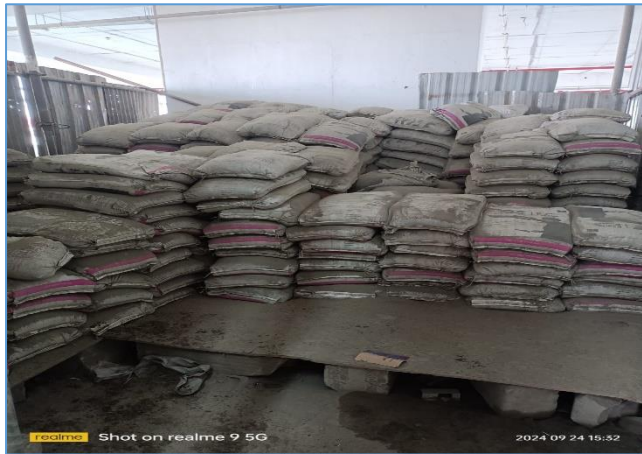
28	Site storage	Plaster bags were observed stacked more than 10 nos vertically. Bags were observed touching the wall. Space of 600mm around exterior wall to be maintained.	Observation

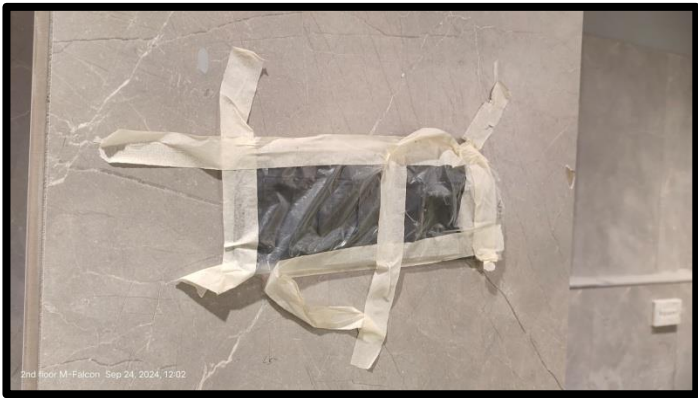
A. INSPECTION & FINDINGS					
Sr. No.	LOCATION	AUDIT FINDINGS / OBSERVATIONS	TYPE OF FINDINGS	IMAGE/ EVIDENCE	Status
1	2 nd floor Mens restroom	Switch plates are properly protected with masking tape during other works.	Good Observation

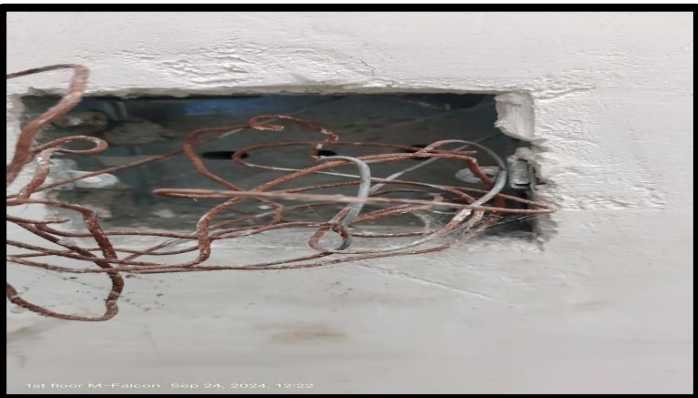
Info
2	1 st Floor – Lobby	The use of GI (galvanized iron) wires has been observed to result in rusting over time. It is recommended to use nylon wires instead.	Minor Observation

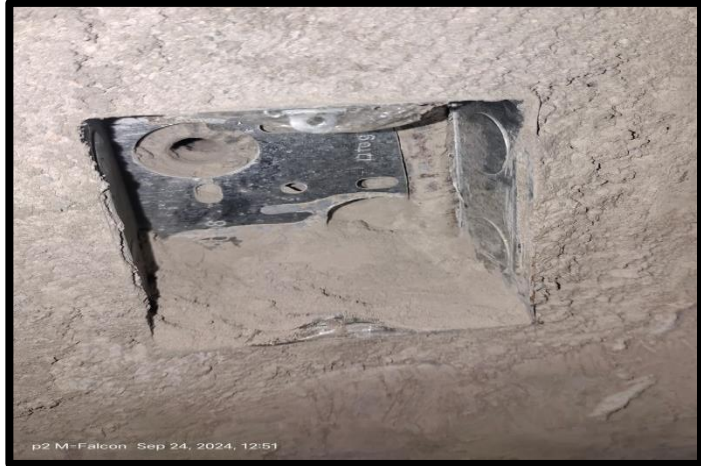
5	P2	The module box is currently unprotected during ongoing work, leading to the accumulation of cement plaster inside the boxes. It is crucial to secure the boxes immediately to prevent further contamination.	Minor Observation

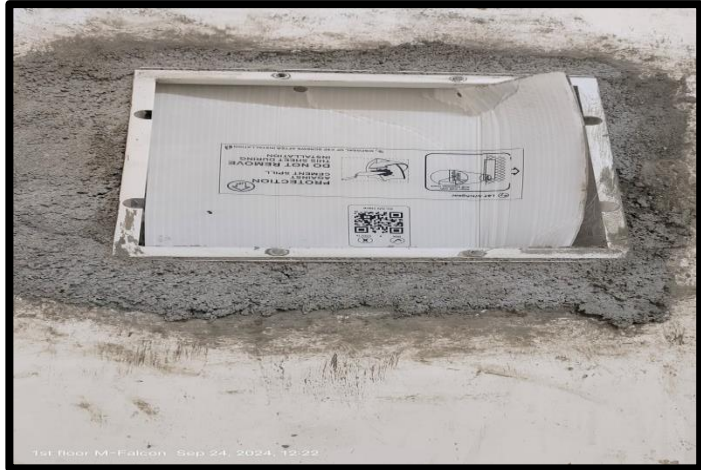
<p>p2 M-Falcon Sep 24, 2024, 12:51</p>	Open
6	1 st Floor lobby	The DB (Distribution Board) box has been protected using a protection sheet; however, there are gaps, and the sheets are not properly secured.	Minor Observation

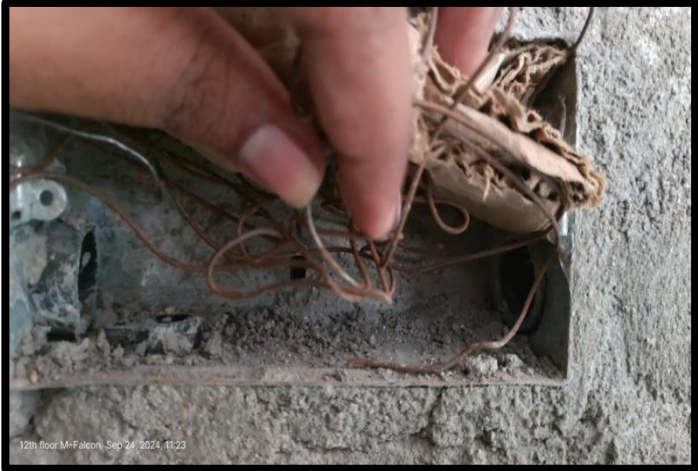
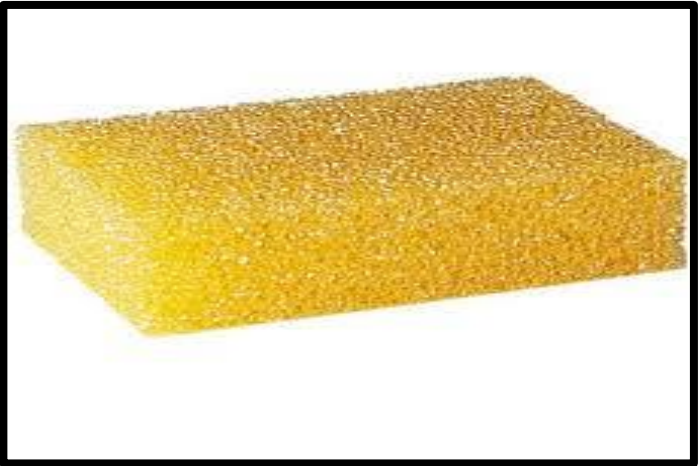
7	12 th Floor lobby	<p>Cotton boxes have been used to protect the module boxes from cement slurry accumulation. However, despite this, cement slurry has still managed to accumulate around the module boxes. It is recommended to use hard sponges cut to the same size as the module boxes.</p>	Minor Observation

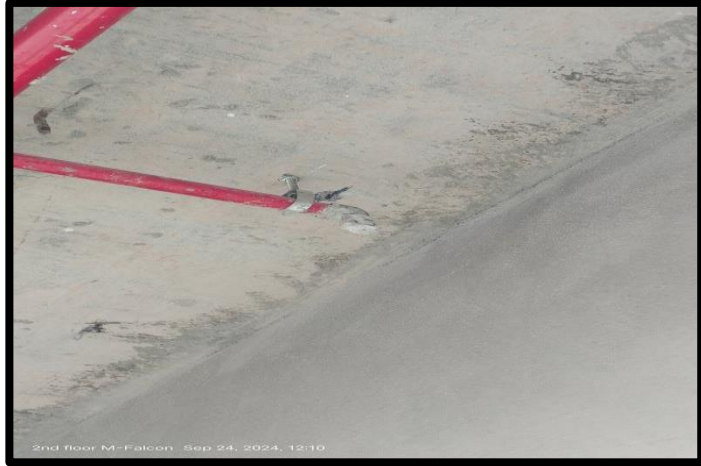
8	2nd Floor – Office area	Cement slurry's are accumulated around the sprinkler. Recommended to protect sprinkler.	Minor Observation

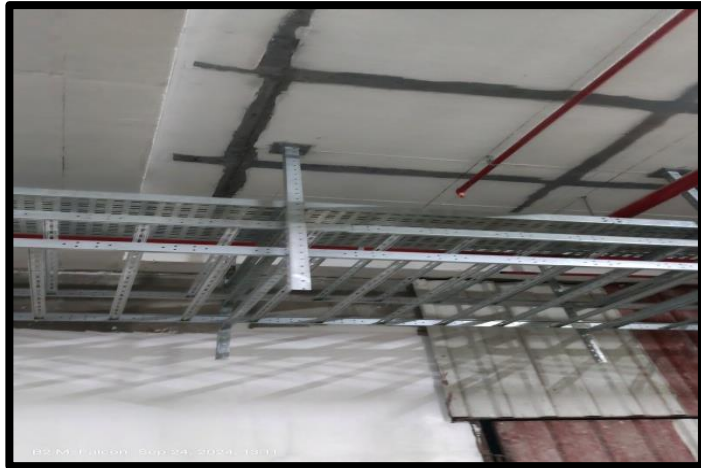
<p>2nd floor M-Falcon Sep 24, 2024, 12:10</p>	Open
9	B2	<p>Sprinklers can be installed above cable trays, but it is not recommended. However, if installed above, the following conditions must be met: As per IS 14489:1998,</p> <ul style="list-style-type: none"> - Minimum distance of 300 mm (12 inches) above the cable tray. - Sprinklers positioned to avoid direct water discharge on cables. - Cable tray width of at least 600 mm (24 inches) for adequate water discharge. 	Recommendation

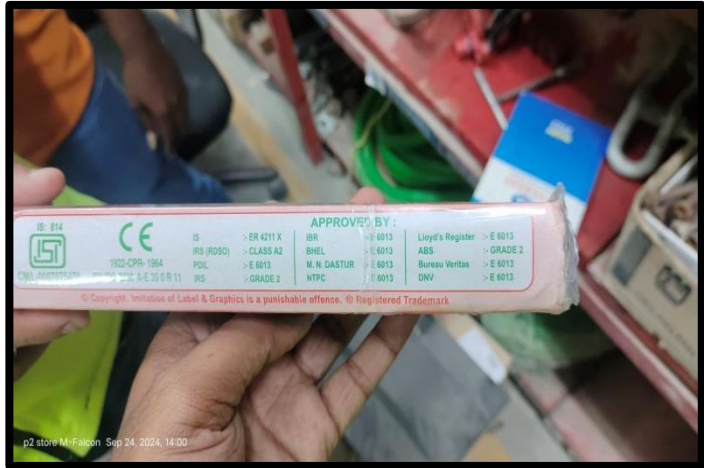
10	P2 store room	E6013 grade welding rods used for welding.	Good Observation

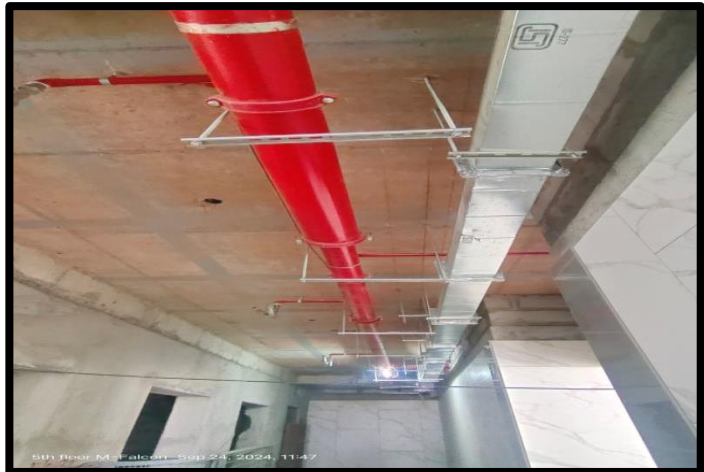
Info
11	5 th floor lobby 2 nd floor lobby	It is recommended to position the cable trays away from the fire pipes due to the potential risk of water leaks at the welded joints in the future.	Information

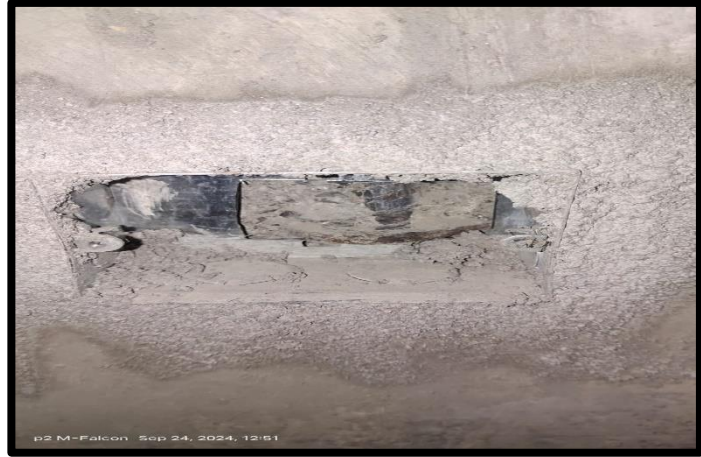
13	P2 - Entrance Lobby	The module box has been damaged due to contact with an RCC rod during construction. This could compromise the electrical system and lead to further structural or functional issues if not corrected.	Major Observation

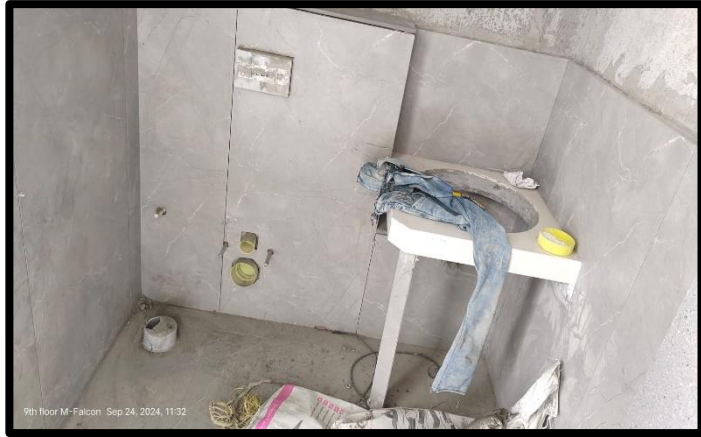
Open
14	9 th Floor – Toilet	The use of end caps to protect drainage outlet points is a good practice, but in this case, the end cap is damaged and requires attention. Supervision is necessary to ensure the damage is addressed.	Minor Observation
