## **M- FIBONACCI (ARYABHATTA)**

MAHALUNGE, PUNE, MAHARASHTRA - 411045

### **QAQC AUDIT REPORT**

25 SEPTEMBER 2024

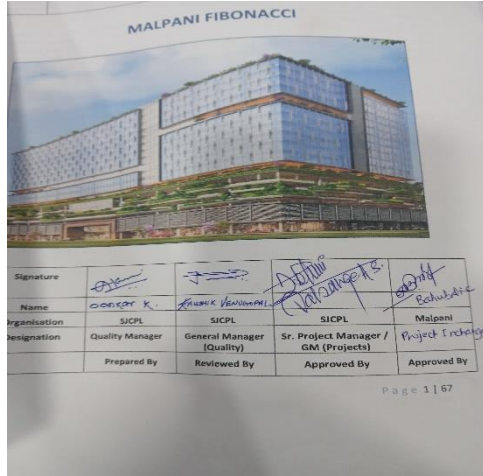
A. INSPECTION & FINDINGS					
Sr. No.	LOCATION	AUDIT FINDINGS / OBSERVATIONS	TYPE OF FINDINGS	IMAGE/ EVIDENCE	Status
1	M Fibonacci Site	Construction status at Tower A & A1	Info	Building : Basement + Ground + 6 Podiums + Amenity + 11 Floors Current Status :GF slab 100% + P1 slab 30 %+P2 slab 18%+column (GF to P1) 65%.	Info
2	Site Office	Project quality plan with QAP & ITP was available at Site Office	Positive

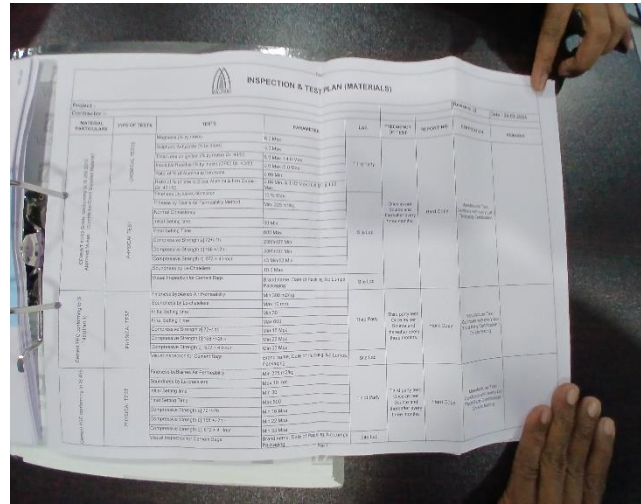
3		ITP was available at Site Office.	Positive

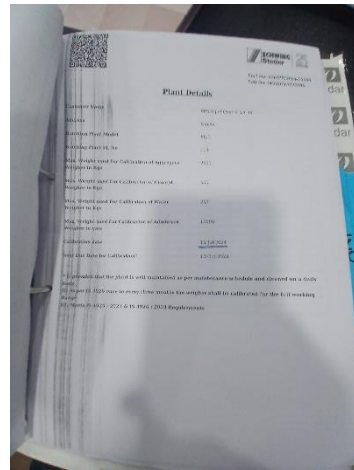
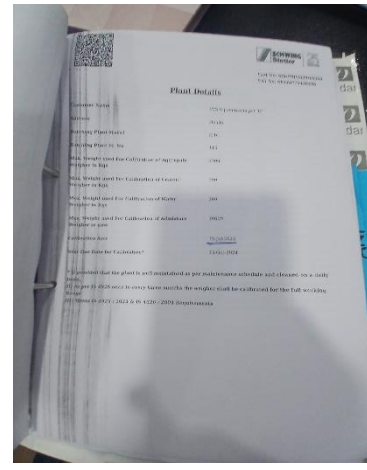
4	Site Office	Batching plant calibration certificates verified & found valid as per QAP requirements. Model M1C bearing S.No – 113 Calibration date 15/7/24	Positive

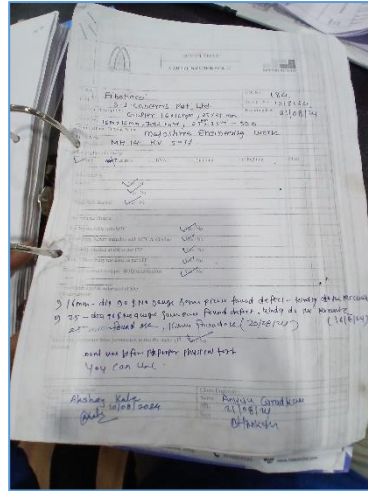
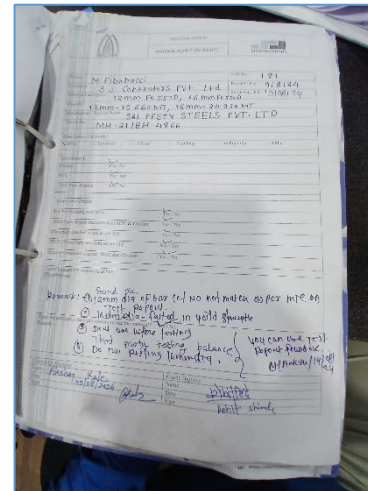
5	Site Office	MIR for incoming material and their record checked. it was seen that any observation w.r.t materials were highlighted in the report and kept on hold till it has been cleared.	Positive

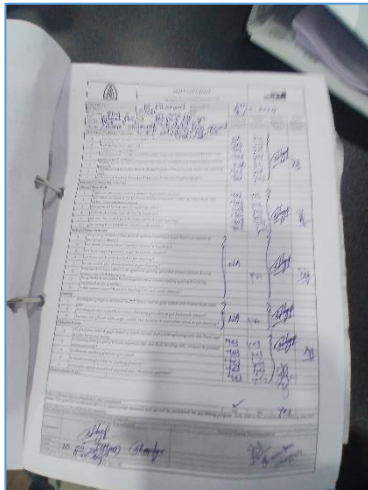
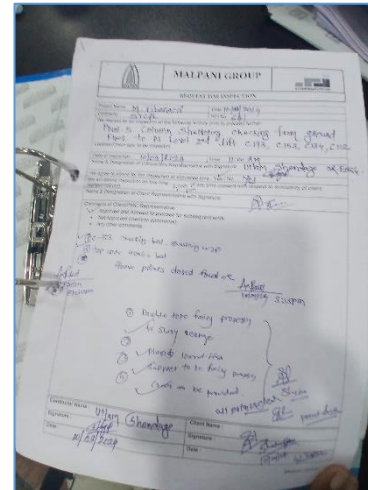
6	Site Office	Randomly reviewed method statement, pour card of various activities construction materials & found in order	Positive

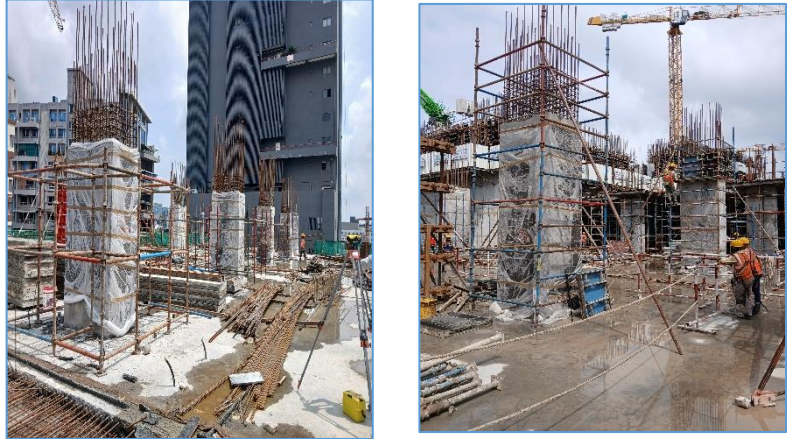
7	Site	<p>Curing is being carried out properly and date of casting is mentioned on member.</p> <p>Vertical Member were covered with plastic sheet to ensure the inside surface remains wet continuously. <b>Very good practice</b></p>	Positive

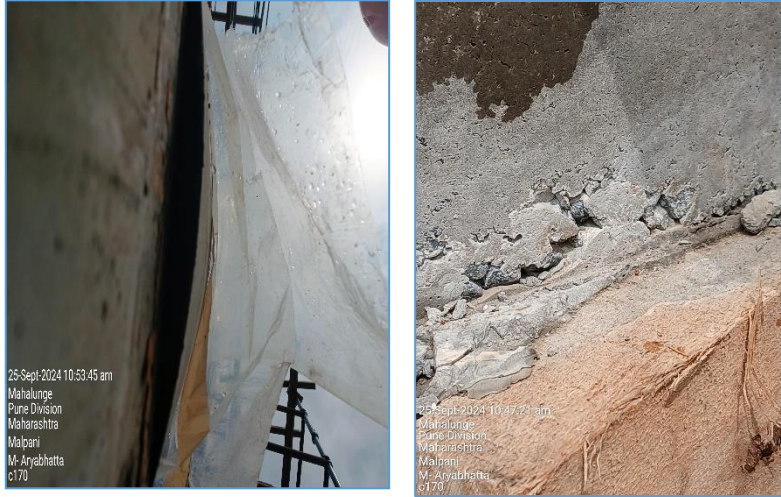
Site Inspection
8	Site Column – C170	<p>RCC- Minor Honeycombing observed in concrete at bottom portion of column.</p>	Minor Observation

- 1) Minor Honeycombing observed in concrete at bottom portion of column column C170
- 2) Links of wall reinforcement C78 were loose and not bent properly as per drawing.
- 3) Rough surface observed on column C121 and slurry loss C 120
- 4) Tie Rod hole were not filled for wall W11,W12 & W13

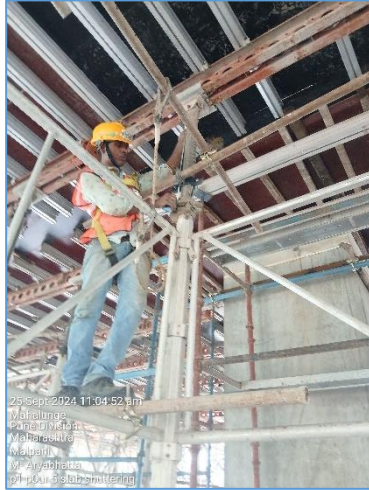
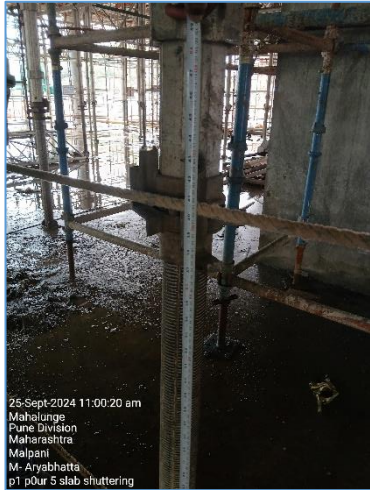
9	Site P1 pour 5 slab Table formwork	Checked the formwork as per the scheme diagram. The extension of length of top" u "jack observed 975mm w.r.t reqd 775mm	Minor Observation

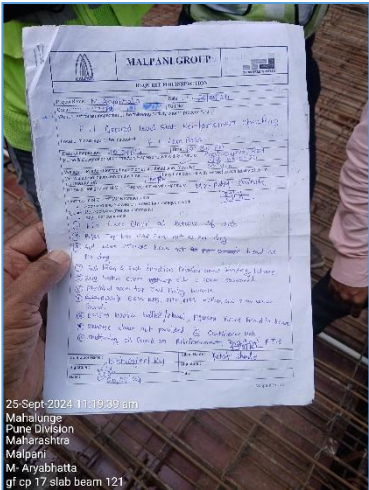
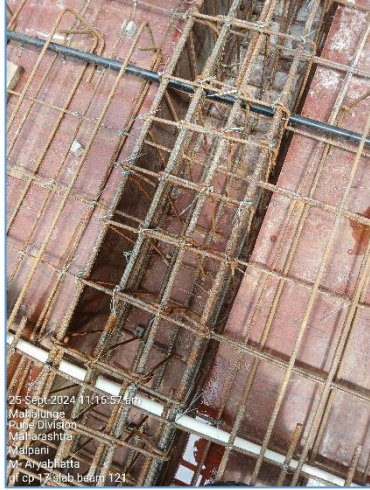
<p>25 Sept 2024 11:00:20 am Mahalunge Pune Division Maharashtra Malpani M- Anyabhata p1 pour 5 slab shuttering</p>	Site Inspection
10	Site – GCP 17 slab	Reinforcement – Checked the slab reinforcement as per drawing, observation pointed out were already mentioned in RFI and rectification given	Positive

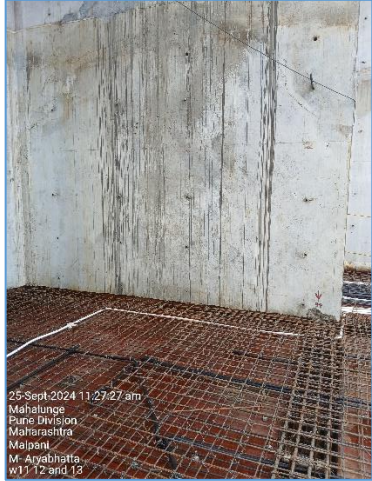
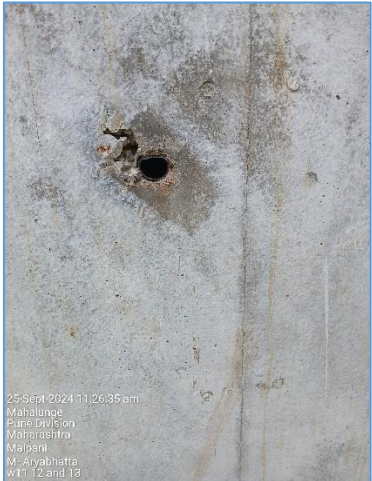
11	Site – Wall -W11,12 and 13	RCC- Tie rod hole were observed not filled.	Minor Observation

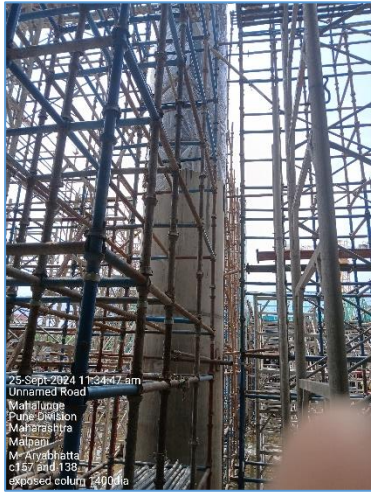
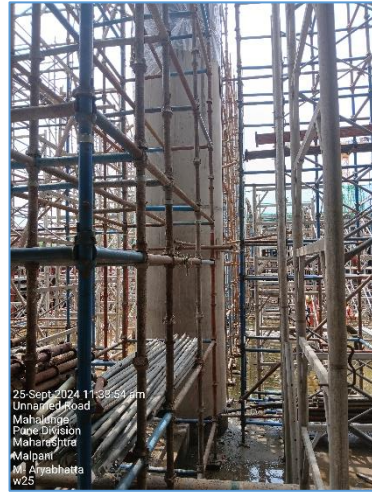
<p>25-Sept-2024 11:26:35 am Mahalunge Pune Division Maharashtra Malpuri Mr. Arvabhata W11,12 and 13</p>	Site Inspection
12	C157 & C138 Exposed concrete column	Form finish concrete with very good surface finish	Positive

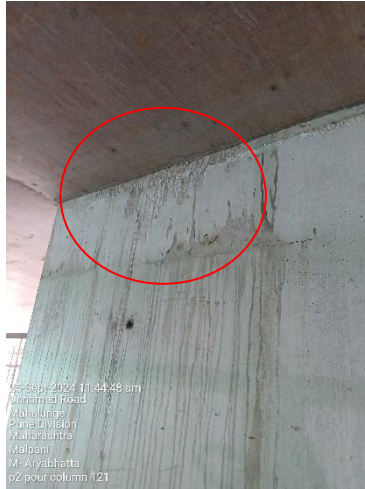
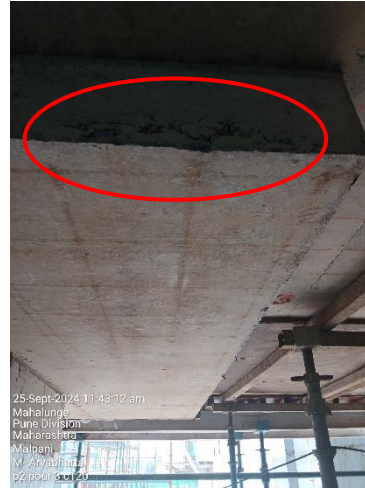
13	P2 pour column 120 and C 121	RCC – 1)Slurry loss observed on the concrete surface. 2)Honeycombing observed in the concrete	Minor Observation

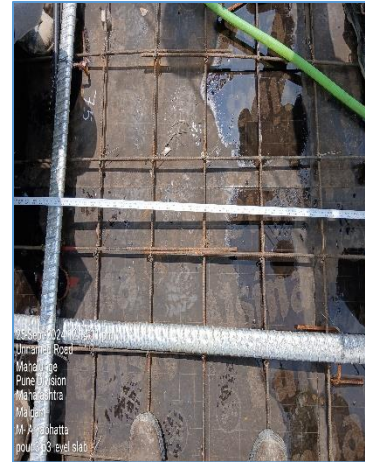
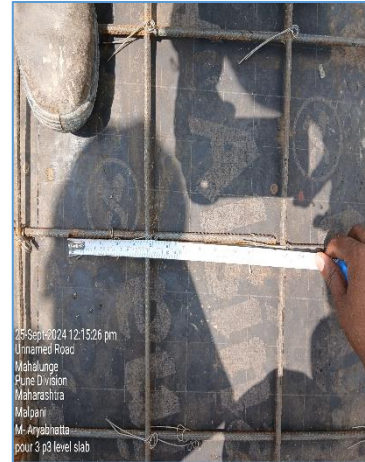
<p>25 Sept 2024 11:48:12 am Mahalunge Pune Division Maharashtra Malpani M. Aryabhata p2 pour column 121</p>	Site Inspection
14	Pour 3 P3 level slab	Reinforcement – Checked the reinforcement as per drawing- 1)Spacing of Rebars 2)Lap length of Rebars 3)Make and cover to rebars And found as per drawing	Positive

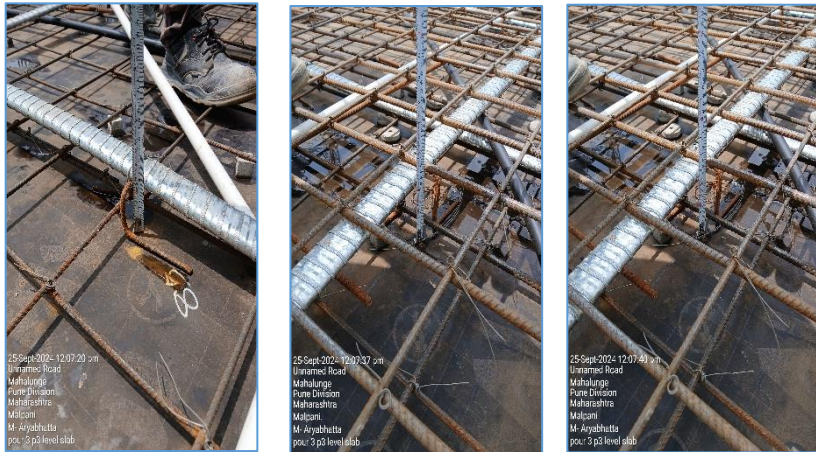
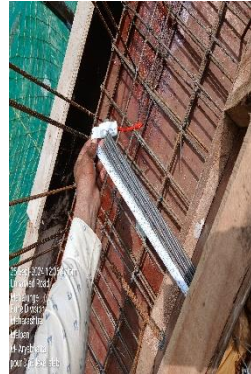
15	Pour 3 P3 level slab	Reinforcement Ongoing- Checked the Tendon profile layout along x and y direction as per drawing 1)Vertical profile 2)Horizontal Profile 3) Dia f strands 4) Stressing Length Found as per Drawing.	Positive

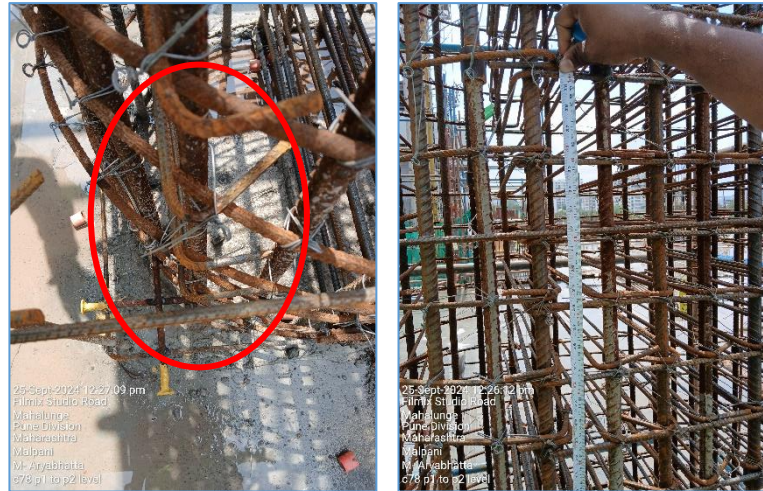
<p>25 Sept-2024 12:07:55 pm Unnamed Road Mahalunge Pune Division Maharashtra Malpuri M-Anyabhata pour 3 p3 level slab</p>	Drwg no- 1202/4/7/R1 and 1202/4/8/R1
16	Site Column C78 p1 to p2 level	Reinforcement- Checked the reinforcement 1) Spacing of links 2) No. of vertical main bars 3) Hook bend @90 degree. 4) Coupler Joint.  Links were not observed bend around the vertical reinforcement. Binding wire not tied properly, loose links observed.	Minor Observation

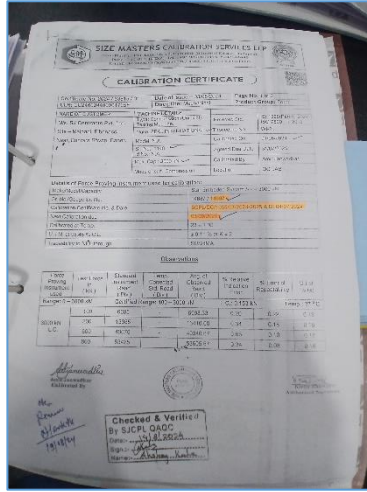
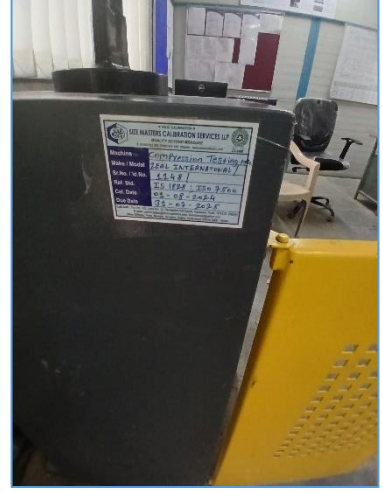
19	Site Lab	<p>CTM &amp; Cube moulds calibration certificates verified &amp; found valid as per QAP requirements</p> <p>CTM Sr.no – 1148</p> <p>Due date 31/07/2025</p>	Positive

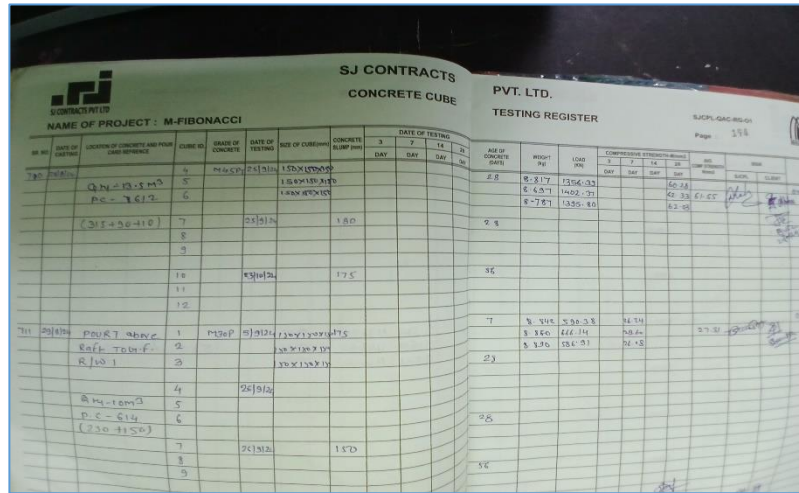
Certificate No - 2024/68815/01 dtd 03/08/2024
20	Site Lab	<p>Checked the cube register, testing results were observed dully filled as per the pour card and maintained properly</p>	Positive

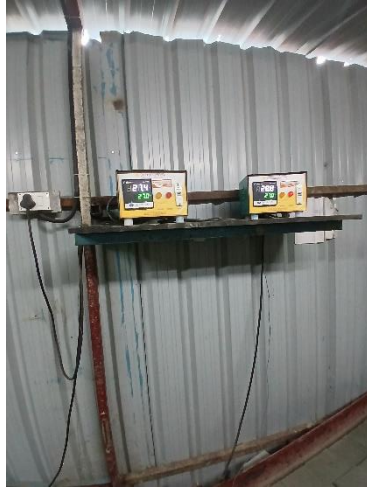
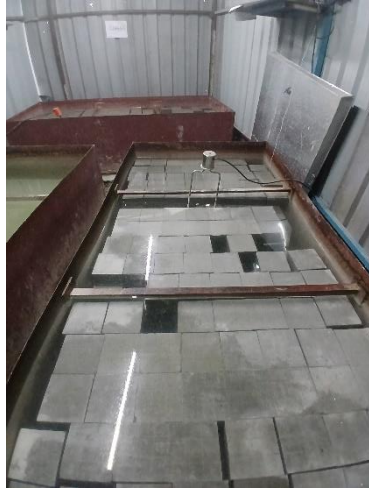
21	Site Lab	Cube curing tank with thermostatic control to maintain the temperature of water. Observed temp 27.4 °C and 28 °C - OK	Positive

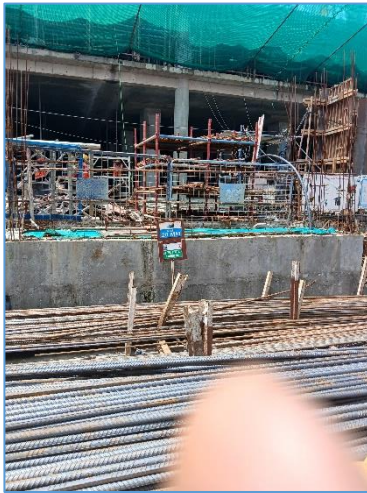
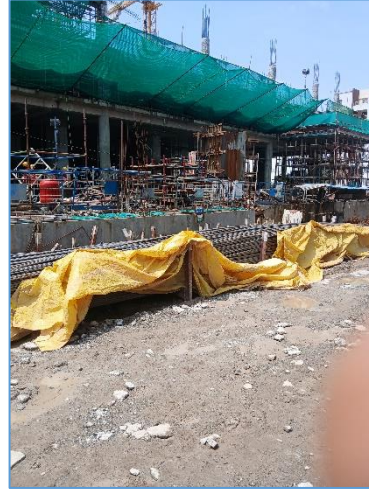
IS 1199 : part 5 :2018 Fresh Concrete – Methods Of Sampling,Testing and Analysis Part 5 – Making and curing of test specimen
22	Site Rebar stacking yard	Two different diameters of Rebar stacked separately and colour coding done for tested and untested Rebar.	Positive

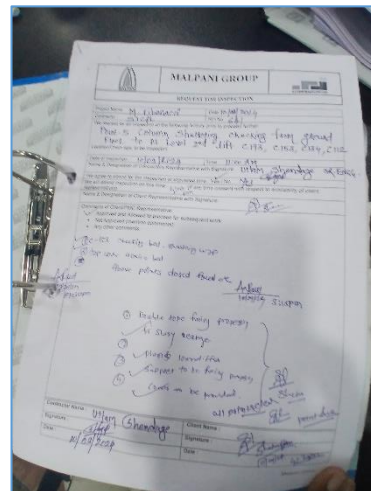
23	Site	Quality park is maintained at site with pictorial representation.	Positive	 	
24	Site Office	RFI being raised by contractor & inspection for reinforcement, Formwork & pour card is being carried out by Client. Records are maintained as per requirements.	Positive

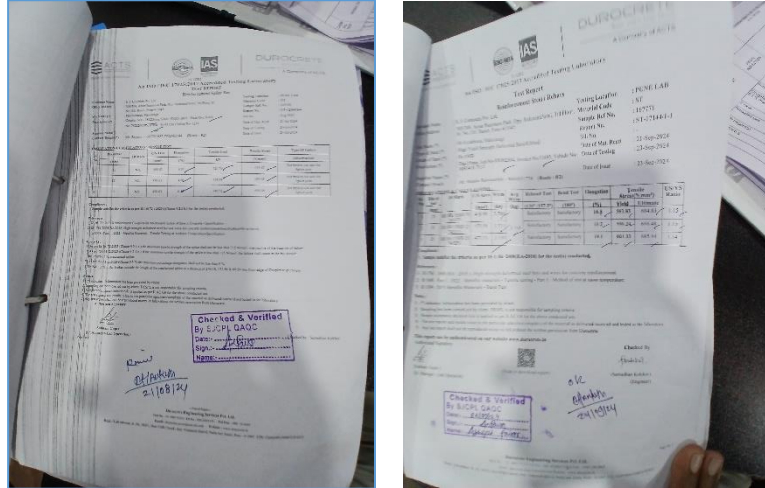
25	Site Office	Randomly reviewed in house as well as third party test reports for construction materials & found maintained properly as per ITP requirements	Positive

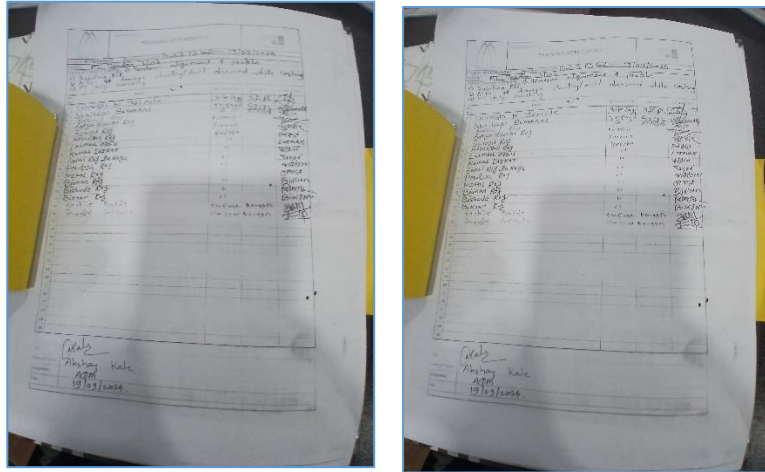
26	Training	Randomly checked Training records.	Positive
