**M- SOUL STRINGS**  
PASHAN, PUNE, MAHARASHTRA - 411021  
**QAQC AUDIT REPORT**  
26 SEPTEMBER 2024

<b>INSPECTION / AUDIT REPORT/MGPUNE/SOULSTRINGS/BVP/QAQC/CIVIL/IR-03</b>		<b>REV.NO. 0</b>
<input type="checkbox"/> Initial <input checked="" type="checkbox"/> Interim <input type="checkbox"/> Final <input type="checkbox"/> Resident.		
Inspection/ Audit Requested By : Malpani Group		
Inspection / Audit performed as Recognised Authority : Rohan A Patil		Yes <input checked="" type="checkbox"/> NO: <input type="checkbox"/>
BV Job / Zig No : 21641036

Project Name : M Soul Strings	IPO ( if applicable):N/A
Audit by : Bureau Veritas (India)Pvt Ltd, Pune	PO no. WO/Pashan/2024/159 Date 31.01.2024
Vendor/Manufacturer : Malpani Group	PO No. N/A ( Client to Vendor)
Architect : Meraki Design	Contractor : Millenium Engineers & Contractors Pvt. Ltd.
Sub Vendor : NA	Vertical : Civil
Inspection Location : M Soul Strings – Baner Pune	Previous Inspection : 27 <sup>th</sup> June 2014
Inspection Performed from : 26 <sup>th</sup> Sept 2024.	Next Inspection : As per Clients requirement

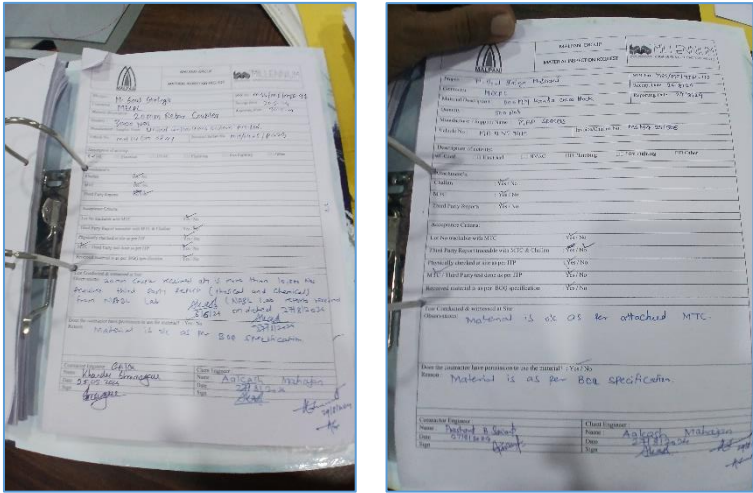
3	Site Office	<p>Randomly checked the MIR for different incoming material at site. MIR is maintained and filled regularly as per ITP.</p> <p>Observation –</p> <p>It was observed in MIR for Coupler it was not mentioned the coupler were checked with Go-No gauge and as per ITP</p>	<p>Minor Observation</p>

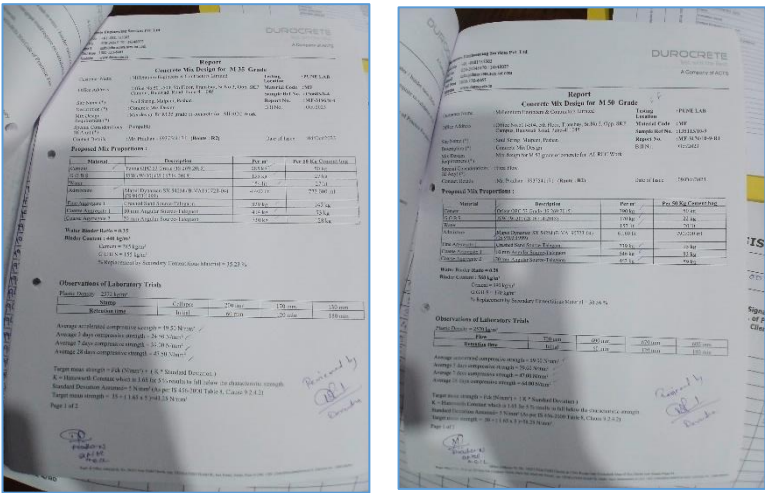
4	Site Office	<p>Concrete mix design with Trials conducted for approval is maintained as per QAP / ITP requirements</p>	<p>Positive</p>

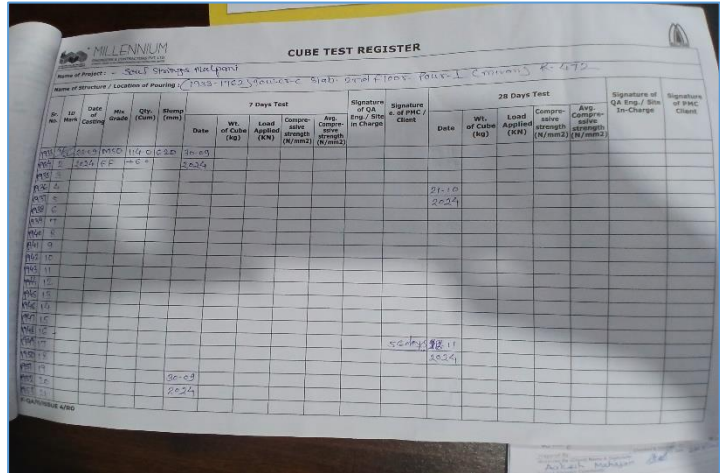
10	Quality Lab	Concrete cube register checked for testing records.. Qty of concrete mentioned in cube register and pour card 1933-1962 were not matching, difference observed.Cube register to be maintained properly.	Minor Observation

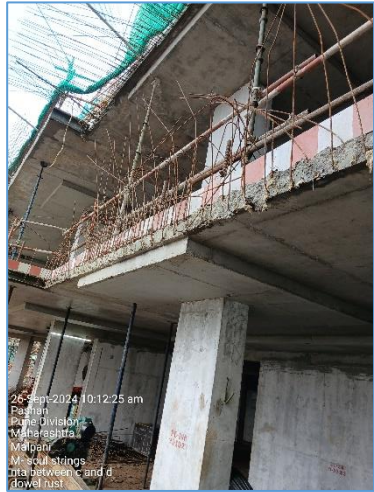
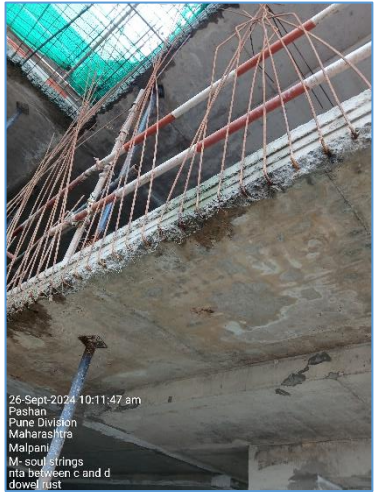
11	Site Non tower Area Between C & D	Reinforcement – 1)Dowel bars were observed not protected. 2) Dowel bars observed rusted and not properly tied/supported vertically.	Major Observation

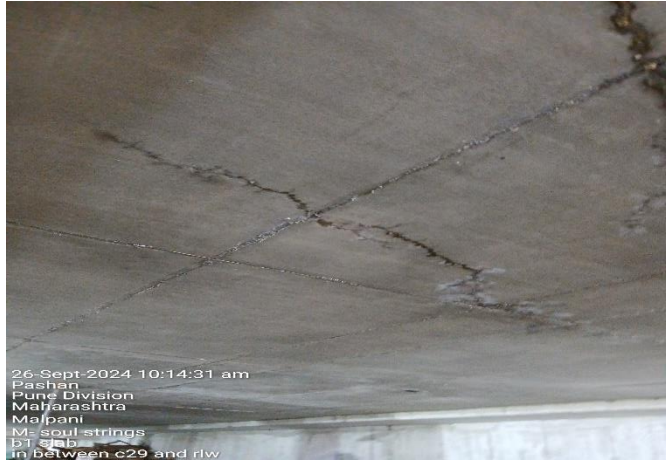
12	B1 slab In between C29 and R/w	RCC- Minor seepage observed in the bare slab	Minor Observation

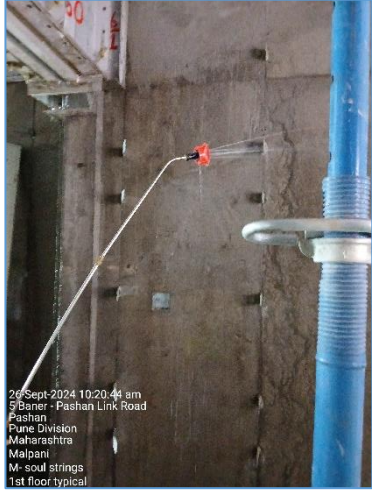
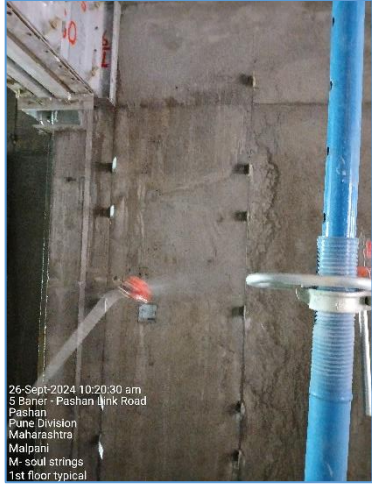
Site Inspection
13	Tower C – 1 <sup>st</sup> floor	Aluform- De-shuttering is under progress, curing is done immediately after de-shuttering	Positive

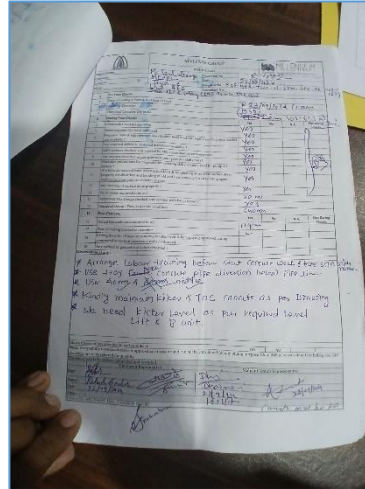
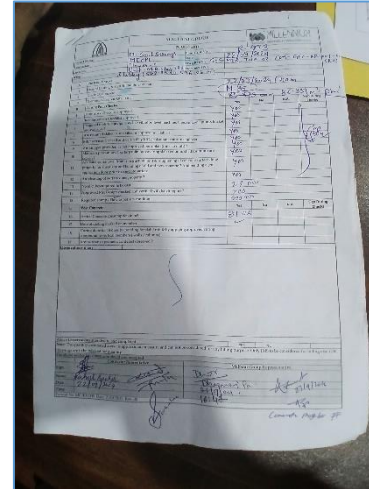
14	Site Office	RFI being raised by contractor & inspection for reinforcement, Formwork & pour card is being carried out by Client. Records are maintained as per requirements.	Positive

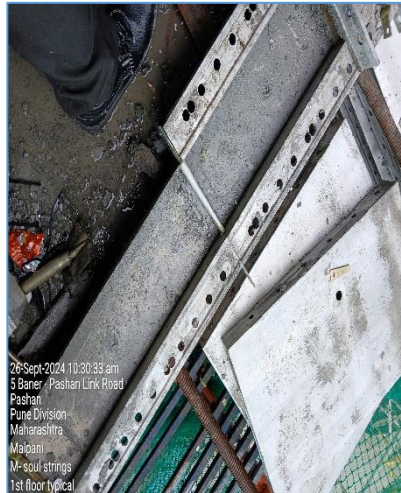
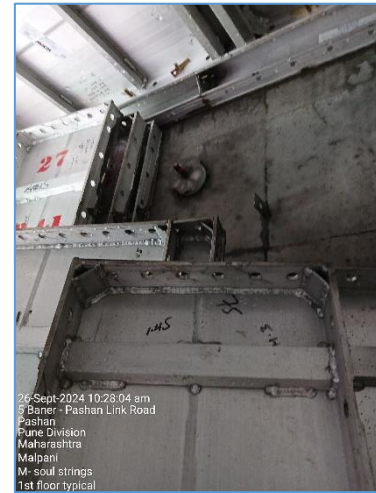
15	Site Tower C- First floor	Aluform – De-shuttering is under progress, surface finish of wall and window sill observed smooth and in level	Positive

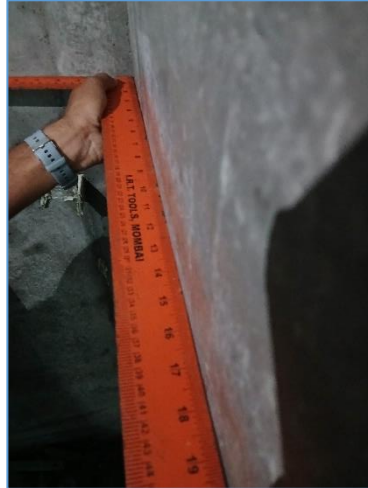
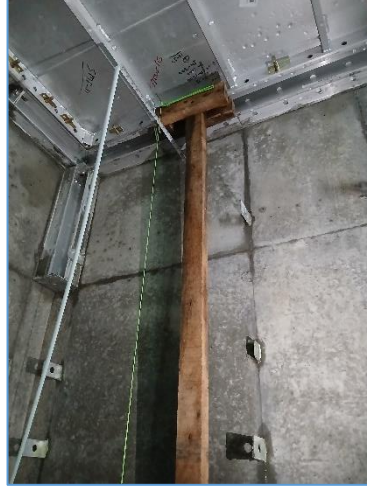
16	Tower-C First Floor	RCC- 1)Checked the wall for plumb and found true plumb. 2)Checked the right angle and found ok	Positive

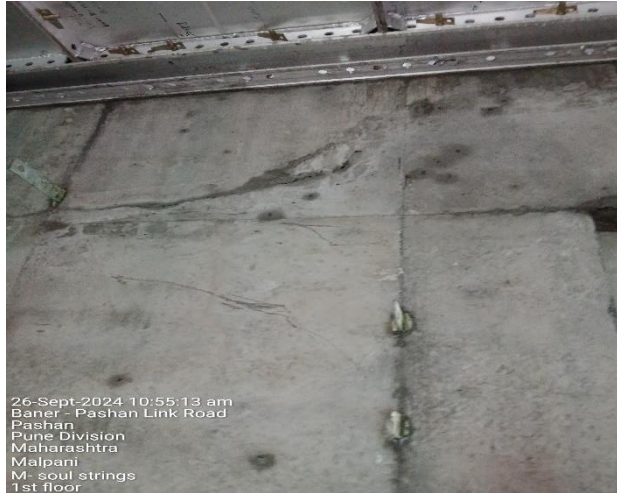
<p>26-Sept-2024 10:55:13 am Baner - Pashan Link Road Pashan Pune Division Maharashtra Malpani M- soul strings 1st floor</p>	Site Inspection

Site Inspection
17	Site- Tower C 1 <sup>st</sup> Floor	RCC- Minor honeycombing observed in the concrete surface	Minor Observation

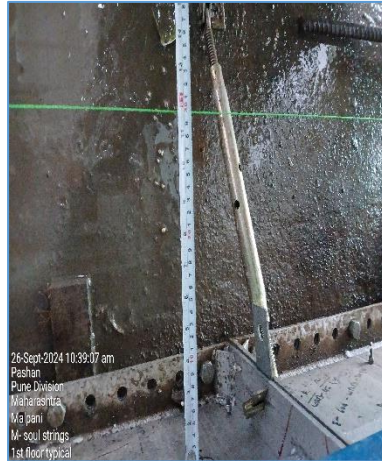
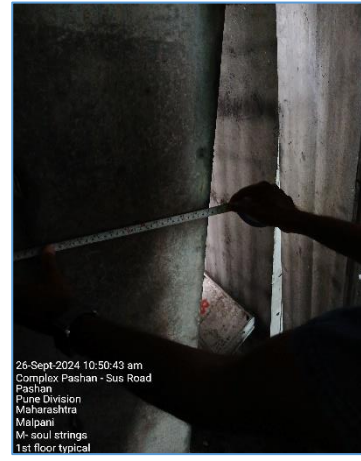
18	Tower C 1 <sup>st</sup> floor	RCC – 1)Diension were checked for one room after de-shuttering as per drawing found ok 2) Reference line was checked for aluform- ok	Positive

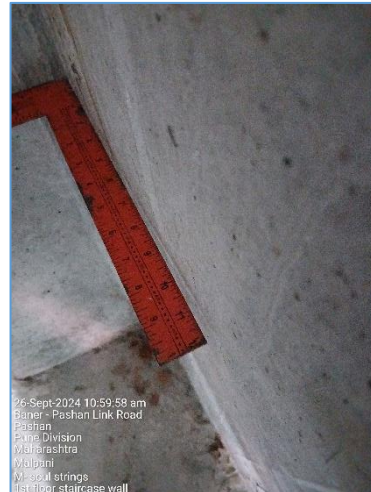
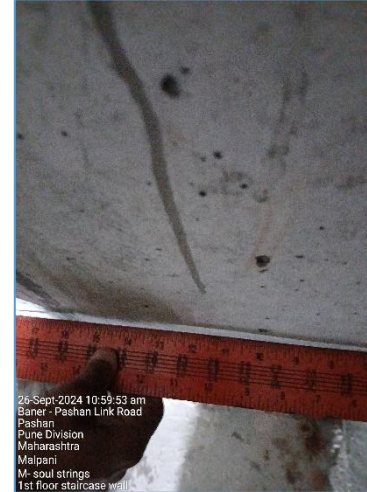
<p>26-Sept-2024 10:50:43 am Complex Pashan - Sus Road Pashan Pune Division Maharashtra Malpani M- soul strings 1st floor typical</p>	Site Inspection
19	Tower C 1 <sup>st</sup> floor staircase wall.	RCC – Checked the right angle, deviation of more than 5mmm obserevd	Minor observation

- 1) Minor Honeycombing observed in concrete at bottom portion of column column C170
- 2) Links to be secured/bend properly around the main bar.Club house basement 1
- 3) Minor Honeycombing observed in the column concrete, column PC 157
- 4) Deviation observed in wall near staircase
- 5) Waterproofing membrane observed damaged at the junction and is exposed for longer duration which result into lost of its longevity and not good for further use.

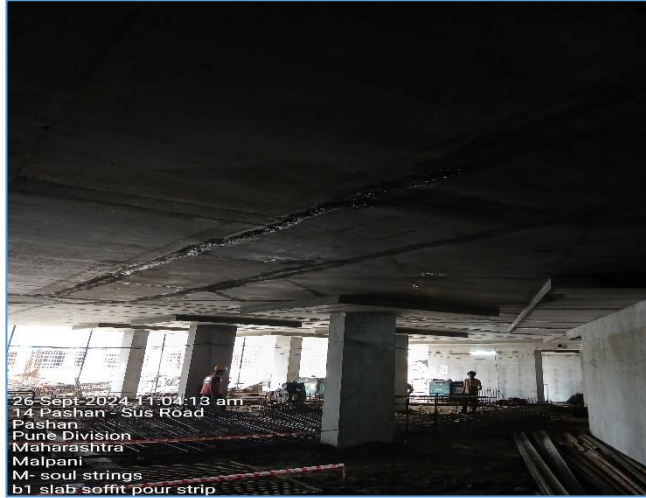
20	Tower B B1 slab soffit Pour strip	RCC- Seepage observed along the pour strip of B1 soffit Slab.	Minor observation

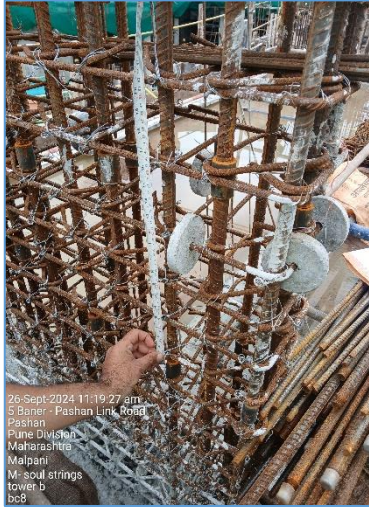
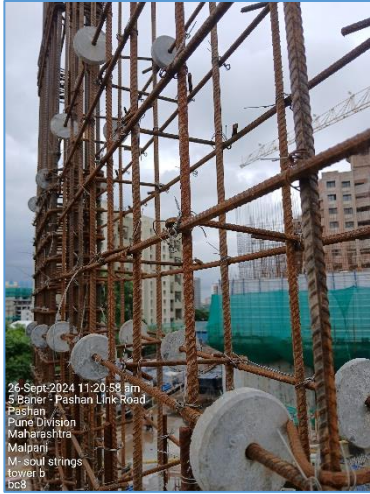
<p>26-Sept-2024 11:04:18 am 14 Pashan - Sus Road Pashan Pune Division Maharashtra Malpani M- soul strings b1 slab soffit pour strip</p>	Site Inspection
21	Site Tower B Bc8	Reinforcement – Checked the reinforcement of s/w as per drawing found ok. Improvement with respect to binding of link properly is required	Minor Observation

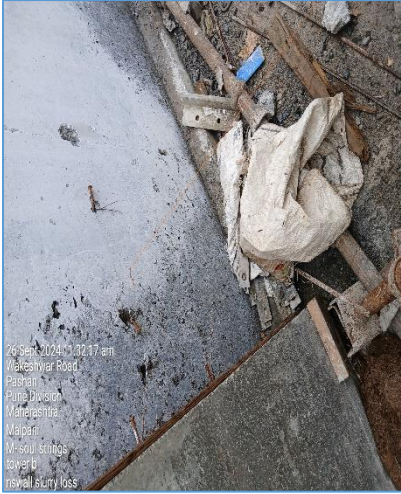
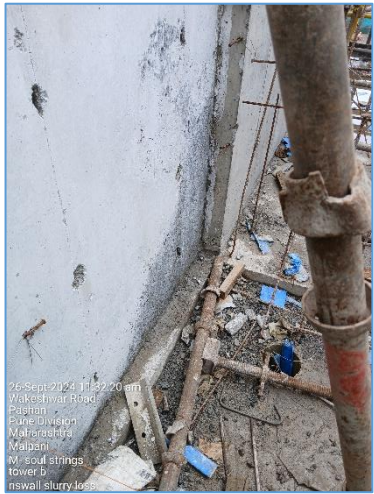
22	Site Tower B NS wall	RCC – Slurry loss and honeycombing observed on the wall surface	<b>Minor Observation</b>

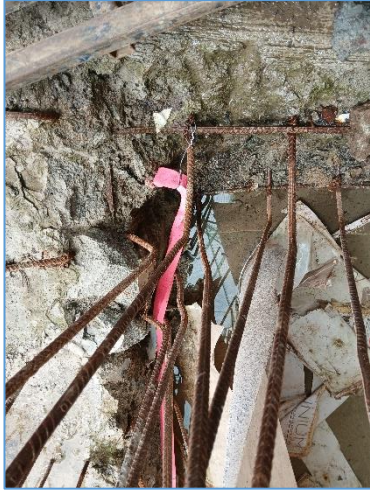
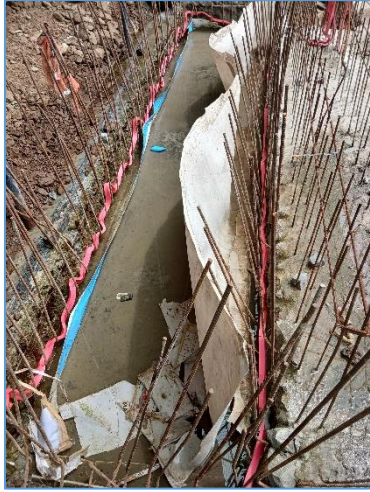
Site Inspection
23	Near tower C Pour strip at raft level	Waterproofing membrane observed damaged at the junction and is exposed for longer duration which result into lost of its longevity and not good for further use.	<b>Major Observation</b>

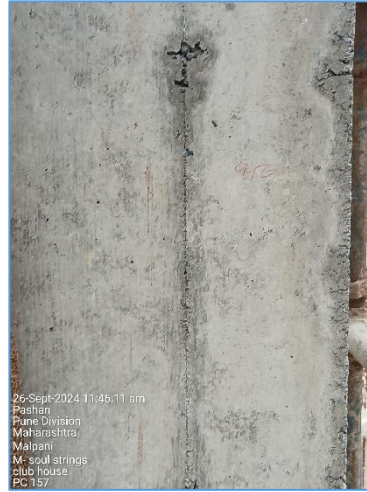
<p>26-Sept-2024 11:45:11 am Pashan Pune Division Maharashtra Malpuri M-soul strings club house PC 157</p>

24	Club House PC 157 & PC 198	RCC – Minor Honeycombing observed in the column concrete	Minor Observation

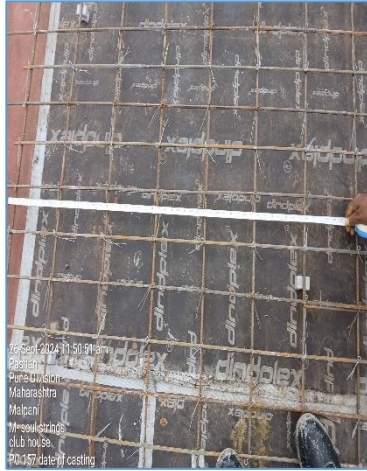
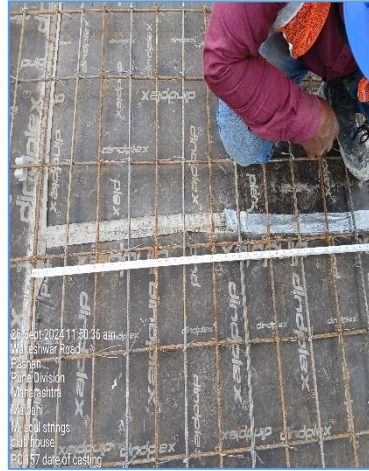
<p>26-Sept-2024 11:45:46 am Pashan Pune Division Maharashtra Malpuri M-soul strings club house PC 198</p>	Site Inspection
25	Club House Basement 1 slab	Reinforcement – ongoing Checked the bottom reinforcement as per drawing for 1) Spacing of reinforcement. 2) Lap length 3) Size and make 4) Cover to reinforcement Found ok	Positive

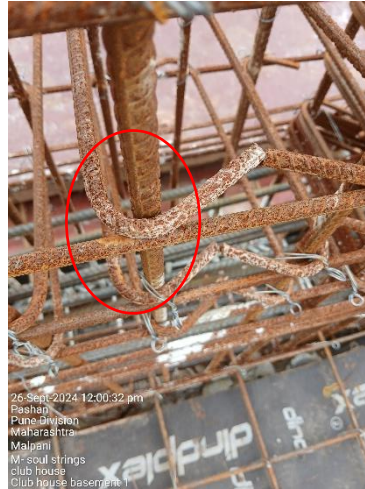
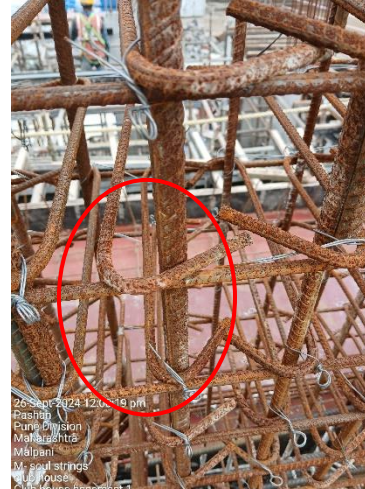
26	Club House Basement 1 slab	Column reinforcement- 1)Binding of few links is not done. 2)Links to be secured/bend properly around the main bar.	Minor Observation

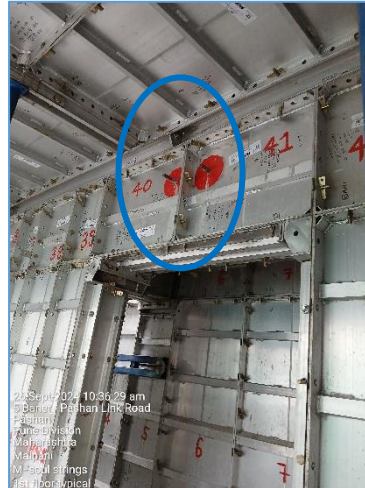
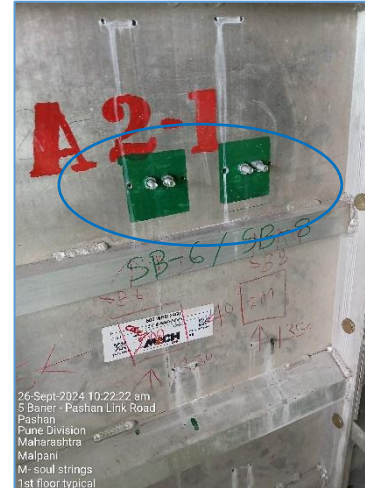
<p>26-Sept-2024 12:00:16 pm Pashan Pune Division Maharashtra Malpani M-soul strings Club house Club house basement 1</p>	Site Inspection
27		Aluform – Color coding is provided for electrical backbox template and for sleeves for easy identification.	Good Practice

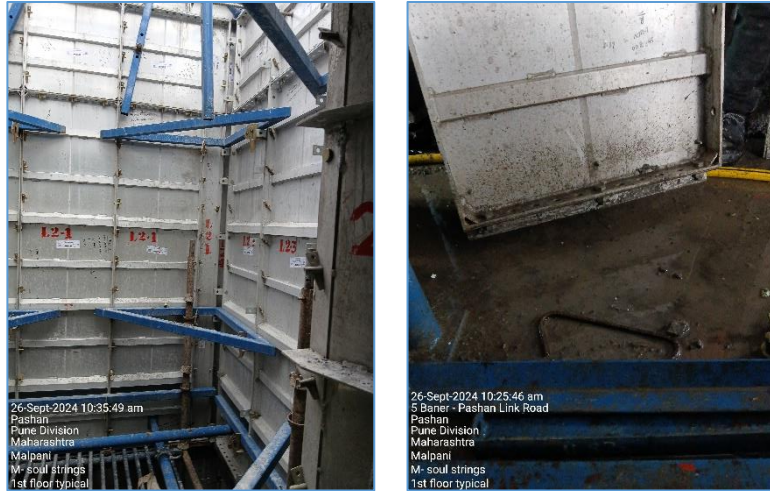
28	Site	<p>Aluform –</p> <p>1) Additional provision of Triangular support provided in the lift shaft to maintain the diagonal.</p> <p>2) Skirting groove provided in aluform itself.</p> <p>3) Electric conduit are binded using cable wire instead of binding wire.</p>	Good Practice
