M- ARYABHATA
MAHALUNGE, PUNE, MAHARASHTRA - 411045
QAQC AUDIT REPORT
16TH APRIL 2025

Building and Infrastructure Division
Site Inspection/ Audit Report

INSPECTION / AUDIT REPORT/ MGPUNE/ARYABHATA/BVP/QAQC/CIVIL/IR-05		REV.NO. 01
<input type="checkbox"/> Initial	<input checked="" type="checkbox"/> Interim	<input type="checkbox"/> Final
<input type="checkbox"/> Resident.		
Inspection/ Audit Requested By : Malpani Venture Pvt. Ltd.		
Inspection / Audit performed as Recognised Authority : Rohan A Patil		Yes <input checked="" type="checkbox"/> NO: <input type="checkbox"/>
BV Job / Zig No : 21641326

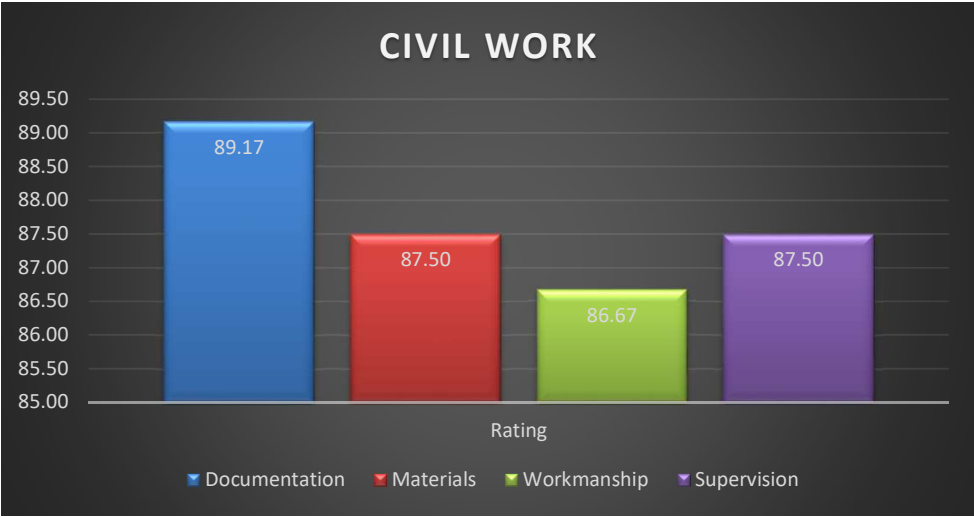
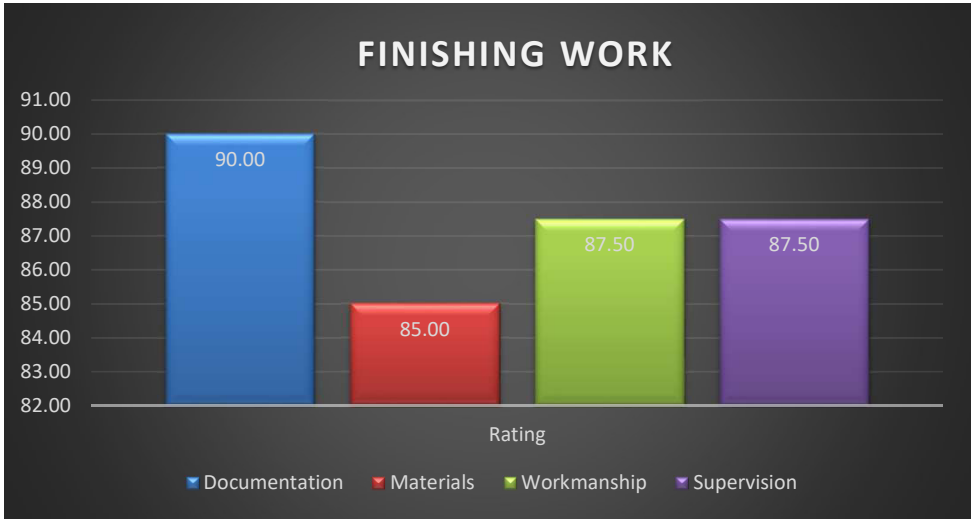
Project Quality Rating (Finishing)				
Project Name: M Aryabhata				
Parameters	Weightage in %	Rating in%	Rating	Overall Rating
Documentation	10	9.00	90.00	87.50
Materials	10	8.50	85.00	
Workmanship	40	35.00	87.50	
Supervision	40	35.00	87.50

Overall Project Quality Rating	87.42
---------------------------------------	--------------
