M- KAUTILYA
VIMAN NAGAR, PUNE, MAHARASHTRA - 411014
QAQC AUDIT REPORT
17TH APRIL 2025

Building and Infrastructure Division
Site Inspection/ Audit Report

INSPECTION / AUDIT REPORT/MGPUNE/KAUTILYA/BVP/QAQC/CIVIL/IR-04		REV.NO. 00
<input type="checkbox"/> Initial	<input checked="" type="checkbox"/> Interim	<input type="checkbox"/> Final
<input type="checkbox"/> Resident.		
Inspection/ Audit Requested By: M- NETWORK ESTATE PVT LTD		
Inspection / Audit performed as Recognised Authority: Rohan A Patil		Yes <input checked="" type="checkbox"/> NO: <input type="checkbox"/>
BV Job / Zig No : 21641690

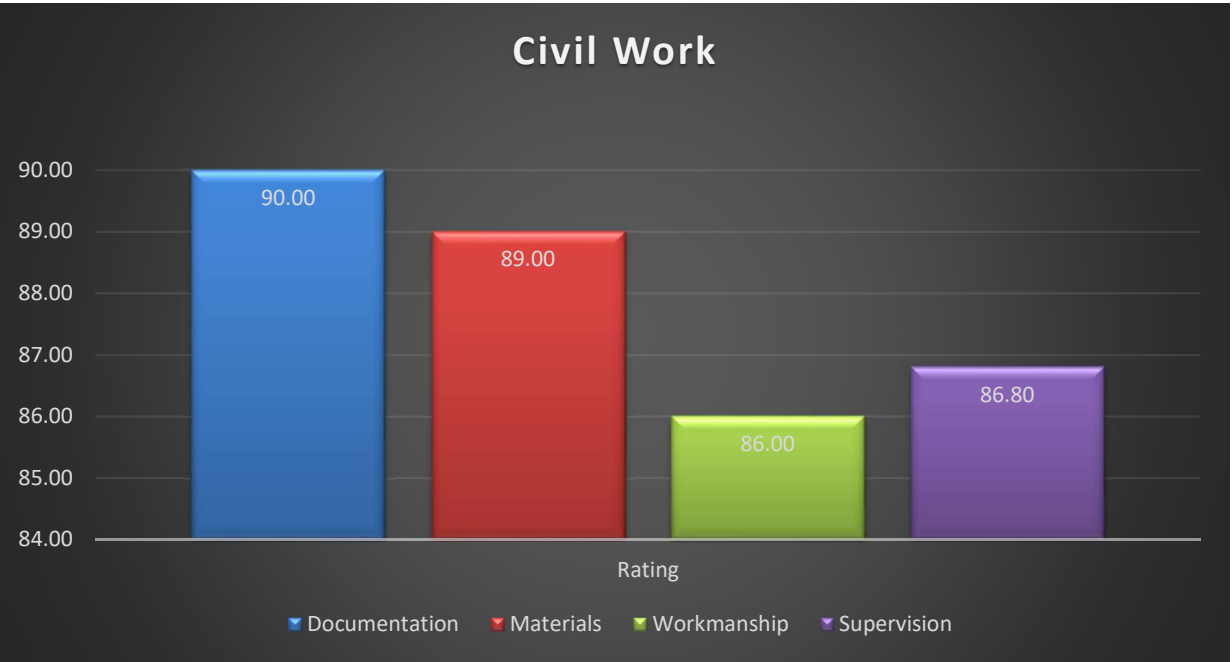
Project Quality Rating (Civil)				
Project Name : M Kautilya				
Parameters	Weightage in %	Rating in%	Rating	Overall Rating
Documentation	10	9.00	90.00	87.02
Materials	10	8.90	89.00	
Workmanship	40	34.40	86.00	
Supervision	40	34.72	86.80
