**MALPANI LOGISTIC PARK PVT LTD.
AMBETHAN, CHAKAN, PUNE, MAHARASHTRA -
410501
QAQC AUDIT REPORT
22ND APRIL 2025**

Building and Infrastructure Division
Site Inspection/ Audit Report

INSPECTION / AUDIT REPORT/MGPUNE/INDUSTRIAL & LOGISTIC PARK/BVP/QAQC/CIVIL/IR-01		REV.NO. 00	
<input checked="" type="checkbox"/> Initial	<input type="checkbox"/> Interim	<input type="checkbox"/> Final	<input type="checkbox"/> Resident.
Inspection/ Audit Requested By : Malpani Industrial & Logistic Park Pvt Ltd			
Inspection / Audit performed as Recognised Authority : Rohan A Patil		Yes	<input checked="" type="checkbox"/> NO: <input type="checkbox"/>
BV Job / Zig No : 26262058

Project Name: Malpani Warehouse, Chakan	IPO (if applicable):N/A
Audit by: Bureau Veritas (India)Pvt Ltd, Pune	PO no. WO/Warehouse/2025/147 Date 01 Apr 2025
Vendor/Manufacturer: Malpani Group	PO No. N/A (Client to Vendor)
Architect: PROCONVIS CONSULTANCY PVT LTD	Contractor: GROUP SURYA
Sub Vendor: NA	Vertical: Civil
Inspection Location: Chakan	Previous Inspection: NA
Inspection Performed from: 21 st April 2025.	Next Inspection: As per Clients requirement

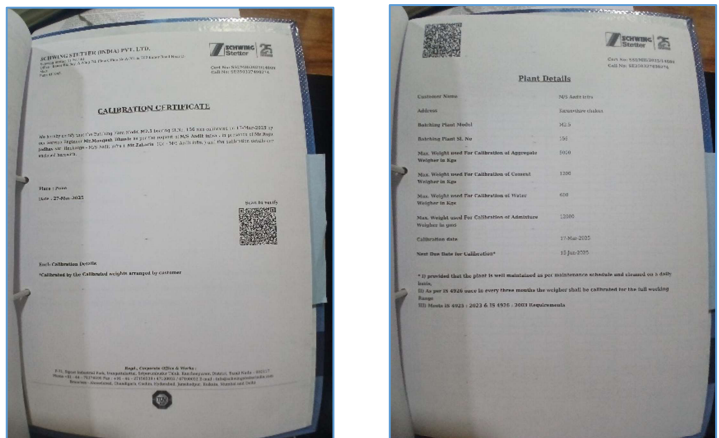
<p>1)MIR No 255 dtd.03/04/2025</p> <p>2)MIR No 252 dtd.01/04/2025</p>
4	Site Office	<p>Batching plant, calibration report</p> <ol style="list-style-type: none"> 1) Plant Model SP30 bearing Sr. No-156, calibrated on 17/03/25, verified & found valid as per QAP requirements. <p>Due 15.06.2025</p>	Positive

<p>Cert No - SSI/MH/2025/14889 dtd.17/03/25 IS 4925:2004 Concrete Batching and Mixing Plant</p>

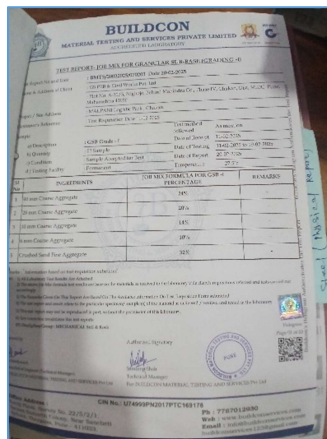
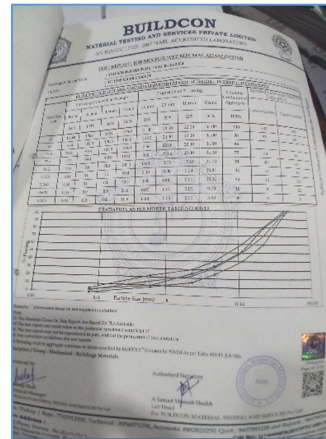
7	Site Office	<p>GSB and WMM mix design with lab testing are conducted, approved and is maintained as per QAP / ITP requirements.</p> <p>At site Density test are carried out and record are maintained</p>	Positive

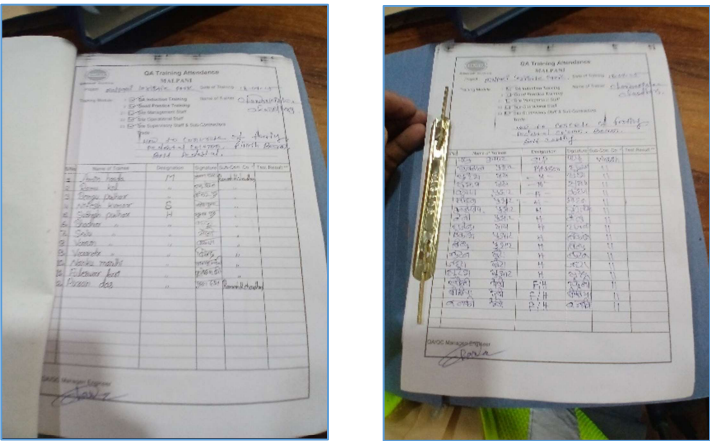
12	Site Office	Randomly checked training record for various personnel involved in the site activity. Records were in order	Positive

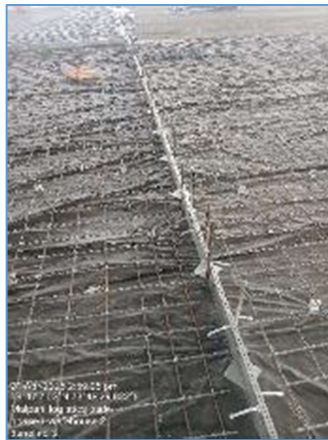
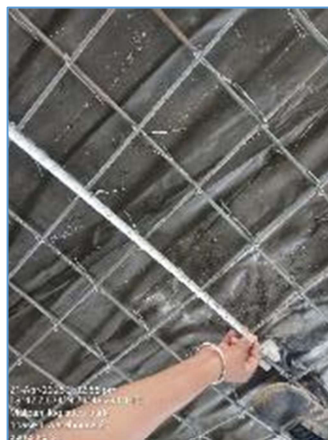
21	Warehouse 2 FM2 Flooring	Reinforcement – 1)Checked the reinforcement as per drawing, a) Diameter and grade of steel. b) Spacing of steel in both directions. c)Lap length and staggering of lap. d)Cover to the reinforcement d) Armour joint distance and size	Positive

Site Inspection. Drwg.No – MILPC_PCPL_STR_VD FLOOR_A2_05 R0 dtd 22.02.2025
22	Warehouse 2 FM2 Flooring	Flooring– Checked the Finished level of FM2 floor and found within range as per WMS.	Positive

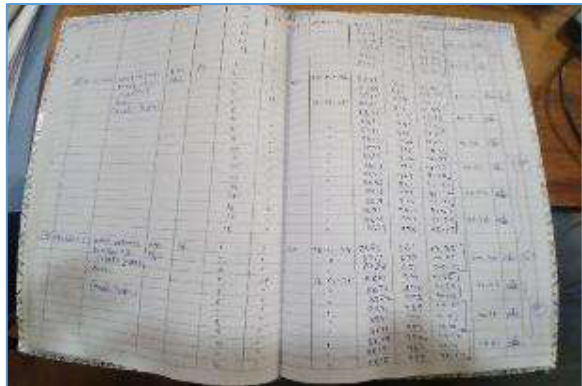
23	Quality Lab	<p>Today's Cube compressive strength test @ 28days witnessed & following result were observed, Grade of Concrete M25</p> <ol style="list-style-type: none"> 1) 34.18 N/mm² 2) 33.47 N/mm² 3) 31.20 N/mm² <p>Avg. – 32.95 N/mm²</p>	Positive

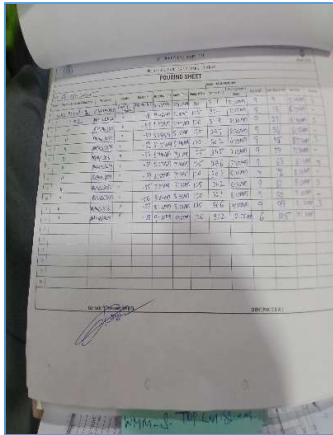
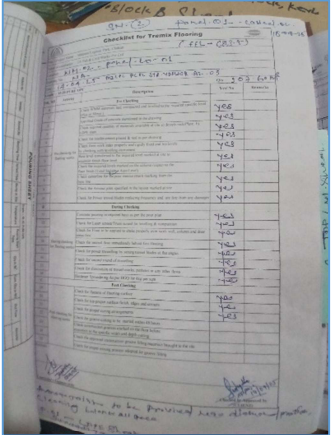
Pour card no 611 dtd.31.12.2024

24	Site Office	<p>RFI being raised by contractor & inspection is being carried out by Client. Records w.r.t to checklist are maintained as per requirements.</p>	Positive

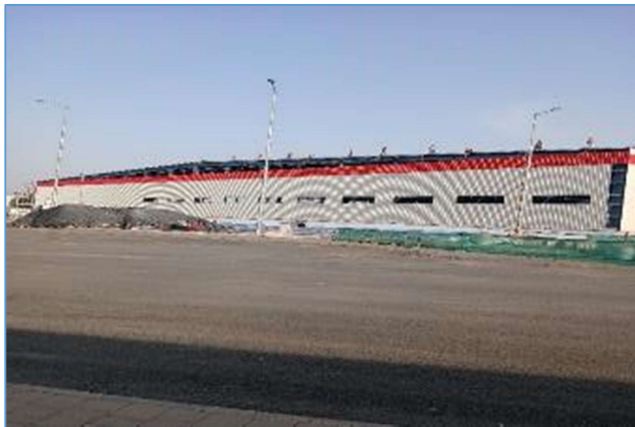
25	Site	Overall site view of Warehouse 2	Info

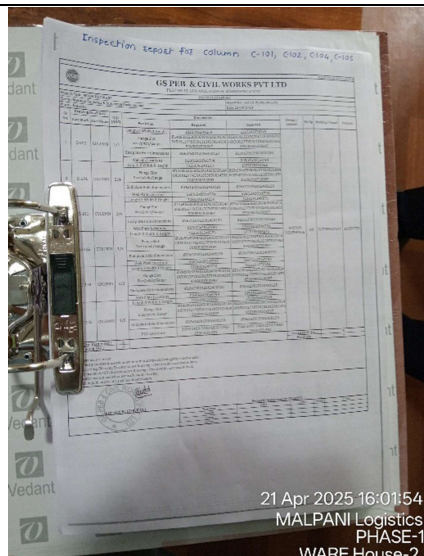
1	Phase 1 Warehouse-02	Documented Records for Field work is Not Available	Major Observation		As per work order & technical Spec
Documents Review As per QAP (Manufacturing)					
1.	Phase 1 Warehouse-02 (As per Field QAP S.N.-1)	Incomplete Material History Chart	Major Observation

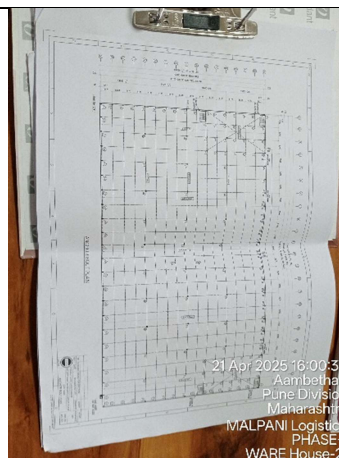
<p>malpani-qap.pdf</p>	
2.	Phase 1 Warehouse-02	Approved Make List & Technical Specification of used items	Record Not Available		
3.	Phase 1 Warehouse-02	Approved Erection Methodology	Record Not Available		
4.	Phase 1 Warehouse-02	Anchor Bolt GA drg	Positive

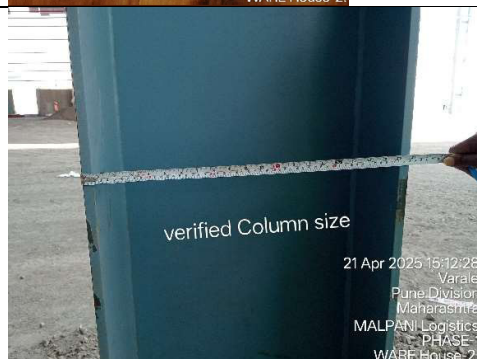
<p>21 Apr 2025 16:00:37 Aambhatan Pune Division Maharashtra MALPANI Logistics PHASE-1 WARE House-2.</p>	Approved by G.S Consultancy
5	Phase 1 Warehouse-02	Verified Column Size	Positive

<p>verified Column size 21 Apr 2025 15:12:28 Vareale Pune Division Maharashtra MALPANI Logistics PHASE-1 WARE House-2.</p>	As per Work Order & BOQ

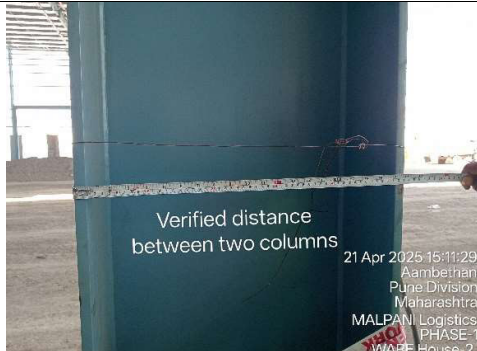
6	Phase 1 Warehouse-02	Verified Distance Between two Column	Positive
